ACCIDENT

Aircraft Type and Registration:	Reims Cessna F152, G-BJKY	
No & Type of Engines:	1 Lycoming O-235-L2C piston engine	
Year of Manufacture:	1981	
Date & Time (UTC):	21 March 2011 at 2000 hrs	
Location:	Ingleborough, North Yorkshire	
Type of Flight:	Training	
Persons on Board:	Crew - 2	Passengers - None
Injuries:	Crew - 2 (Serious)	Passengers - N/A
Nature of Damage:	Aircraft destroyed	
Commander's Licence:	Commercial Pilot's Licence	
Commander's Age:	55 years	
Commander's Flying Experience:	1,615 hours (of which 400 were on type) Last 90 days - 22 hours Last 28 days - 7 hours	
Information Source:	Aircraft Accident Report Form submitted by the instructor and further telephone inquiries by the AAIB

Synopsis

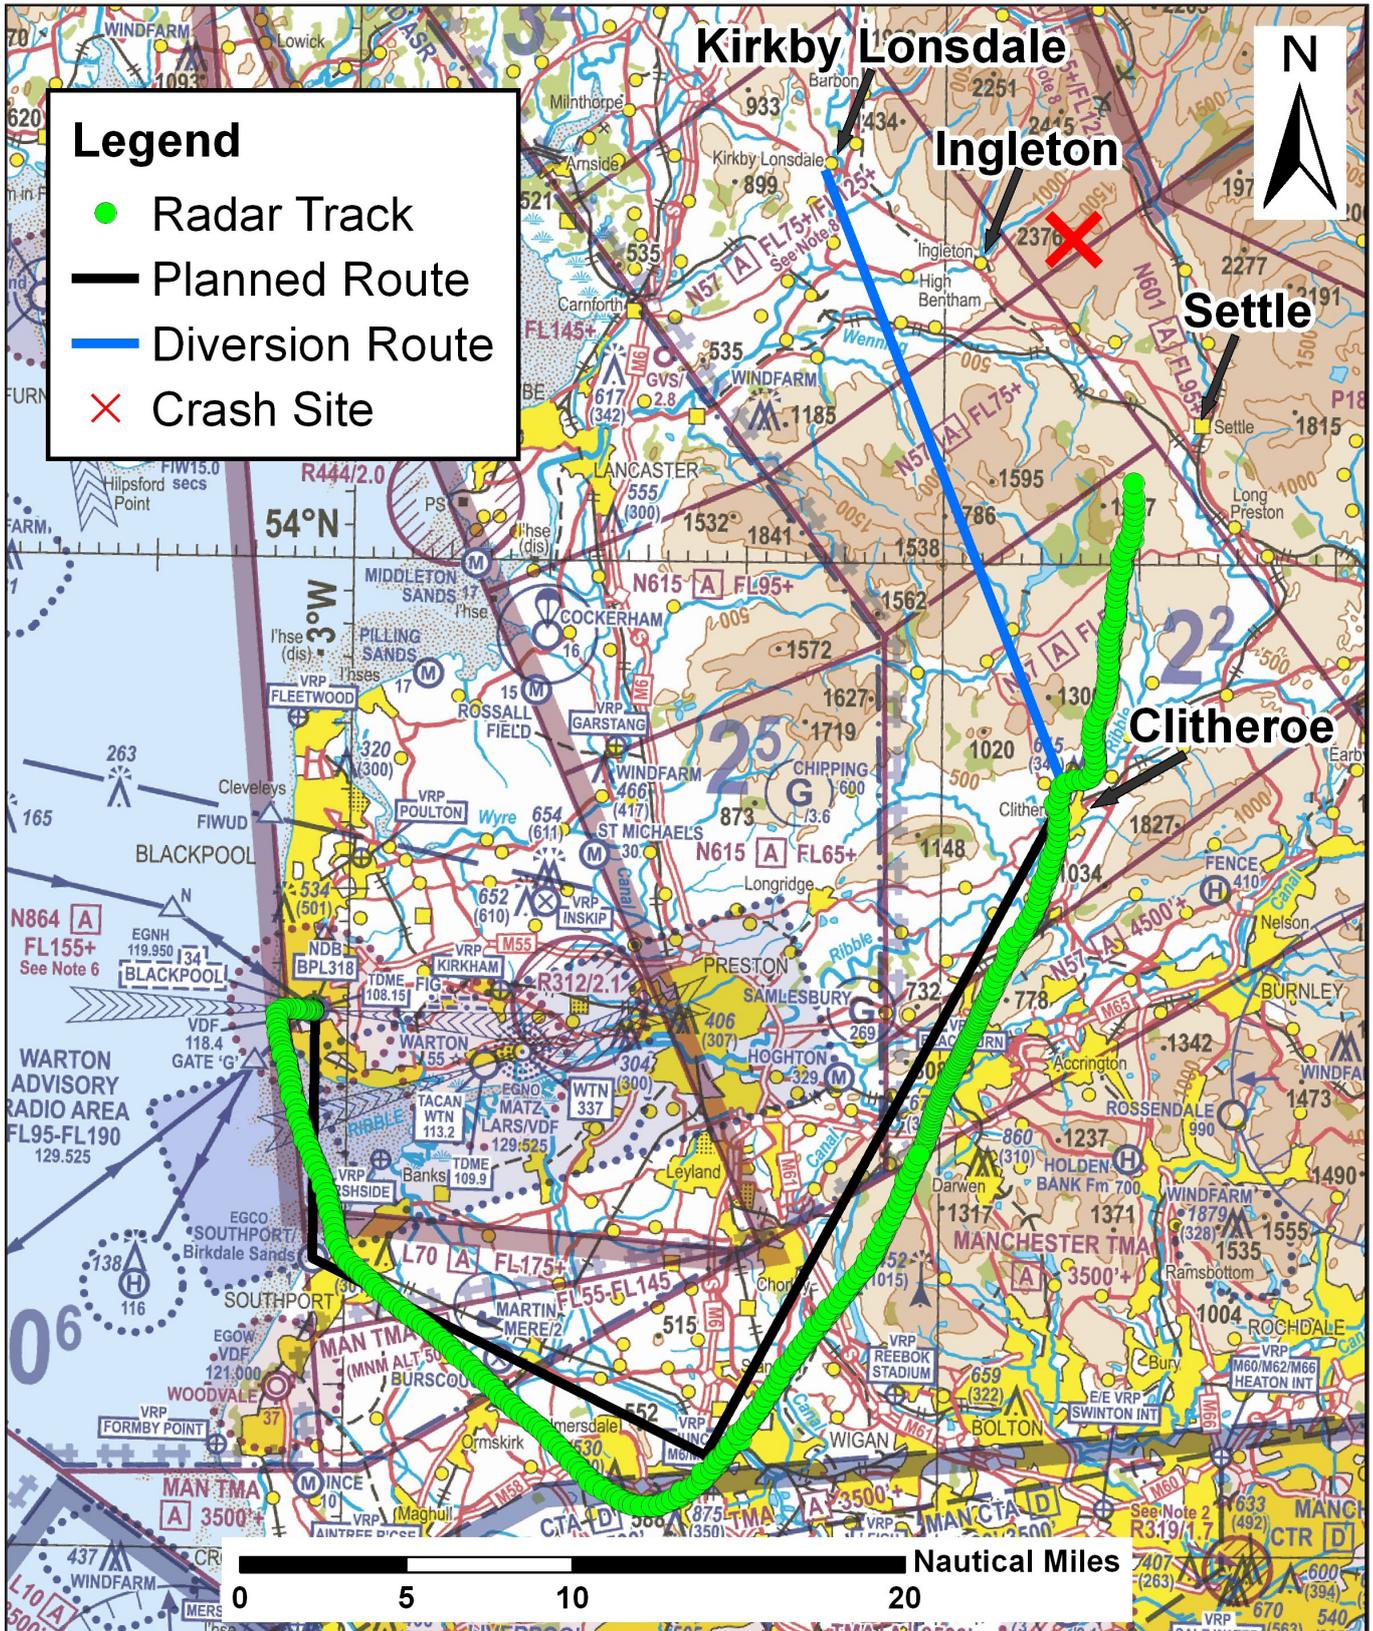
Figure 1

Reconstructed chart showing planned and actual aircraft track

The aircraft was equipped with a transponder but did not have an altitude reporting capability. A portion of the flight was recorded by three separate radars and was transposed on to a 1:500,000 chart (see Figure 1). The track information stopped about 4 nm south-west of the town of Settle, probably due to the aircraft being below radar coverage in the hilly terrain. This position was approximately 8 nm south of the accident site.

The aircraft's track from Clitheroe to Kirkby Lonsdale should have been 343°M. However, the radar data indicated that it initially tracked east before turning left on to a track of approximately 009°M, maintaining this track for at least 9 nm. It is not clear why the aircraft did not follow the correct track (it was over 25° to the east of the intended track) and the crews' recollection of this part of the flight was incomplete. The light conditions were poor and there were few visible features, if any, that the crew could use to confirm their position and any track error.

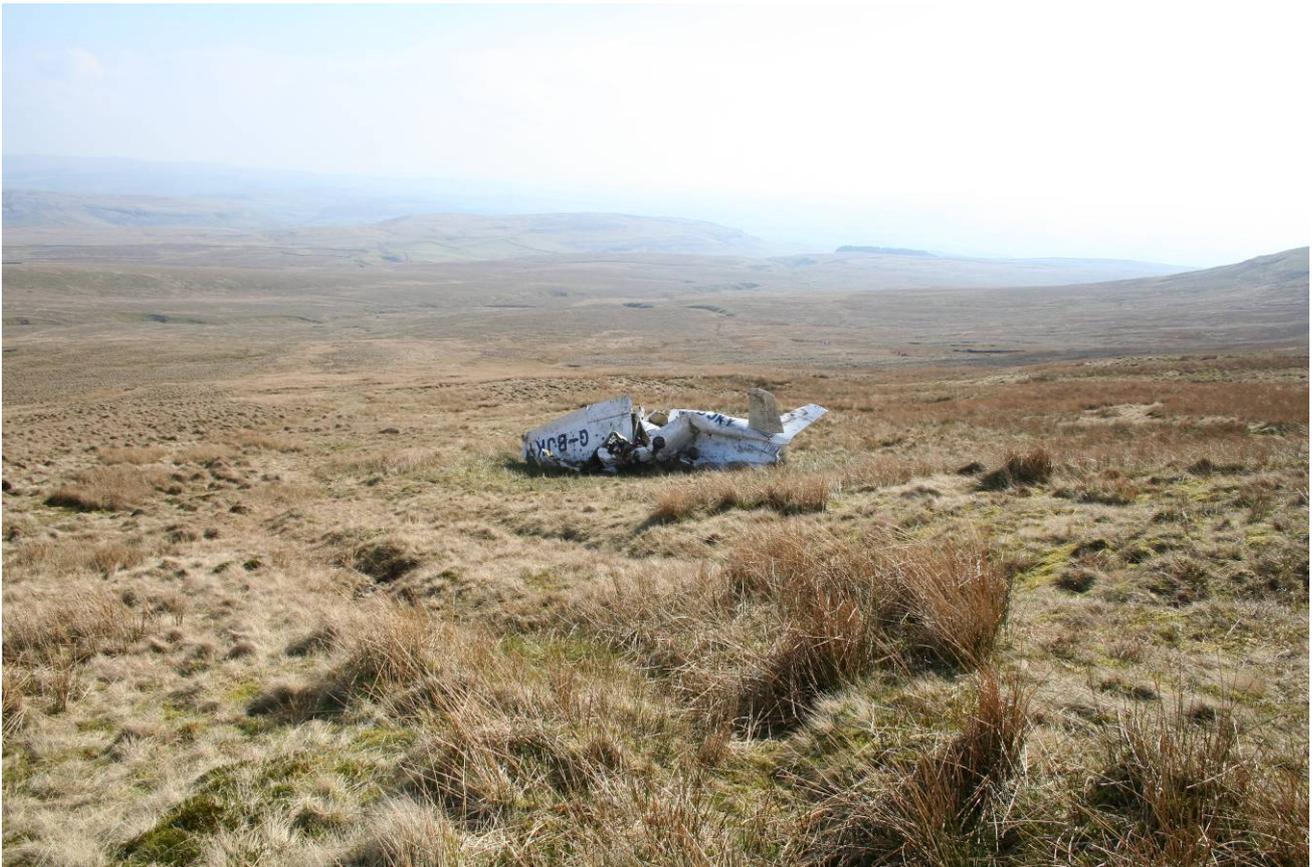
Figure 2

The accident site was located in an area of remote terrain at an elevation of approximately 1,970 ft, within 0.5 nm of the summit of Ingleborough (elevation 2,376 ft) (see Figure 2). It was 6 nm east of the direct track from Clitheroe to Kirkby Lonsdale, in an area noted for its lack of cultural lighting, 8 nm from Kirkby Lonsdale.

Accident site looking south
