Air Accidents Investigation Branch

**Report on the accident between
Grob G115E (Tutor), G-BYXR and
Standard Cirrus Glider, G-CKHT
at Drayton, Oxfordshire
on 14 June 2009**

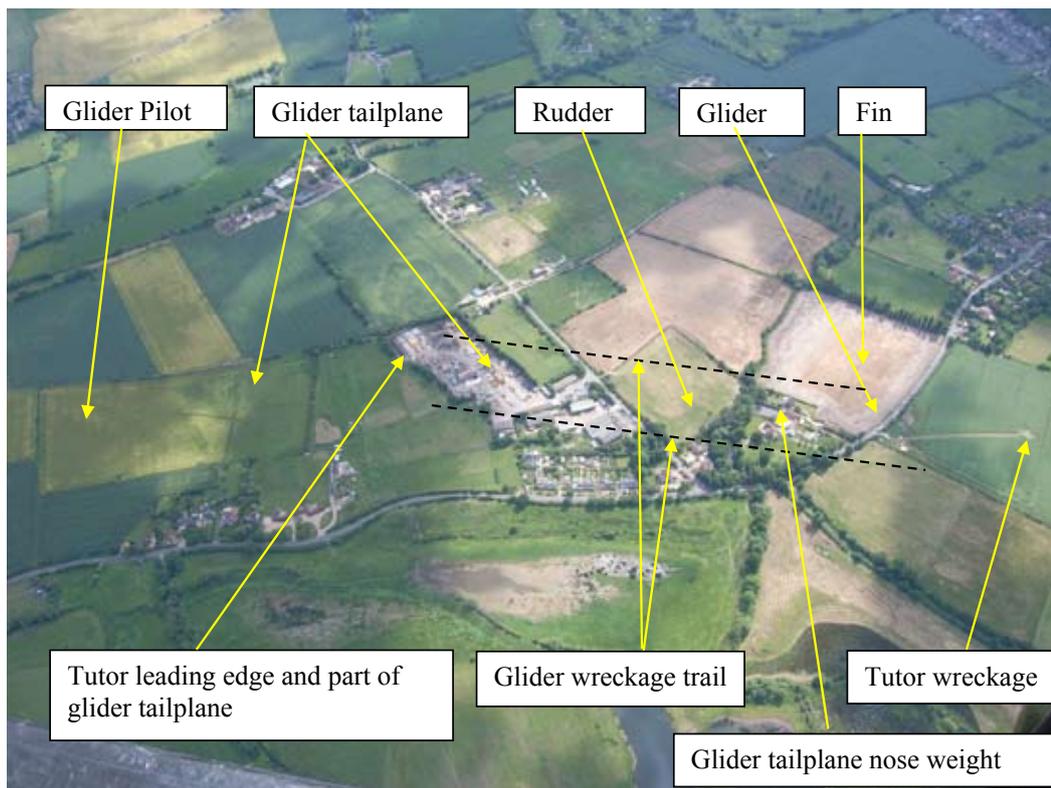
Figure 15

The combined wreckage trail extended for approximately 1 km, aligned along a track of 130°. It encompassed a small residential area, agricultural land containing a mixture of open fields and mature crops, and a large local authority maintenance yard, Figure 15. The glider pilot landed approximately 980 m from his aircraft and the majority of items found in the wreckage trail came from the glider. In addition to the significant items of wreckage detailed in Table 1, pieces of acrylic from the glider canopy and small pieces of glass fibre material were found throughout the wreckage trail.

Distribution of wreckage

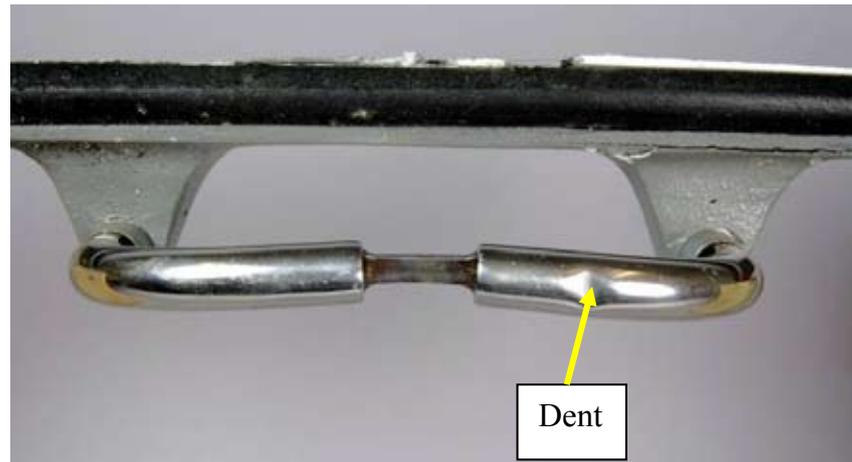
Figure 17

The canopy locking bracket, Figure 17, was slightly bowed upwards and a dent was apparent approximately 4.5 cm from the centre of the catch. No evidence was seen of any transfer of green paint or any damage to the green brackets, which might have occurred had the operating handle been in the closed position during the impact. The damage to the locking bracket is also significantly different from the damage seen on G-BYVN, where the canopy was assessed as being closed during the ground impact. This further suggests that the canopy locking mechanism was in the open position when G-BYXR struck the ground.

Canopy locking bracket on G-BYXR

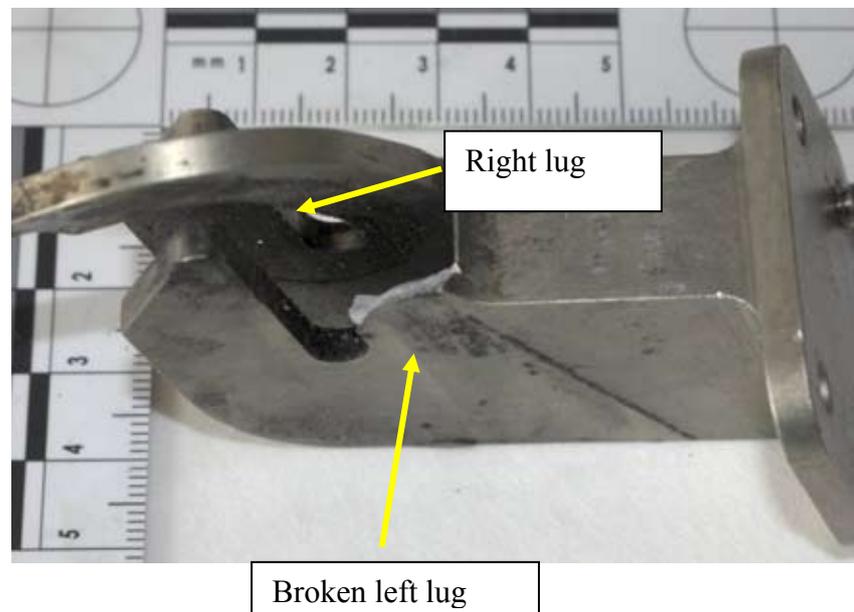
Figure 18

The left lug on the hook guide had failed in overload, consistent with a force being applied from the right, and the right lug was bent to the left, Figure 18. This damage could only have occurred if the hook was not located between the lugs at the time they were deformed. Normally, for the hook to withdraw

Hook guide

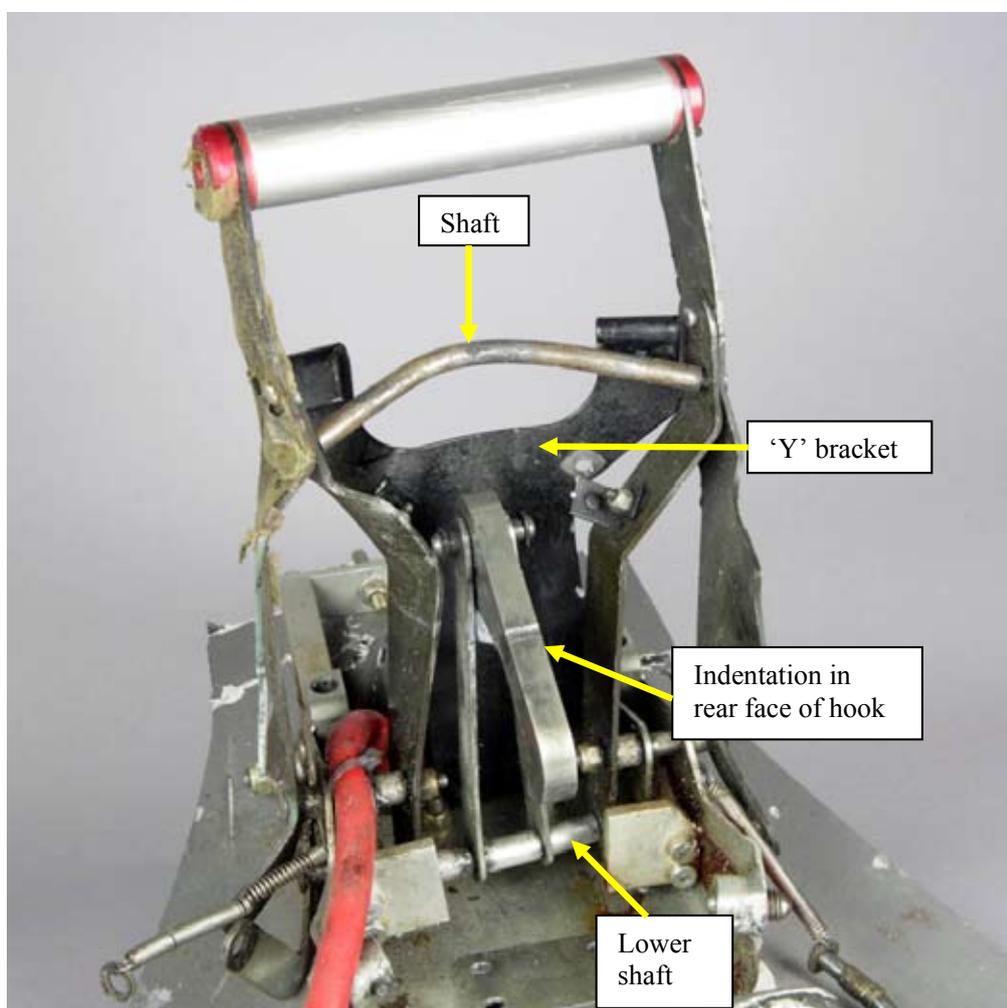
Figure 19

Apart from a small area of deformation, and normal wear, there was no damage on the front face of the hook, although there was an indentation across the rear face, which aligned with the shaft on the operating handle, Figure 19. The shaft on the operating handle had been pushed rearwards with sufficient force to distort the shaft and the sides of the operating handle. The 'Y' shaped bracket had also been deformed in a manner consistent with it being restrained at its aft face whilst the hook was forced into the front face. This would only be possible if the hook had withdrawn from the hook guide. All this damage is consistent with a force being applied to the hook causing it to move rearwards with sufficient force to bend the shaft and form the indentation.

Damage to canopy operating handle assembly

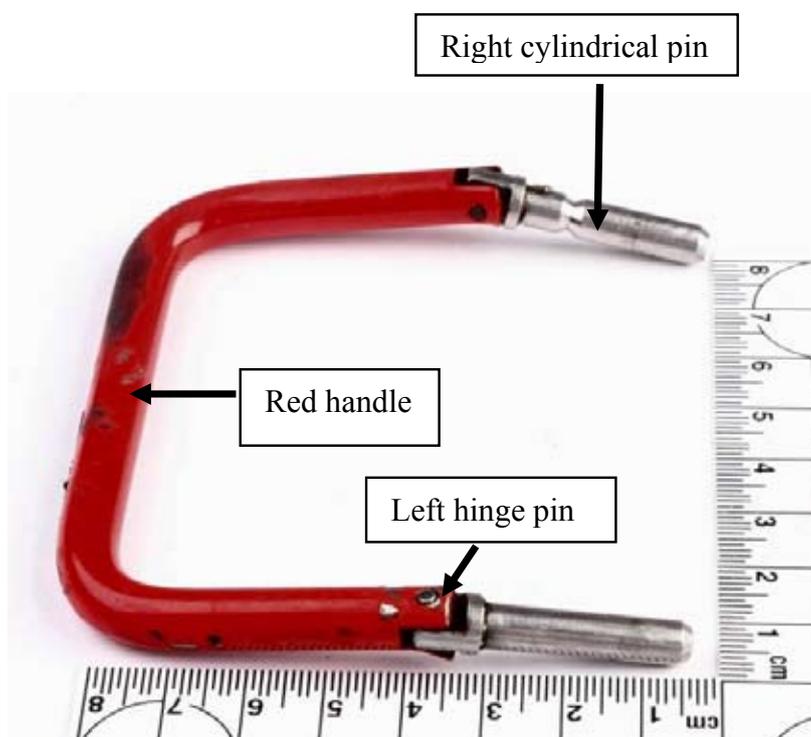
Figure 20

The left and right side of the red 'jettison' handle, where it connects to the cylindrical pins, had splayed and bent in a direction consistent with a load having been applied from the front and right side of the aircraft with the handle installed in the mechanism, Figure 20. In addition, the left steel hinge pin, which connects the cylindrical pin to the handle, had failed and longitudinal witness marks were apparent on the aft face of the right cylindrical pin. Impact and scuff marks along the bottom front face of the 'jettison' handle were also consistent with it having been subject to a large rearward force.

It was established that to fail the steel hinge pin, a force of 2,200 N (495 lbf) would have to be applied to the 'jettison' handle. Moreover, by testing a new handle, it was demonstrated that it would require a force of 546 N (123 lbf) to splay and bend the handle to the extent seen on the left side of the handle from G-BYXR. It would not have been possible for either the pilot or cadet to have applied such a force. However, the damage to the 'jettison' handle is consistent with it having being struck by the operating handle moving rearwards. This action would also account for the handle being found in the wreckage instead of being thrown forward with the other components from the canopy.

Canopy 'jettison' handle

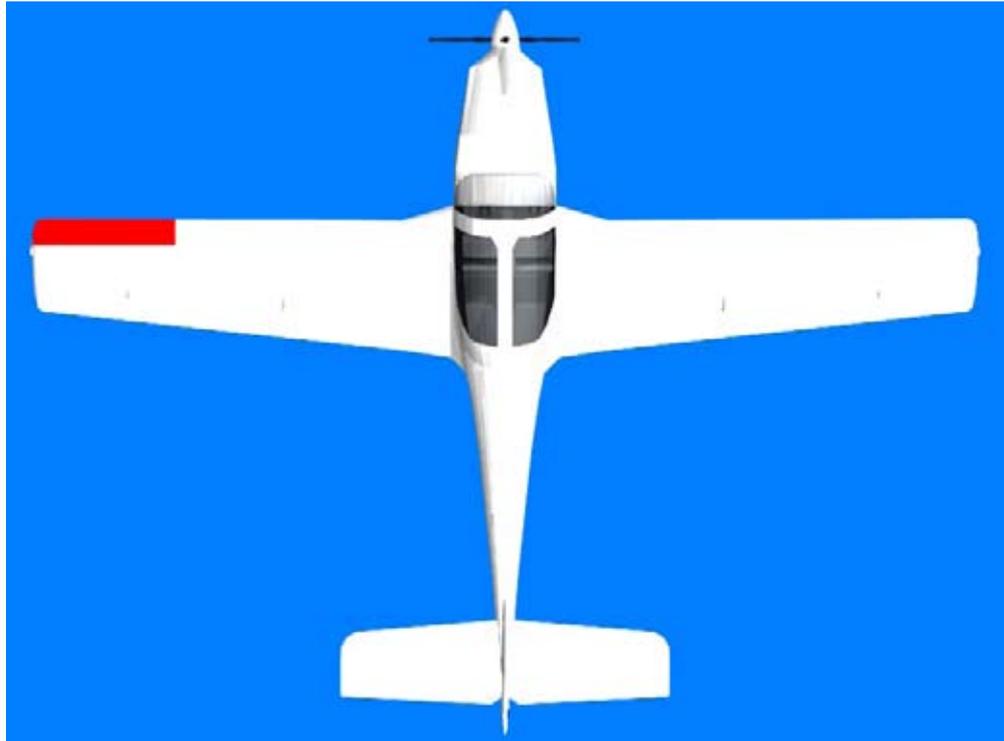
Both wings were reconstructed, as far as possible, at the AAIB's facility at Farnborough. Whilst the wings had been extensively damaged during the ground impact, it was established that, with the exception of the outer 1.5 m of the leading edge of the left wing, the aircraft had been complete and structurally intact prior to impact with the ground. There was no evidence of any pre-impact damage to the wing spars or damage to the wing skins aft of the front spars. By comparison with another aircraft, it was established that the 0.65 m section of carbon fibre structure found approximately 800 m from the main wreckage of the Tutor, originated from this section of the wing. This piece of structure had red smear marks on it, similar in colour to the identification marks on the glider. Figure 21 shows the location on the aircraft where the pre-ground impact leading edge damage occurred. The aircraft's pitot tube, which was not recovered, had been pulled from the lower outer section of the left wing.

Area of Tutor damaged in collision, coloured red

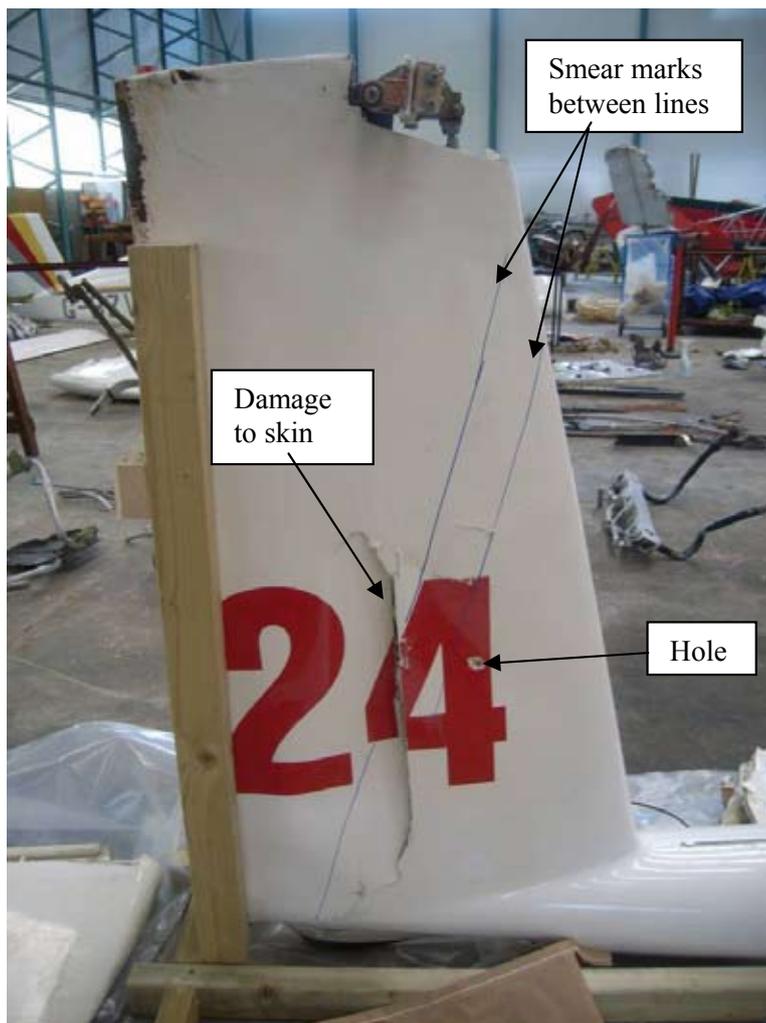
Figure 22

The left side of the fin was undamaged. The skin on the right side of the fin had been forced inwards and locally sheared where it joined a vertical spar. There were also faint black smear marks at an angle of approximately 10° to the vertical across the forward part of the fin and a puncture hole, approximately 20 mm in diameter, 74 cm from the top of the fin, Figure 22.

Damage to the glider's fin

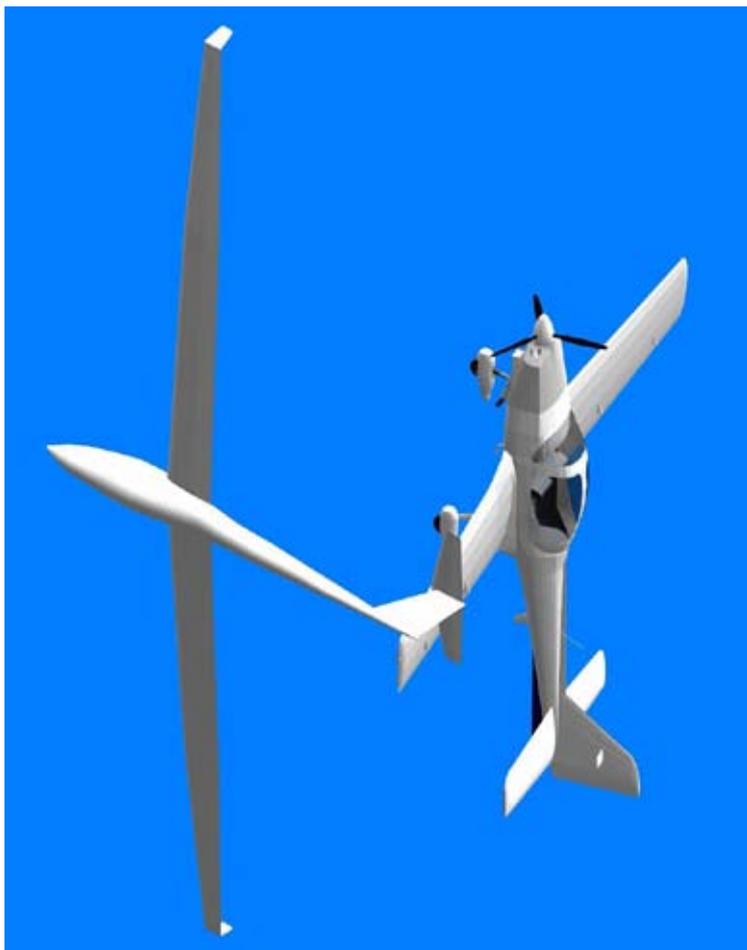
Figure 23

From examination of the wreckage, it was established that a 1.3 m section of the Tutor's left wing, approximately 0.2 m in from the wing tip, struck the right side of the glider's fin. During the impact, the pitot probe, mounted below the Tutor's left outer wing, punctured the fin and was torn from the aircraft. From the damage to the wing leading edge, and the geometry of the smear and puncture marks on the glider, it was apparent that it was the Tutor's lower wing skin just aft of the leading edge, which made contact with the fin of the glider. A visualisation of the collision is at Figure 23.

Visualisation of the mid-air collision
