Aircraft type and registration: Cessna F150M G-BFRP (light single-engined fixed wing aircraft)

Date and time (GMT): 25 October 1983 at 1936 hrs

Location: Edale, Derbyshire

Nature of damage: Aircraft destroyed on ground impact

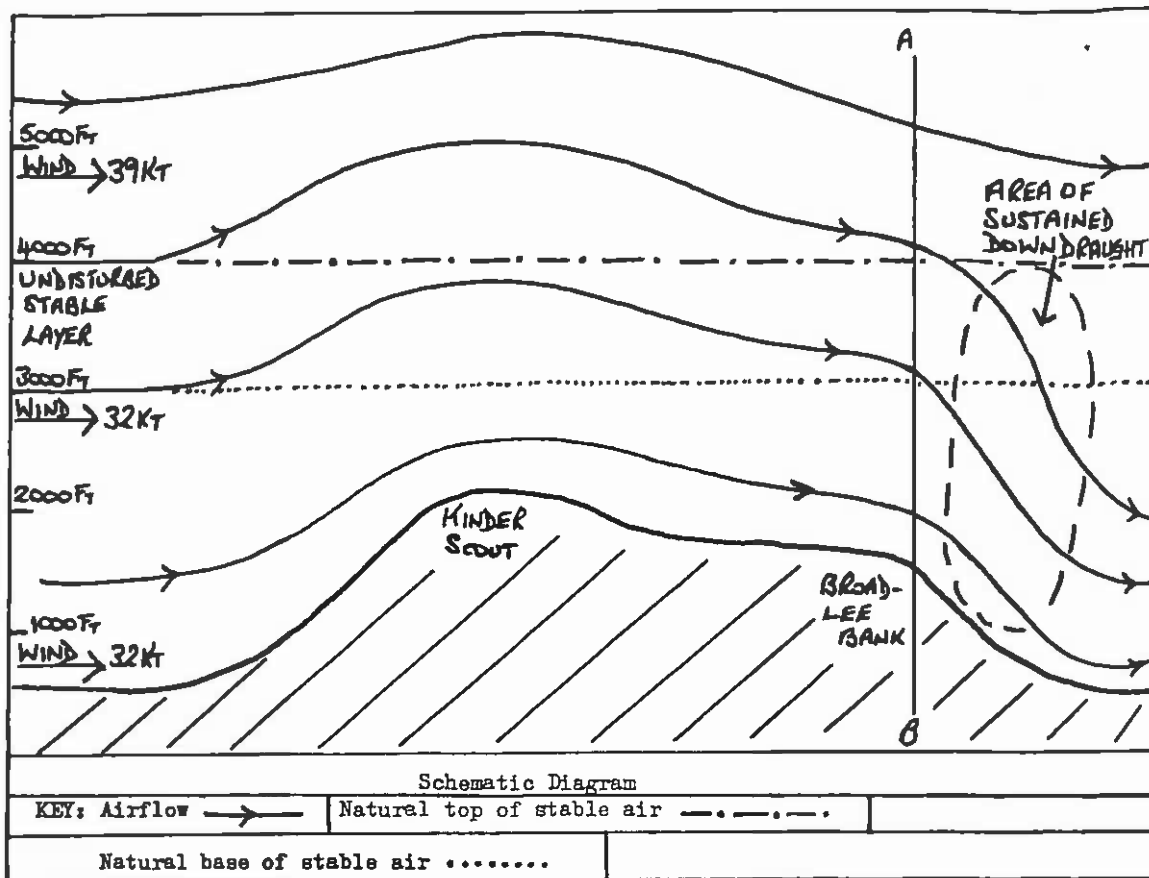
CONDITIONS OVER KINDER SCOUT, 25 OCTOBER 1983

A report from the Meteorological Office on conditions that day stated that the normal requirement for the production of mountain/lee waves, of a consistent increase of wind speed with height, did not exist. However, if the atmosphere below 5000 ft alone was considered, conditions existed which were ideal for mountain/lee waves to form. An inversion existed not far above the high ground, the wind direction was consistently at right angles, or nearly so, to the high ground and the wind showed some tendency to increase with height on the 1200 hrs and 1800 hrs ascents. The influence of the stable air above the inversion would tend to squeeze the air in the lower levels through a narrower band between the top of the high ground and the inversion, thus resulting in an increase in wind speed. The stable air itself would be forced upwards and, as it sank back over the leeward side of the hills at line A B in the diagram, its vertical momentum would carry it below its natural level before stable conditions were restored. With these conditions in the lower atmosphere, there was a strong likelihood of severe downdraughts near the lee of the high ground. The attached diagram, illustrating these conditions, is reproduced by the permission of the Meteorological Office.

It is of particular interest that, although the radar recording of the aircraft's track showed the 3000 ft wind to be approximately 290°/45 knots, the surface wind at Manchester Airport, only 14 miles to the north-west (but on the up-wind side of the Pennines), was of the order of 280°/5 knots at the time.

The behaviour of airflow over and in the vicinity of mountains and the consequent hazards to aircraft were described in AIC 13/1975. It has been recommended to the CAA that this AIC should be reviewed and reissued.
