AAIB Bulletin No: 12/94 **Ref: EW/G94/10/03** **Category: 1.3**

Aircraft Type and Registration: Isaacs Fury, G-RODI

G-RODI EXHAUST VALVE FAILURE

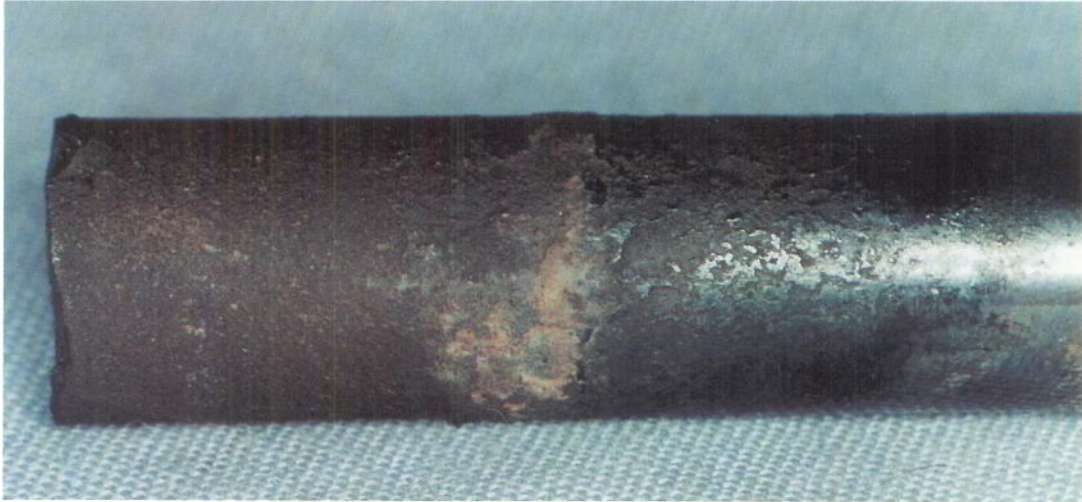
Figure 1

With reference to Figures 1 and 2, examination of the exhaust valve stem showed that it was a very loose fit in the guide and that the guide bore was heavily 'coked' with the combustion products. The stem was also heavily coked adjacent to the fracture and this coke layer had been compacted on that part of the stem which slid in and out of the guide when the engine had been running. The valve stem fracture face was also covered in a layer of coke, except where mechanical damage had occurred during the final failure. Plastic deformation of the stem material was only associated with a small area of the fracture face, the rest of the surface being generally typical of that resultant from a cyclic tension fatigue mechanism, with slight superimposed axial bending. A specific origin for the crack was not established, or for how many hours the crack had been growing, but it was estimated that many millions of load cycles would have been required to produce the type of damage present.

Valve stem failure region

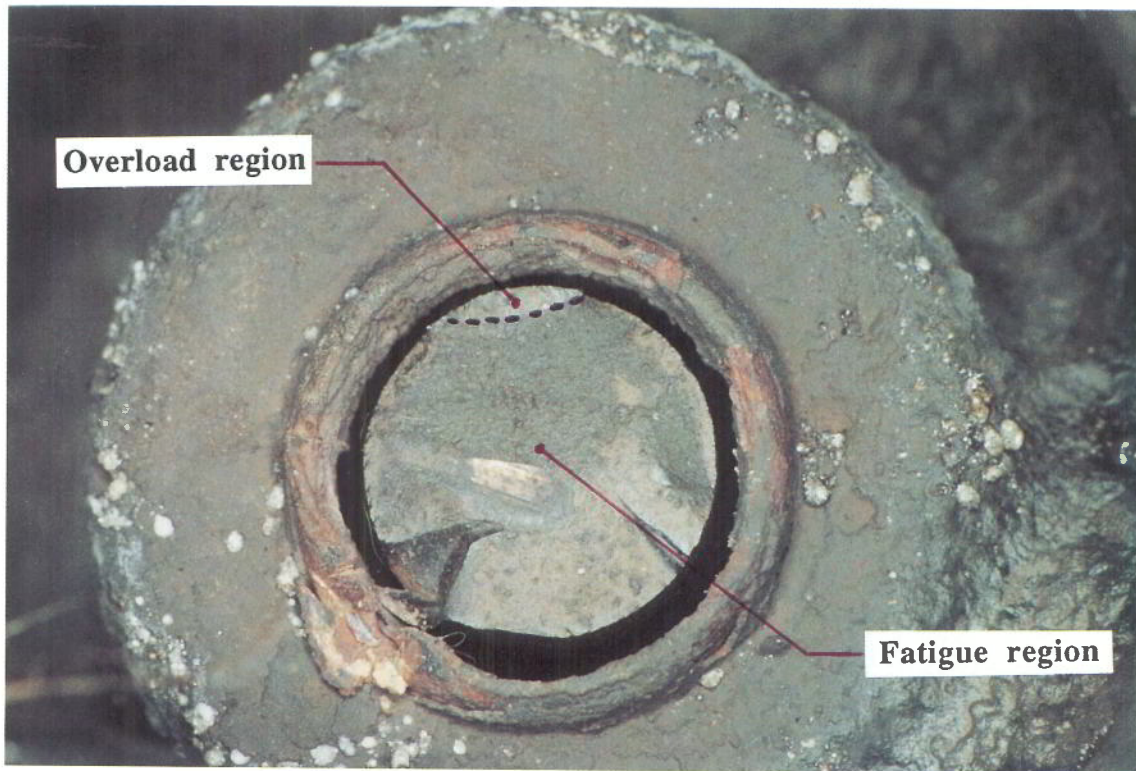
Figure 2

Stem fracture face before removal from valve guide
