**AAIB Bulletin No: 9/95**

**Ref: EW/C95/4/3**

**Aircraft Type and Registration:** Midland Ultralights Sirocco 377GB, G-MNFC

**Nature of Damage:** Aircraft destroyed

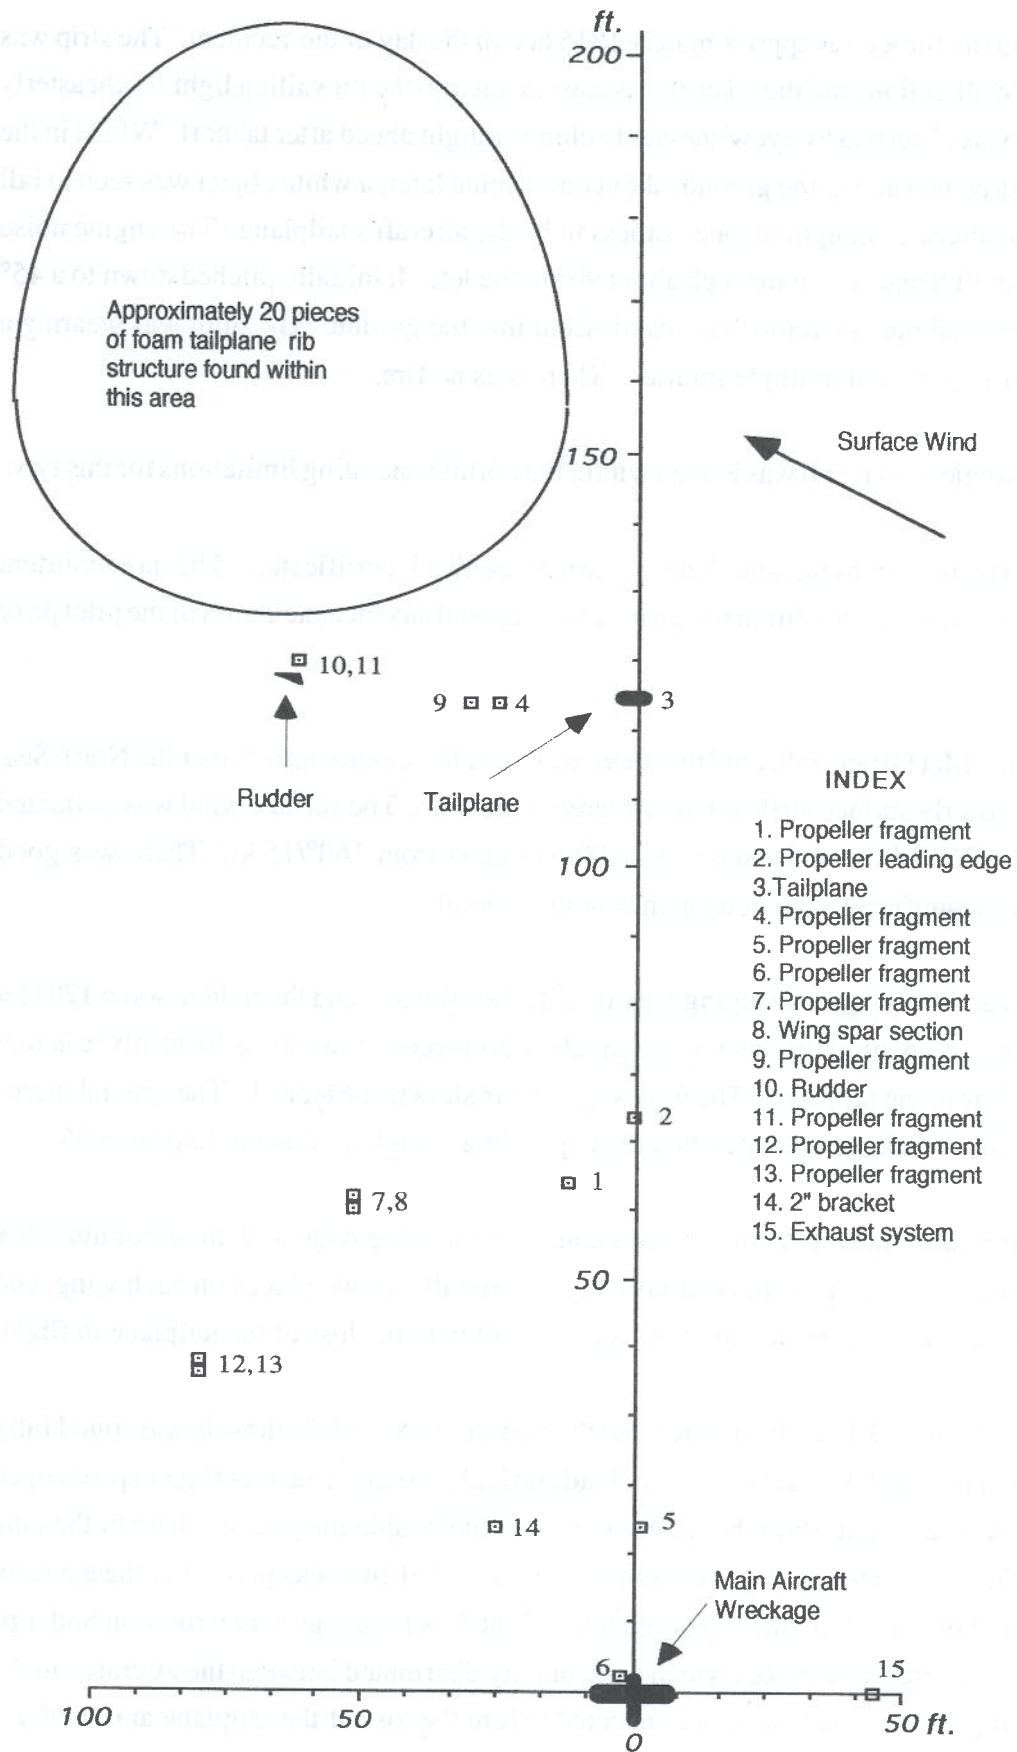
Figure 1 Wreckage Plot

The aircraft wreckage was lying on a sloping hillside with the tailplane and the rudder some 120 feet down track from the main structure, and approximately 20 pieces of tailplane foam rib structure located down wind from the tailplane. The wreckage plot is shown at Figure 1. The ground marks at the site of the main wreckage indicated that the approximate angle of descent had been 65°.

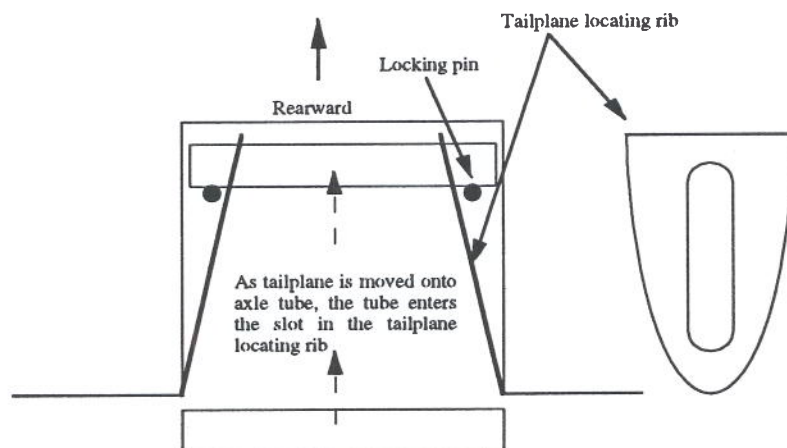
Figure 2 - Schematic showing method of fitting tailplane axle to tailplane

The elevator consisted of an all moving tailplane connected to the control stick by a push rod. The tailplane was constructed from an upper and lower glass reinforced plastic moulding containing rigid foam ribs, and was attached to the tailplane axle, the ends of which fitted into cut-outs in the locating ribs on either side of the tailplane centreline. The tailplane was retained in the cut-outs by two locking pins (see Figure 2).

The tailplane locating ribs were placed at an angle to the tailplane centreline so that as the tailplane was moved onto the axle, the axle ends moved further into the slots provided for them (see fig. 2).

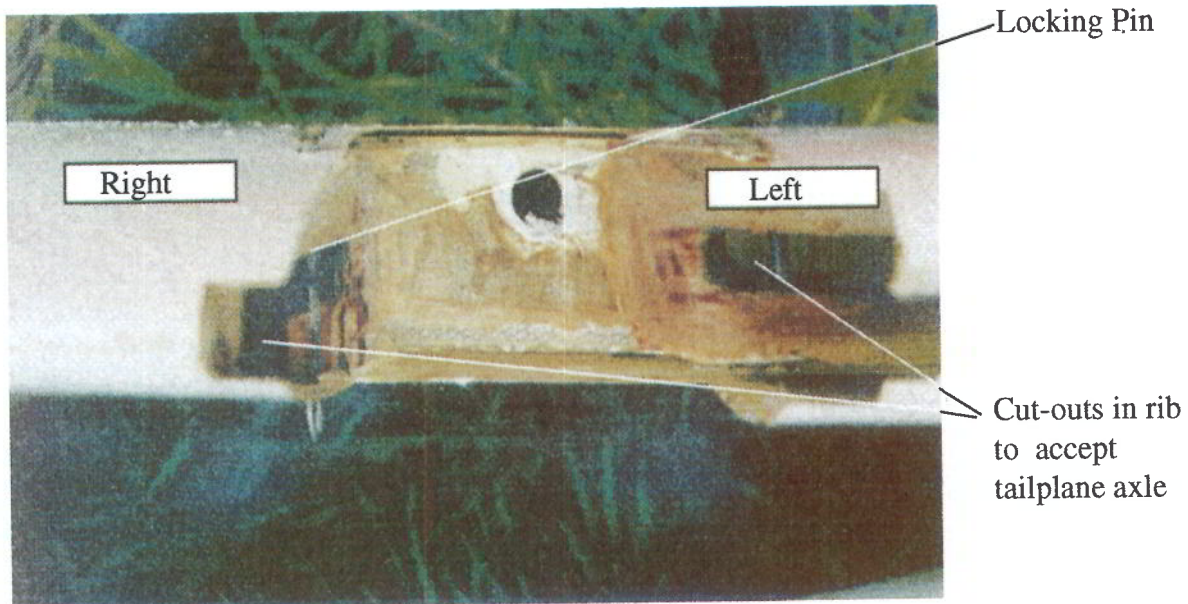
Photograph 1 - The two tailplane locating ribs and cut-outs.

The tailplane had been correctly located and was reported to have been fitted without undue force. When examined on the accident site the left-hand tailplane locating rib was found to have become unbonded from the tailplane structure, and was solely retained by its locking pin (Photo 1).

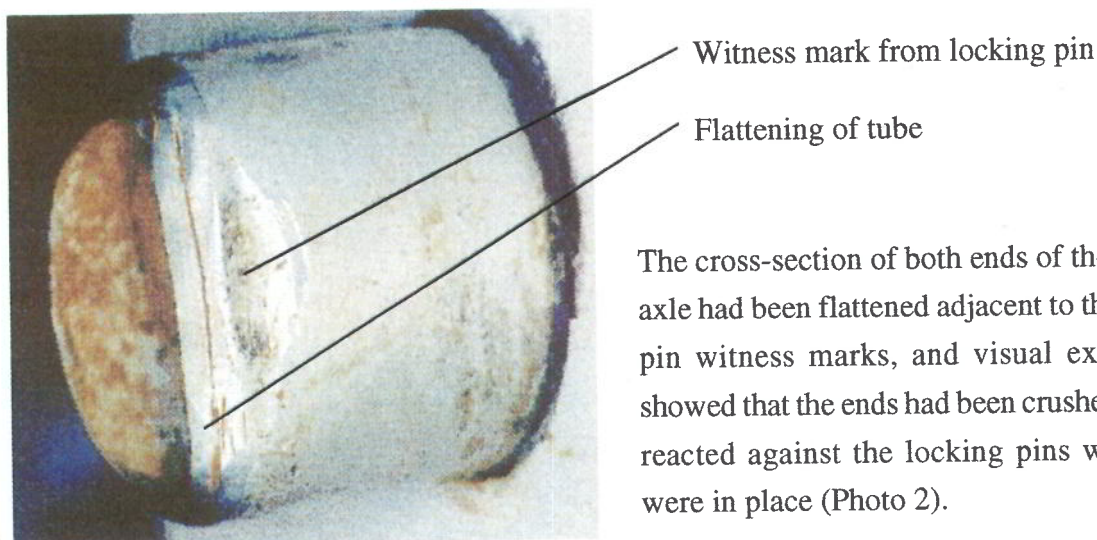
Photograph 2 - Left hand end of axle tube

The cross-section of both ends of the tailplane axle had been flattened adjacent to the locating pin witness marks, and visual examination showed that the ends had been crushed by loads reacted against the locking pins whilst they were in place (Photo 2).

The left hand end diameter of the tube had been reduced from 20mm to of 17.4 mm, allowing fore-and-aft movement of the tailplane axle in the cut-out. The length of the tailplane axle was found to be 166.5mm: the drawing calls for 170mm, but does not give a tolerance.

Witness marks made by the locking pins on the ends of the tailplane axle tube showed that the pins had been positioned 4.5mm from the ends of the tube, which had a 2.5mm chamfer *machined* on to them at an angle of 30°. This machined chamfer was not a feature of axle tubes supplied with the aircraft, which merely had the edge taken off the ends of the tube by hand.

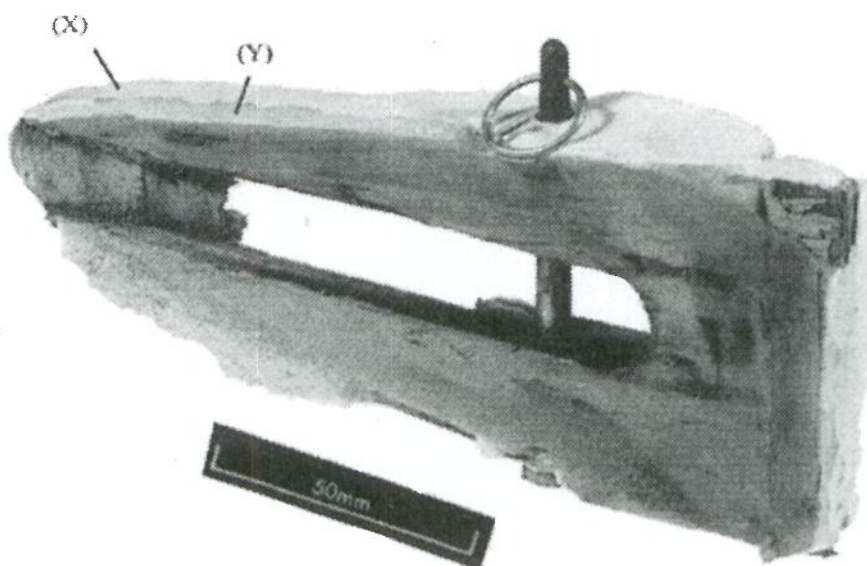
Left tailplane locating rib showing possible adhesive repair

'.....The photograph shows the smooth surface of the adhesive found on the back of the wooden rib. It was noted that the bonding between the wooden rib and the surrounding structure appeared to have been undertaken in two stages using two slightly different adhesives. On the internally bonded edge of the rib, a white adhesive appeared to have been applied first along the line (X). A second more transparent adhesive appeared to have been applied afterwards along the line (Y). Application of the second adhesive was probably from the external surface. Close examination of the interface between the two adhesives showed the edge of the white adhesive to be irregular in shape with numerous sharp edges. This suggested that the edges of the adhesive may have broken away perhaps as the result of an earlier disbond. It appeared also that in some areas the more transparent adhesive was slightly proud of the white coloured adhesive. This latter point would suggest that a disbond was present and that the transparent adhesive was inserted underneath. It is possible that the adhesive along line (Y) was applied as part of a repair. The rib on the right side was also thought to have received similar treatment.'

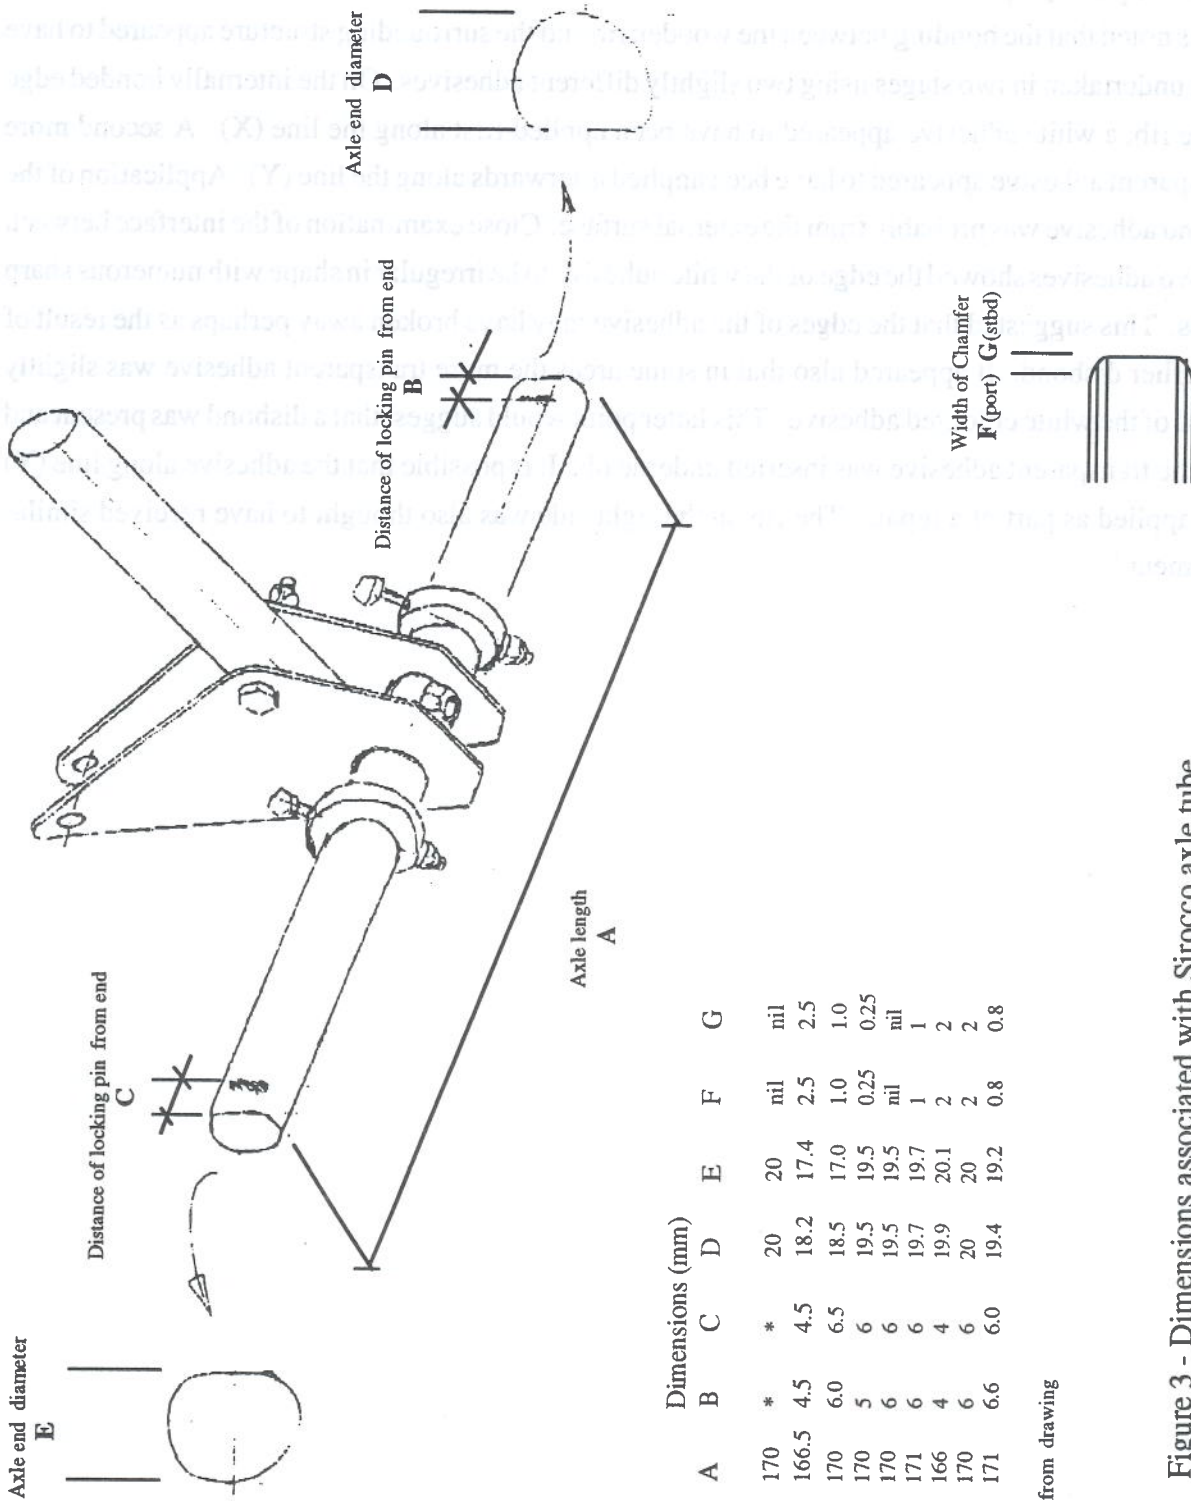
Figure 3 - Dimensions associated with Sirocco axle tube

Not only would the crushed axle tubes have allowed fore-and-aft play when fitted, but the method of retaining the tailplane, using a locking pin to bear on a point contact on a tube, had been degraded in effectiveness by the reduced distance between the pin and the end of the tube, and by the chamfer at the end. In order to assess the significance of this degradation, the axle tube dimensions of seven other Siroccos were obtained. These dimensions are summarised at Figure 3.

Drawing	Dimensions (mm)						
	A	B	C	D	E	F	G
170	*	*	20	20	20	nil	nil
G-MNFC	166.5	4.5	4.5	18.2	17.4	2.5	2.5
1	170	6.0	6.5	18.5	17.0	1.0	1.0
2	170	5	6	19.5	19.5	0.25	0.25
3	170	6	6	19.5	19.5	nil	nil
4	171	6	6	19.7	19.7	1	1
5	166	4	4	19.9	20.1	2	2
6	170	6	6	20	20	2	2
7	171	6.6	6.0	19.4	19.2	0.8	0.8
