SERIOUS INCIDENT

Aircraft Type and Registration:	BN2A MK.III-2 Trislander, G-BDTO	
No & Type of Engines:	3 Lycoming O-540-E4C5 piston engines	
Year of Manufacture:	1976	
Date & Time (UTC):	27 March 2012 at 0724 hrs	
Location:	27 nm north-east of Alderney, Channel Islands	
Type of Flight:	Commercial Air Transport (Passenger)	
Persons on Board:	Crew - 1	Passengers - 7
Injuries:	Crew - None	Passengers - None
Nature of Damage:	Uncontained engine failure with associated cowling damage	
Commander's Licence:	Commercial Pilot's Licence	
Commander's Age:	56 years	
Commander's Flying Experience:	6,150 hours (of which 3,116 were on type) Last 90 days - 27 hours Last 28 days - 27 hours	
Information Source:	Aircraft Accident Report Form submitted by the pilot and additional AAIB enquiries

Synopsis

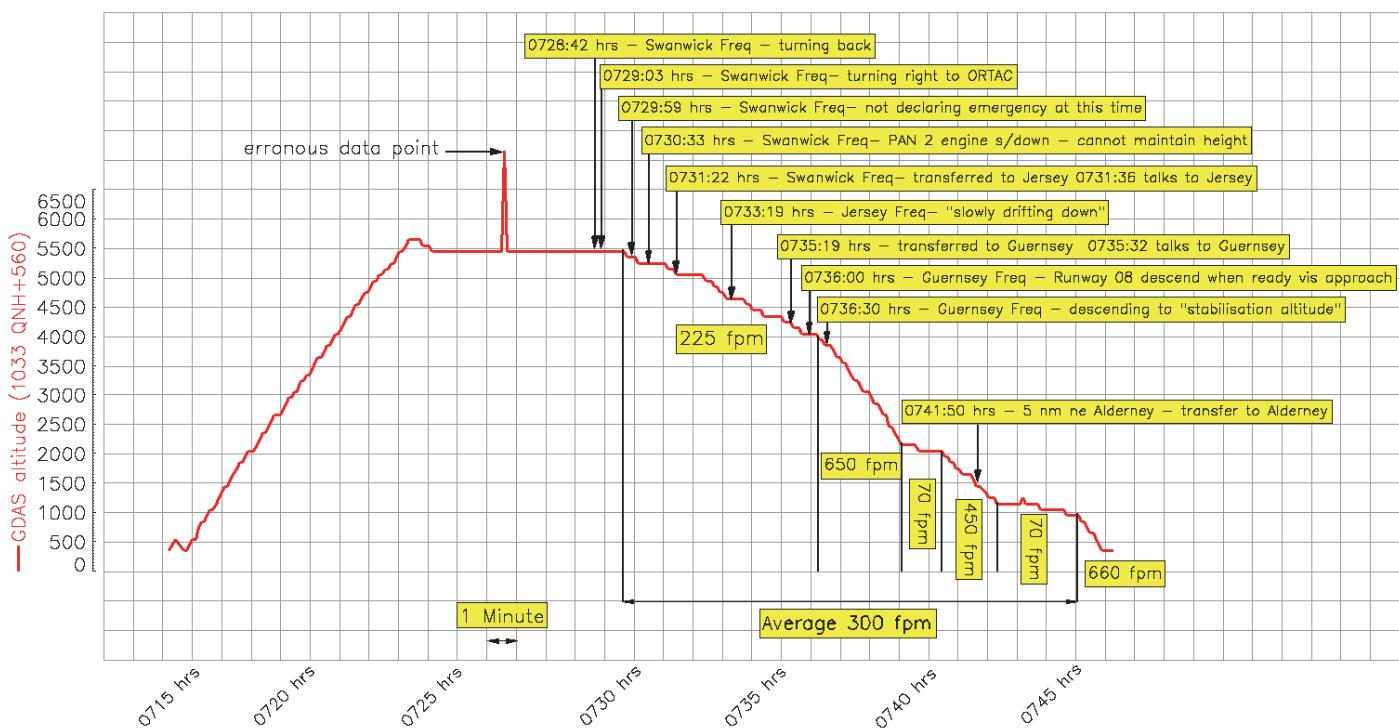
During the return to Alderney, the pilot was cleared by ATC to fly a near continuous descent profile (Figure 1) and thus did not note the altitude the aircraft had drifted down to with one engine inoperative (OEI). The pilot made an uneventful visual approach and landing to Runway 08 at Alderney.

Figure 1
Radar altitude profile of the incident flight

During the incident, the aircraft's actual descent rate from FL50 was just over 200 ft/min. Given the manufacturer's assessment that OEI with an unfeathered propeller at this altitude would give a descent rate of 140 ft/min, it would suggest the contribution of the damaged cowl was significantly less in comparison. However, no empirical evidence was available to determine an accurate performance penalty for these factors, so it was not possible to assess if obstacle clearance according to EU 965/2012 would have been maintained.

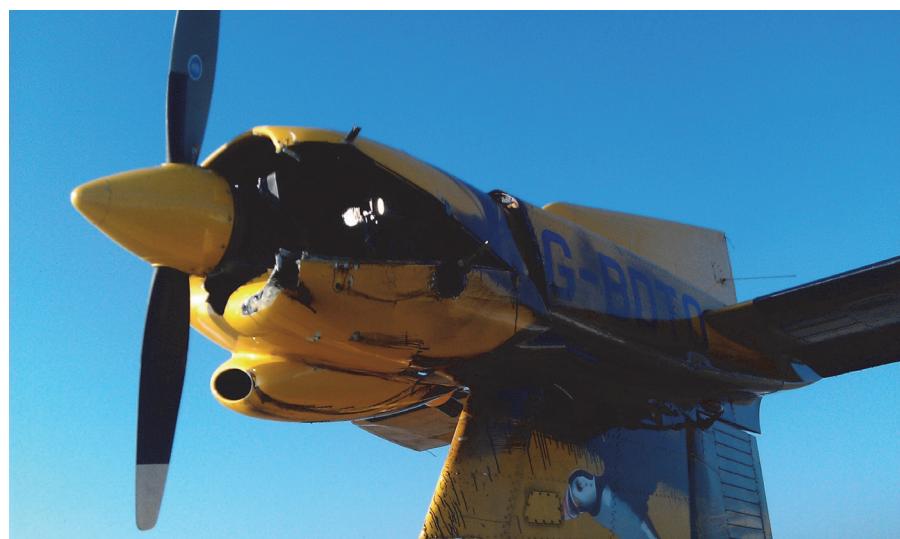
On landing, the operator’s maintenance provider inspected the aircraft. They reported that a large section of the engine cowling was missing on the left side of the engine (Figure 2). The remaining cowling and aircraft empennage were heavily stained with oil released from the engine during the failure.

Figure 2
Engine cowl damage and oil staining

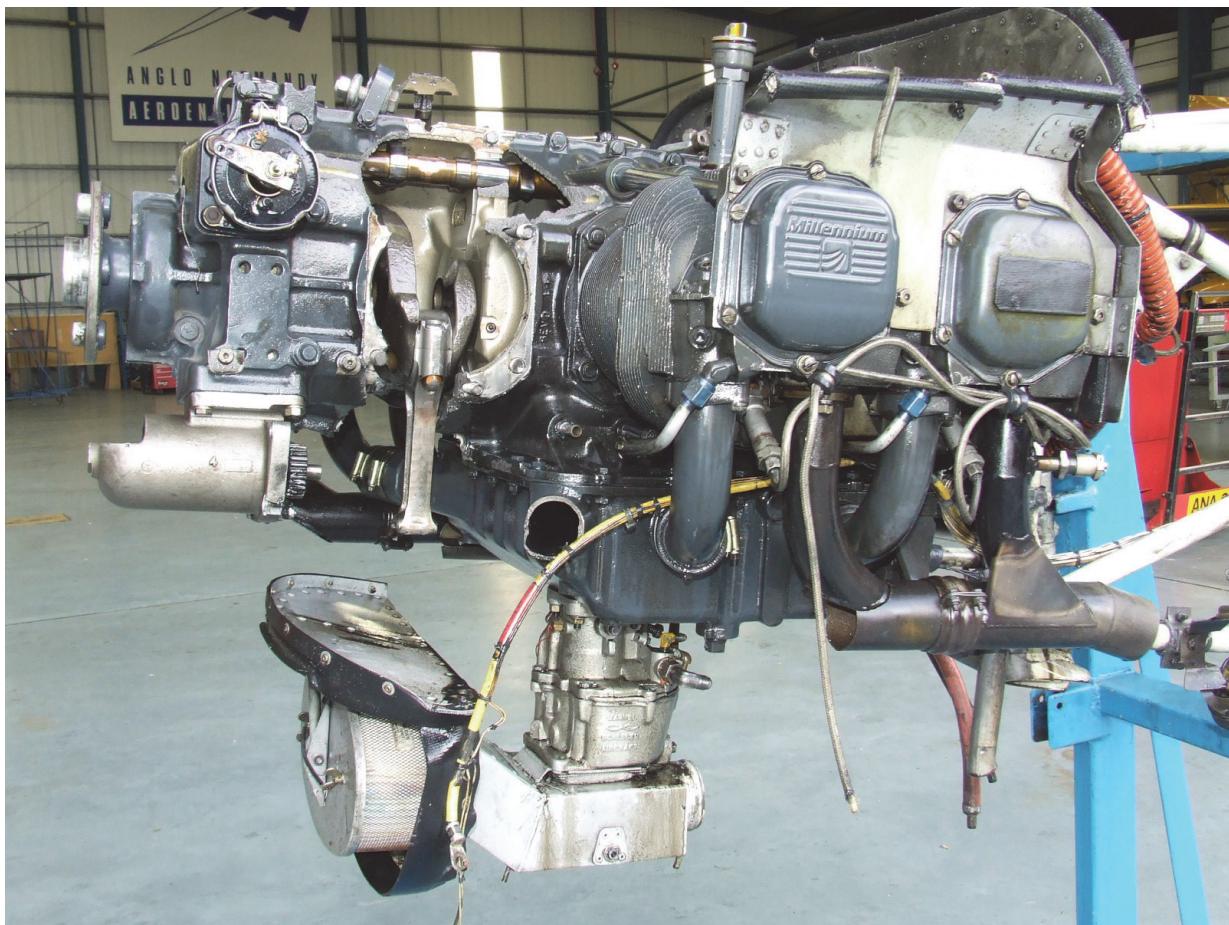
the crankcase after failure of the mounting studs. This had resulted in damage to the surrounding crankcase from the flailing connecting rod. The piston head and push rods were missing, as was the inlet pipe from the manifold and the section of exhaust pipe from the cylinder head to the exhaust manifold. The starter motor had been dislodged from the engine, but remained attached by its power lead and the guide tube for the propeller-feathering unit Teleflex control cable was damaged (Figure 3).

Figure 3
Missing cylinder and associated damage

The operator identified that the propeller had most likely initially failed to feather due to damage to the Teleflex cable guide conduit, preventing the control cable within it from moving freely when the pilot attempted to move the No 2 propeller control lever through the feather gate on the console. They considered the damage may have been caused by the release of the starter motor, which distorted the guide tube. The propeller did eventually feather some time after the pilot shut down the engine. When oil was lost from the engine through the hole in the crankcase, it is likely that there was an associated loss of oil pressure in the blade pitch control piston, allowing the feathering spring and counterweights to move the blades to the feather position.

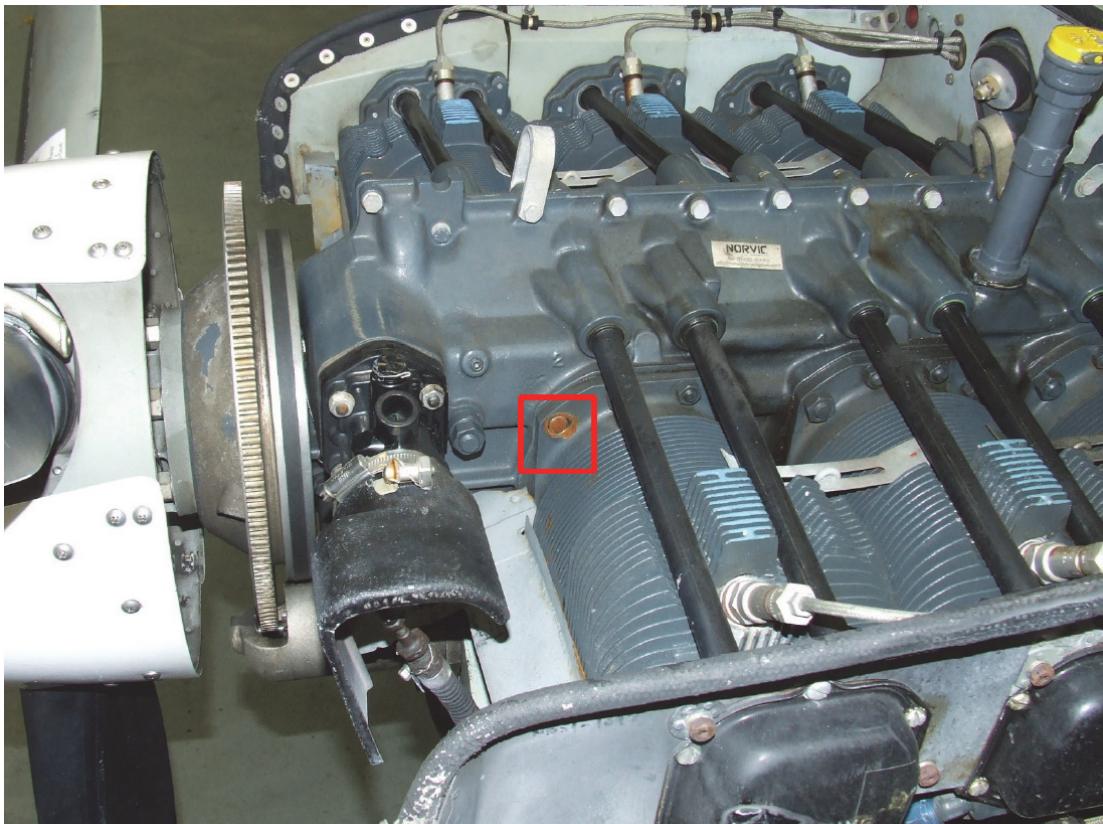
Two months after the initial incident, a routine maintenance check of the No. 3 engine fitted to another aircraft (G-RLON) from the same operator's fleet, identified another stud failure (Figure 4). This engine had operated 9,041 hours since new and 460 hours since its last overhaul. Only a single stud had failed and the released section of the stud and 'hold down' nut were found trapped in the baffle between the No 2 and No 4 cylinder barrels. The released section of the stud was sent for independent metallurgical assessment, while

Figure 4
Second mounting stud failure (G-RLON)

Analysis of the failed stud from the engine fitted to G-RION confirmed that it had also failed in high cycle fatigue initiating from a corrosion pit in the thread root. Again no cadmium coating was found on the section of the stud inspected, although traces of cadmium coating were present on the 'hold down' nut. The inspection techniques could not confirm whether the lack of cadmium coating had been due to corrosion or mechanical action

The manufacturer also challenged the findings of the independent metallurgical assessment. Their laboratory analysis of the section of failed stud from G-RLON identified overtorqueing of the stud as the cause of the fatigue crack.

Following the identification of the failed stud from G-RLON, the operator carried out a fleet-wide inspection of all their engines, checking the visual condition of the cylinder 'hold down' nuts and their torque load. No anomalies were found. They have subsequently introduced a replacement programme for the cylinder mounting studs fitted to their engines, prioritising engines in the fleet with the highest time since new.

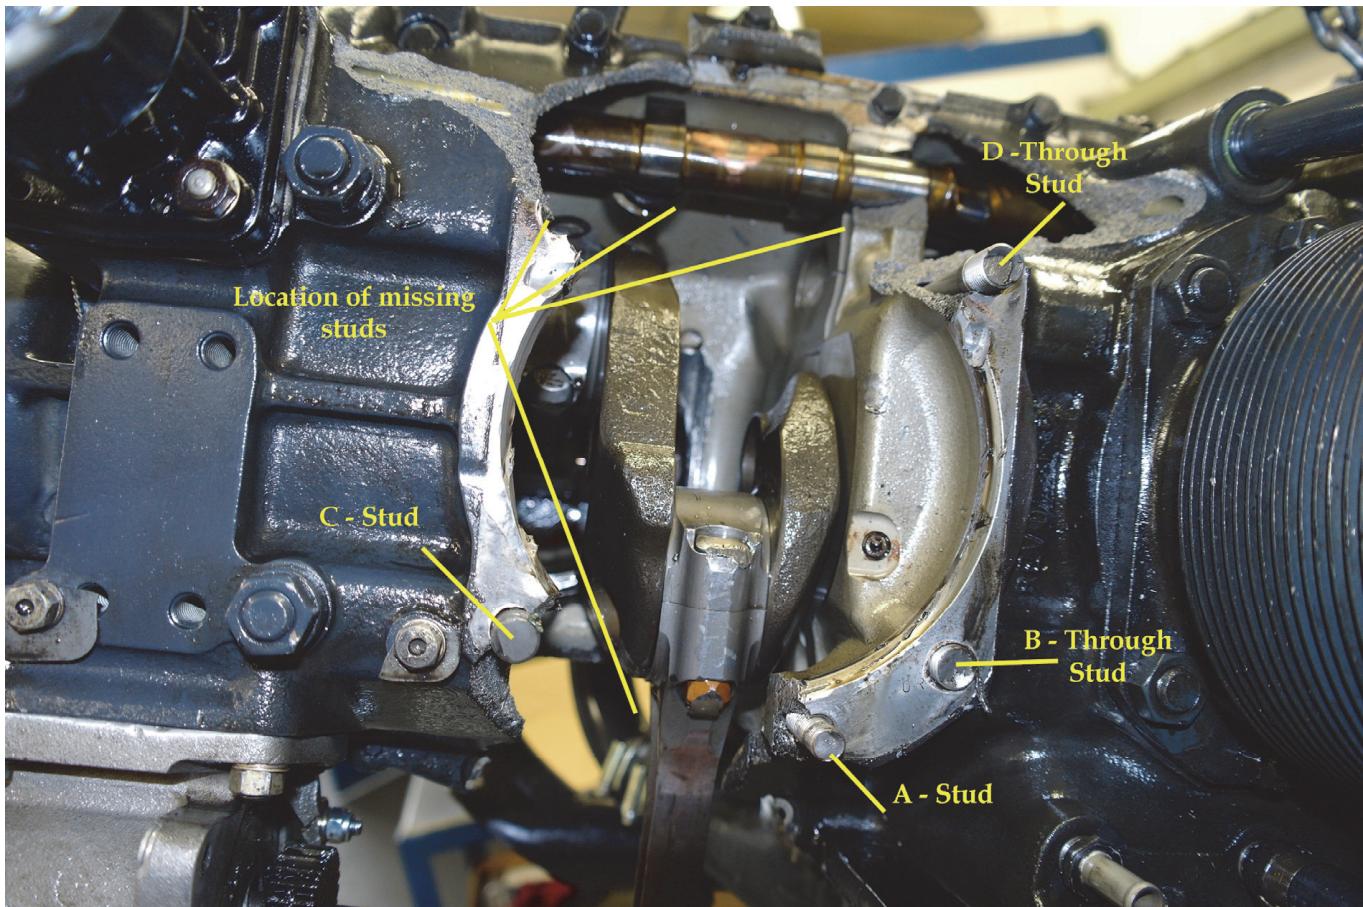
Independent metallurgical analysis using optical and Scanning Electron Microscope (SEM) techniques was conducted on the four failed studs that were recovered from G-BDTO's engine following the incident. The studs were annotated A to D for ease of reference (Figure 5).

The laboratory analysis determined that stud C had suffered a fatigue fracture, which initiated from a single point, coincident with corrosion pitting in one of its thread roots. The stress concentration caused by the pitting had been superimposed onto that provided

by the thread root itself. As the pitting grew in depth, the combined stress concentration had exceeded the threshold value for fatigue crack initiation. A primary high cycle fatigue crack initiating from the pitting then propagated across the diameter of the stud, with the continued loading from operation of the engine. The primary crack joined with two secondary fatigue cracks, also initiating from corrosion pits. Eventually, a point was reached when the remaining uncracked ligament of stud C became overloaded and failed. Although the exact time to failure could not be determined from the fracture surface features, the metallurgist advised that in his opinion it was possible for the corrosion pit to develop and the crack to have propagated to failure within the time between engine overhaul of 3,000 hours.

Figure 5
Location of failed studs

Laboratory analysis of stud C confirmed evidence of remains of a protective coating of cadmium on the coarse threaded section of the stud. However, no evidence was present of cadmium coating where the corrosion pit developed, on the fine threaded section. The stud material also tested outside the manufacturer's specification for hardness.

In contrast to stud C, the fatigue fractures of studs A, B and D had all initiated from multiple sites in thread roots which were not associated with pre-existing material defects. These were typical of failure of threaded fasteners from abnormal cyclic loading. In this case, the most likely cause of the abnormal loading was following the separation of stud C. However, it was not

Review of stud C from G-BDTO's fracture surface confirmed the primary fatigue crack had initiated directly from a corrosion pit before it joined with the two secondary cracks; although, the chronology of each crack initiation was not significant, given that all three cracks were initiated by the same mechanism.

Therefore, the investigation determined that the cause of the loss of the No 2 cylinder during the incident to G-BDTO was the presence of corrosion pitting in the thread root of a cylinder mounting stud. This initiated the growth of fatigue cracks, under the cyclic load of routine operation of the engine, until the stud failed in overload. The same failure mechanism was evident on the stud found on G-RLON.

It is recommended that Lycoming introduce additional maintenance requirements to ensure that the cadmium coating on the cylinder mounting studs, fitted to O-540-E4C5 engines, is not permitted to degrade to a level where corrosion of the base stud material can result in failure of the stud.
