Piper PA-34-200T, G-BEJV, 24 June 1996

AAIB Bulletin No: 8/96 Ref: EW/G96/06/36 Category: 1.3

Aircraft Type and Registration: Piper PA-34-200T, G-BEJV

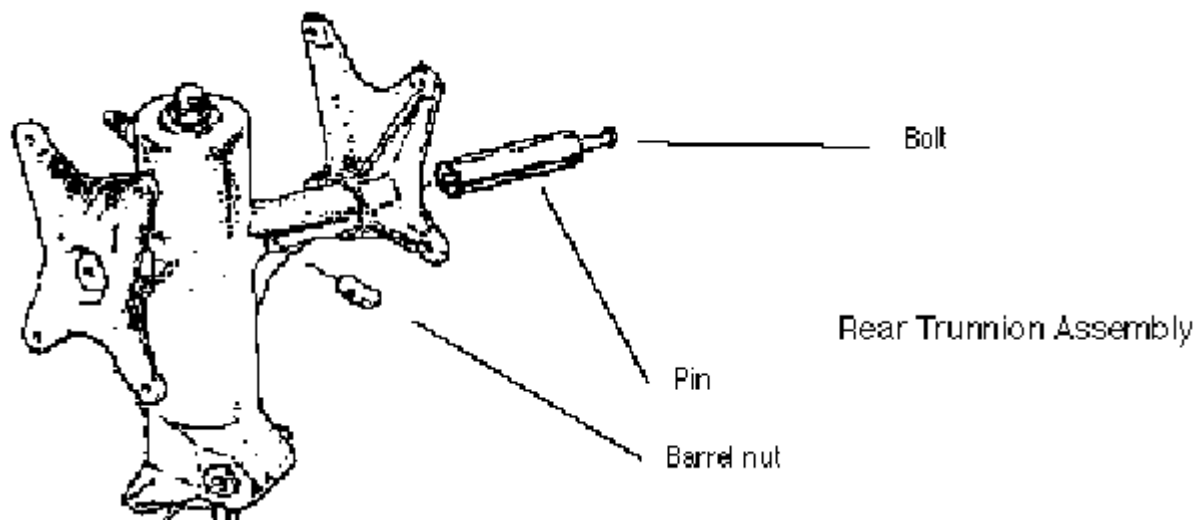
The failure was caused by the displacement of the rear main trunnion attachment bolt and pin. The pin is held into the fitting by a bolt through its centre that engages a cylindrical barrel nut containing a stiffnut. An inquiry by the maintenance organisation has concluded that the stiffnut was serviceable, but the thread engagement could not be determined after the accident due to damage; an independent check will be called for on this bolt in future. A bolt considered to have insufficient thread engagement has been found on another aircraft and a fleet check will be carried out.
