No: 11/92

Ref: EW/C92/5/3

Aircraft Type and Registration: Partenavia P68 Victor, G-HPVC

Nature of Damage: Severe damage to right engine, fire damage to right engine bay, nacelle fairing, wing, flap and tailplane

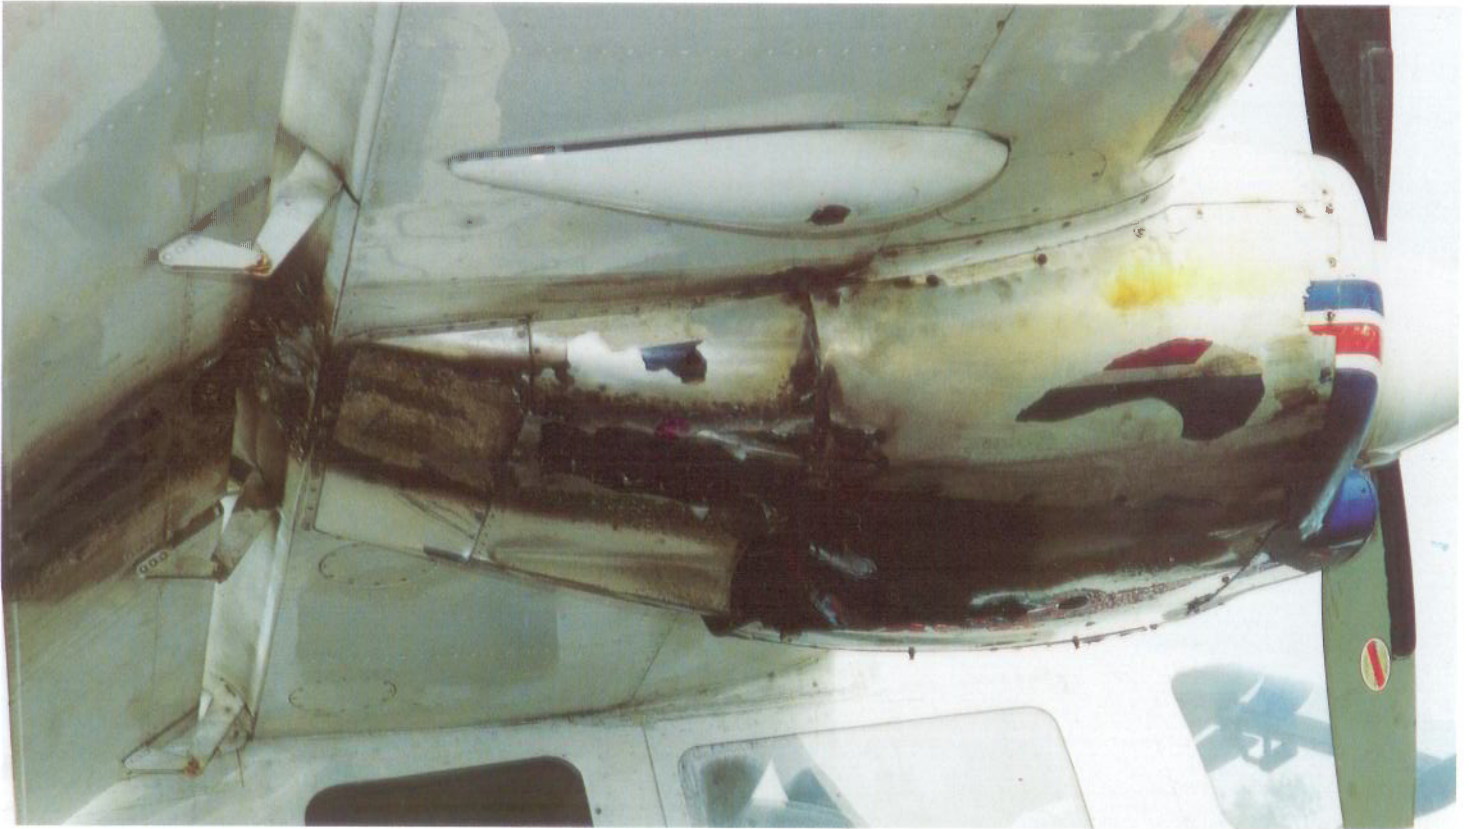
Figure 1

Inspection showed that the right engine had been very severely damaged, with large holes in the crankcase top and bottom, revealing gross internal disruption of the rear half of the engine. There was also considerable engine bay fire damage, concentrated in the aft outboard corner and indicative of fairly brief exposure to a quite intense fire. Parts of the engine cowling panels had been burnt away (Figure 1), including an area in the bottom cowl in the region of the overboard drain from the engine-driven fuel pump. Fire overheat had also caused extensive holing of the aluminium cowl/wing fairing and of the right flap; local scorching of the forward spar, undersurface and rear spar of the wing torque

Right Engine (viewed from right underside)

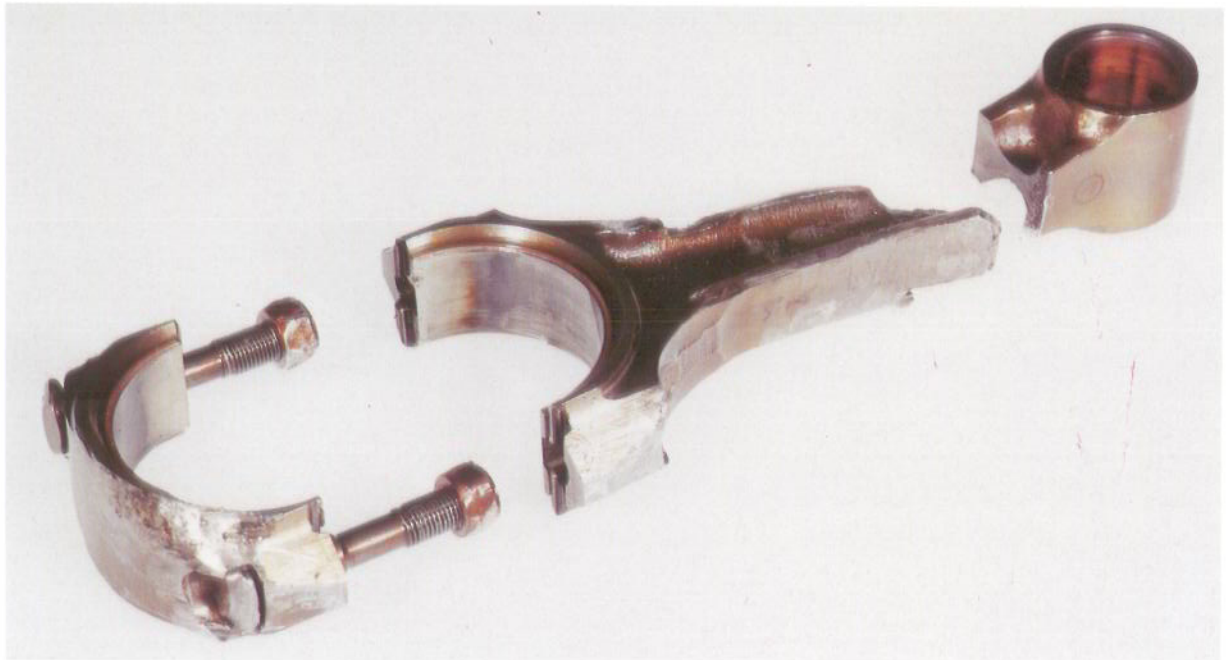
Figure 2

No 2 engine strip examination showed that parts of the No 4 piston had broken off, causing separation of the piston from its gudgeon pin and hence from its connecting rod, which remained attached to the crankshaft. In addition, the No 3 connecting rod (Part No 75484) had fractured near the small end (Figure 2). The fracture showed clear signs of extensive transverse fatigue cracking that had extended over approximately 50% of the I-shaped cross section from a position close to one flange corner (Figure 3), before the remainder had failed under overload. Specialist examination concluded that the failure had been caused by fatigue cracking that had originated from a relatively large discontinuity in the material that was apparent on the connecting rod surface (Figure 4).

Right Engine No. 3 Connecting Rod

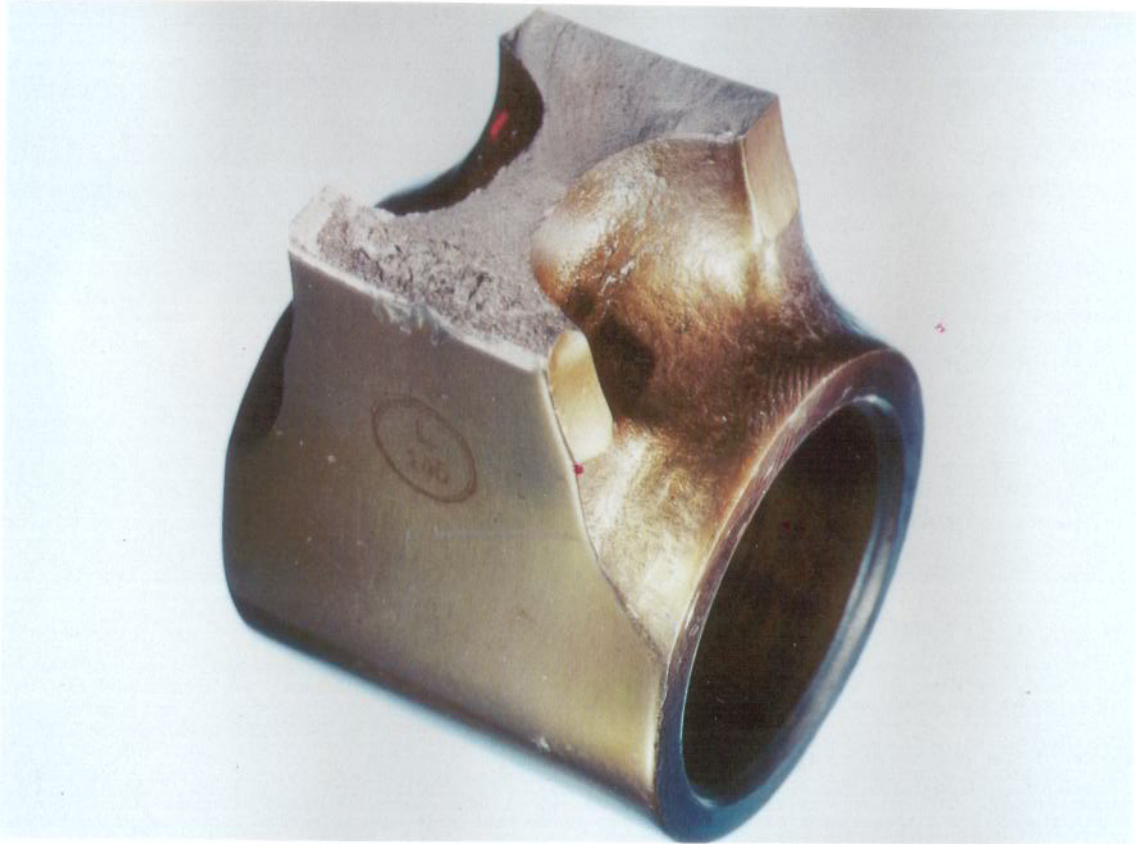
Figure 3

Thus the evidence was consistent with the No 3 connecting rod having fractured after suffering extensive long term fatigue cracking as a result of an undetected material defect and with the flailing long end of the rod having jammed the No 4 piston, causing overload failure of its gudgeon pin attachments. Extensive internal and crankcase damage had been caused by impact from the No 3 and No 4 connecting rods, flailing on their big end bearings as the crankshaft rotated.

No. 3 Connecting Rod Fracture

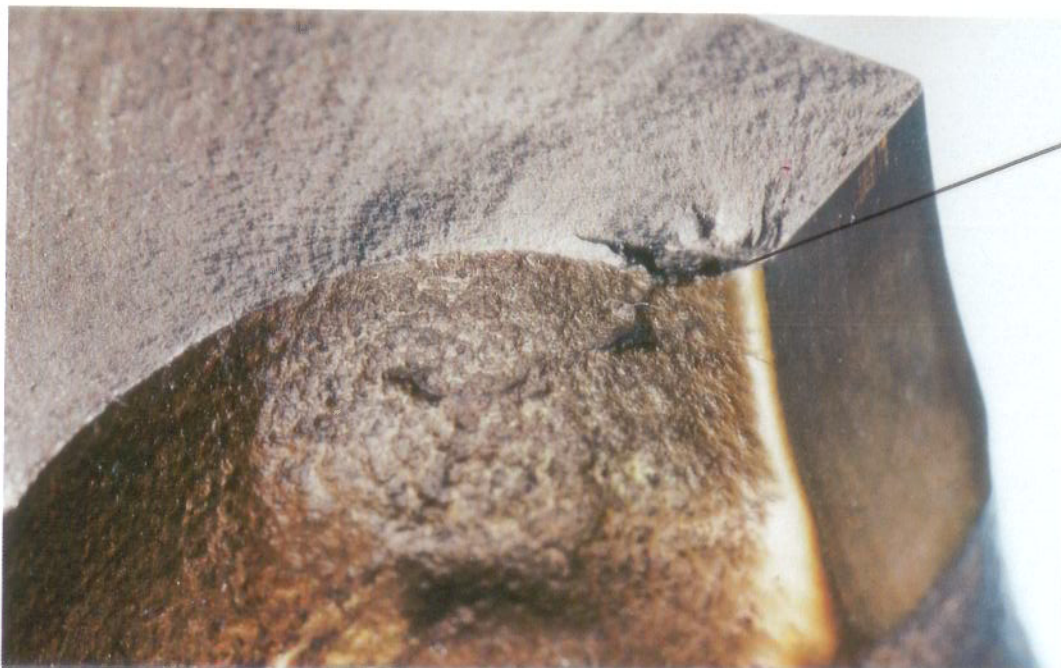
Figure 4

Microsectioning through the fatigue origin and X-ray spectra analysis revealed a number of folds in the material with included layers of steel oxide and decarburised material. The defect had clearly originated at manufacture either as a result of an inclusion from the original melt material or from a lap, or fold, of surface oxidised material at the forging stage. The surface marking caused by the defect was readily visible without magnification as a linear ridge several millimetres long and raised approximately 0.1 mm.

**Fatigue
Origin**

Material Defect at Connecting Rod Fracture Origin
