## **BULLETIN ADDENDUM**

<b>AAIB File:</b>	<b>EW/G93/06/28</b>
<b>Aircraft Type and Registration:</b>	<b>Cessna R182 Skylane RG, G-BPUM</b>
<b>Date &amp; Time (UTC):</b>	<b>30 June 1993 at 1810 hrs</b>
<b>Location:</b>	<b>Farnborough Airport, Hampshire</b>
<b>Type of Investigation:</b>	<b>Aircraft Accident Report Form submitted by the pilot, engineering examination by an aircraft engineer, AAIB and enquiries with the aircraft manufacturer</b>

### **SYNOPSIS (AAIB Bulletin 10/93 refers)**

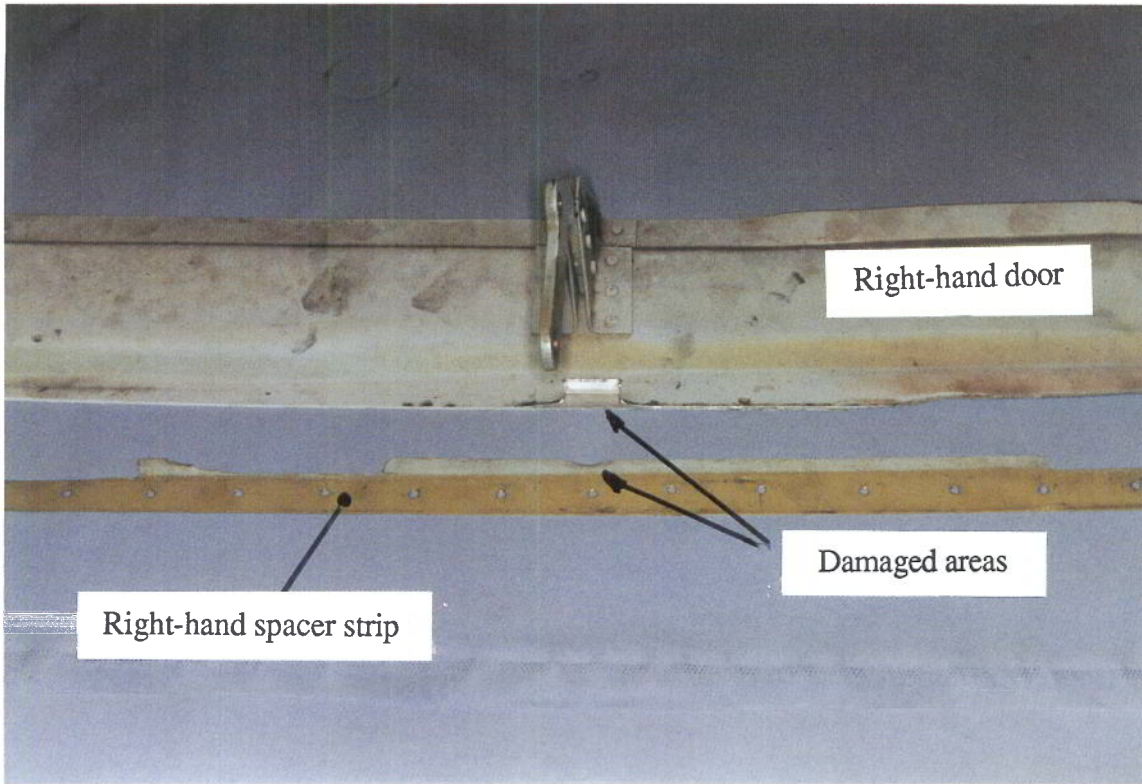
During the repair of the aircraft following this latest accident it was found that a spacer strip (photograph nos 1 and 2) had been inserted between the lower fuselage skin and the aircraft structure on both sides of the nose landing gear bay. This spacer strip was not a Cessna part and is not specified in the Aircraft Parts Manual. The repair organisation also encountered considerable difficulty in achieving free operation of the landing gear doors and on a number of occasions managed to lock the doors in the closed position. The associated foul was caused by interference between the hinge edge of the door and the edge of the fuselage skin (figure no 1). This jamming of the doors was sufficient to hold the nose landing gear in the 'UP' position after it had been selected 'DOWN'.

**Photograph No 1 Damaged edges of the right-hand nose landing gear door and spacer strip**

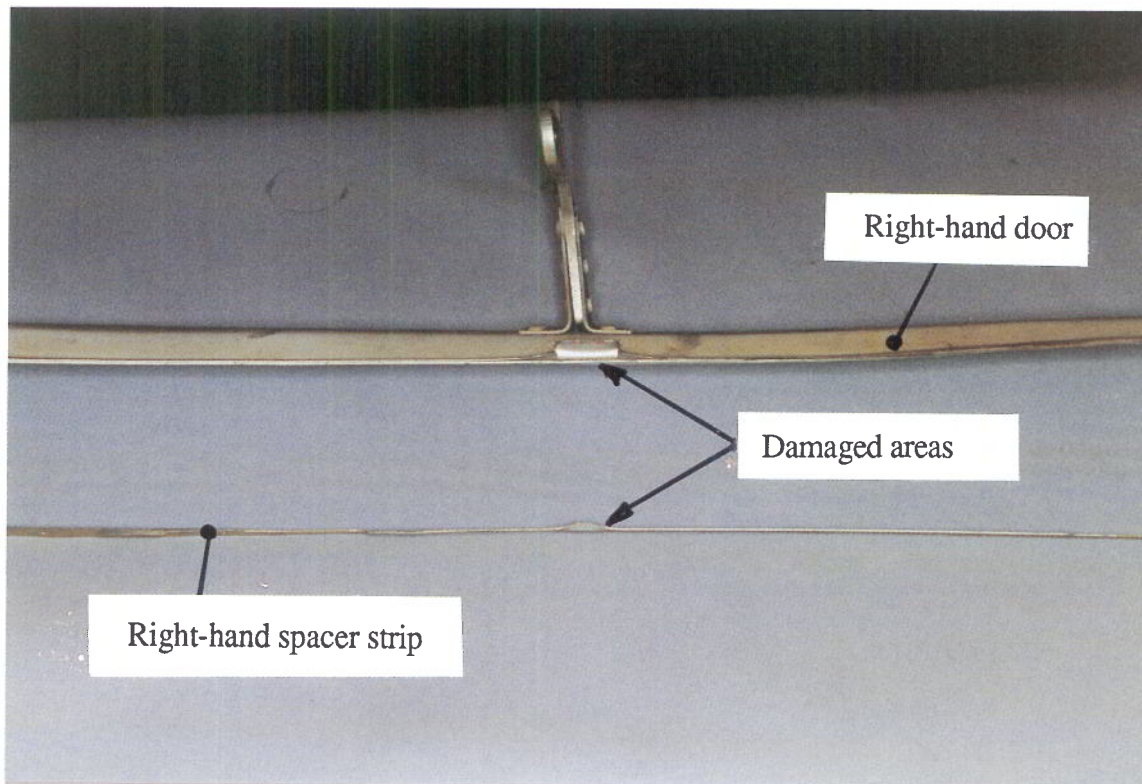
**Photograph No 2 Damaged edges of the right-hand nose landing gear door and spacer strip**

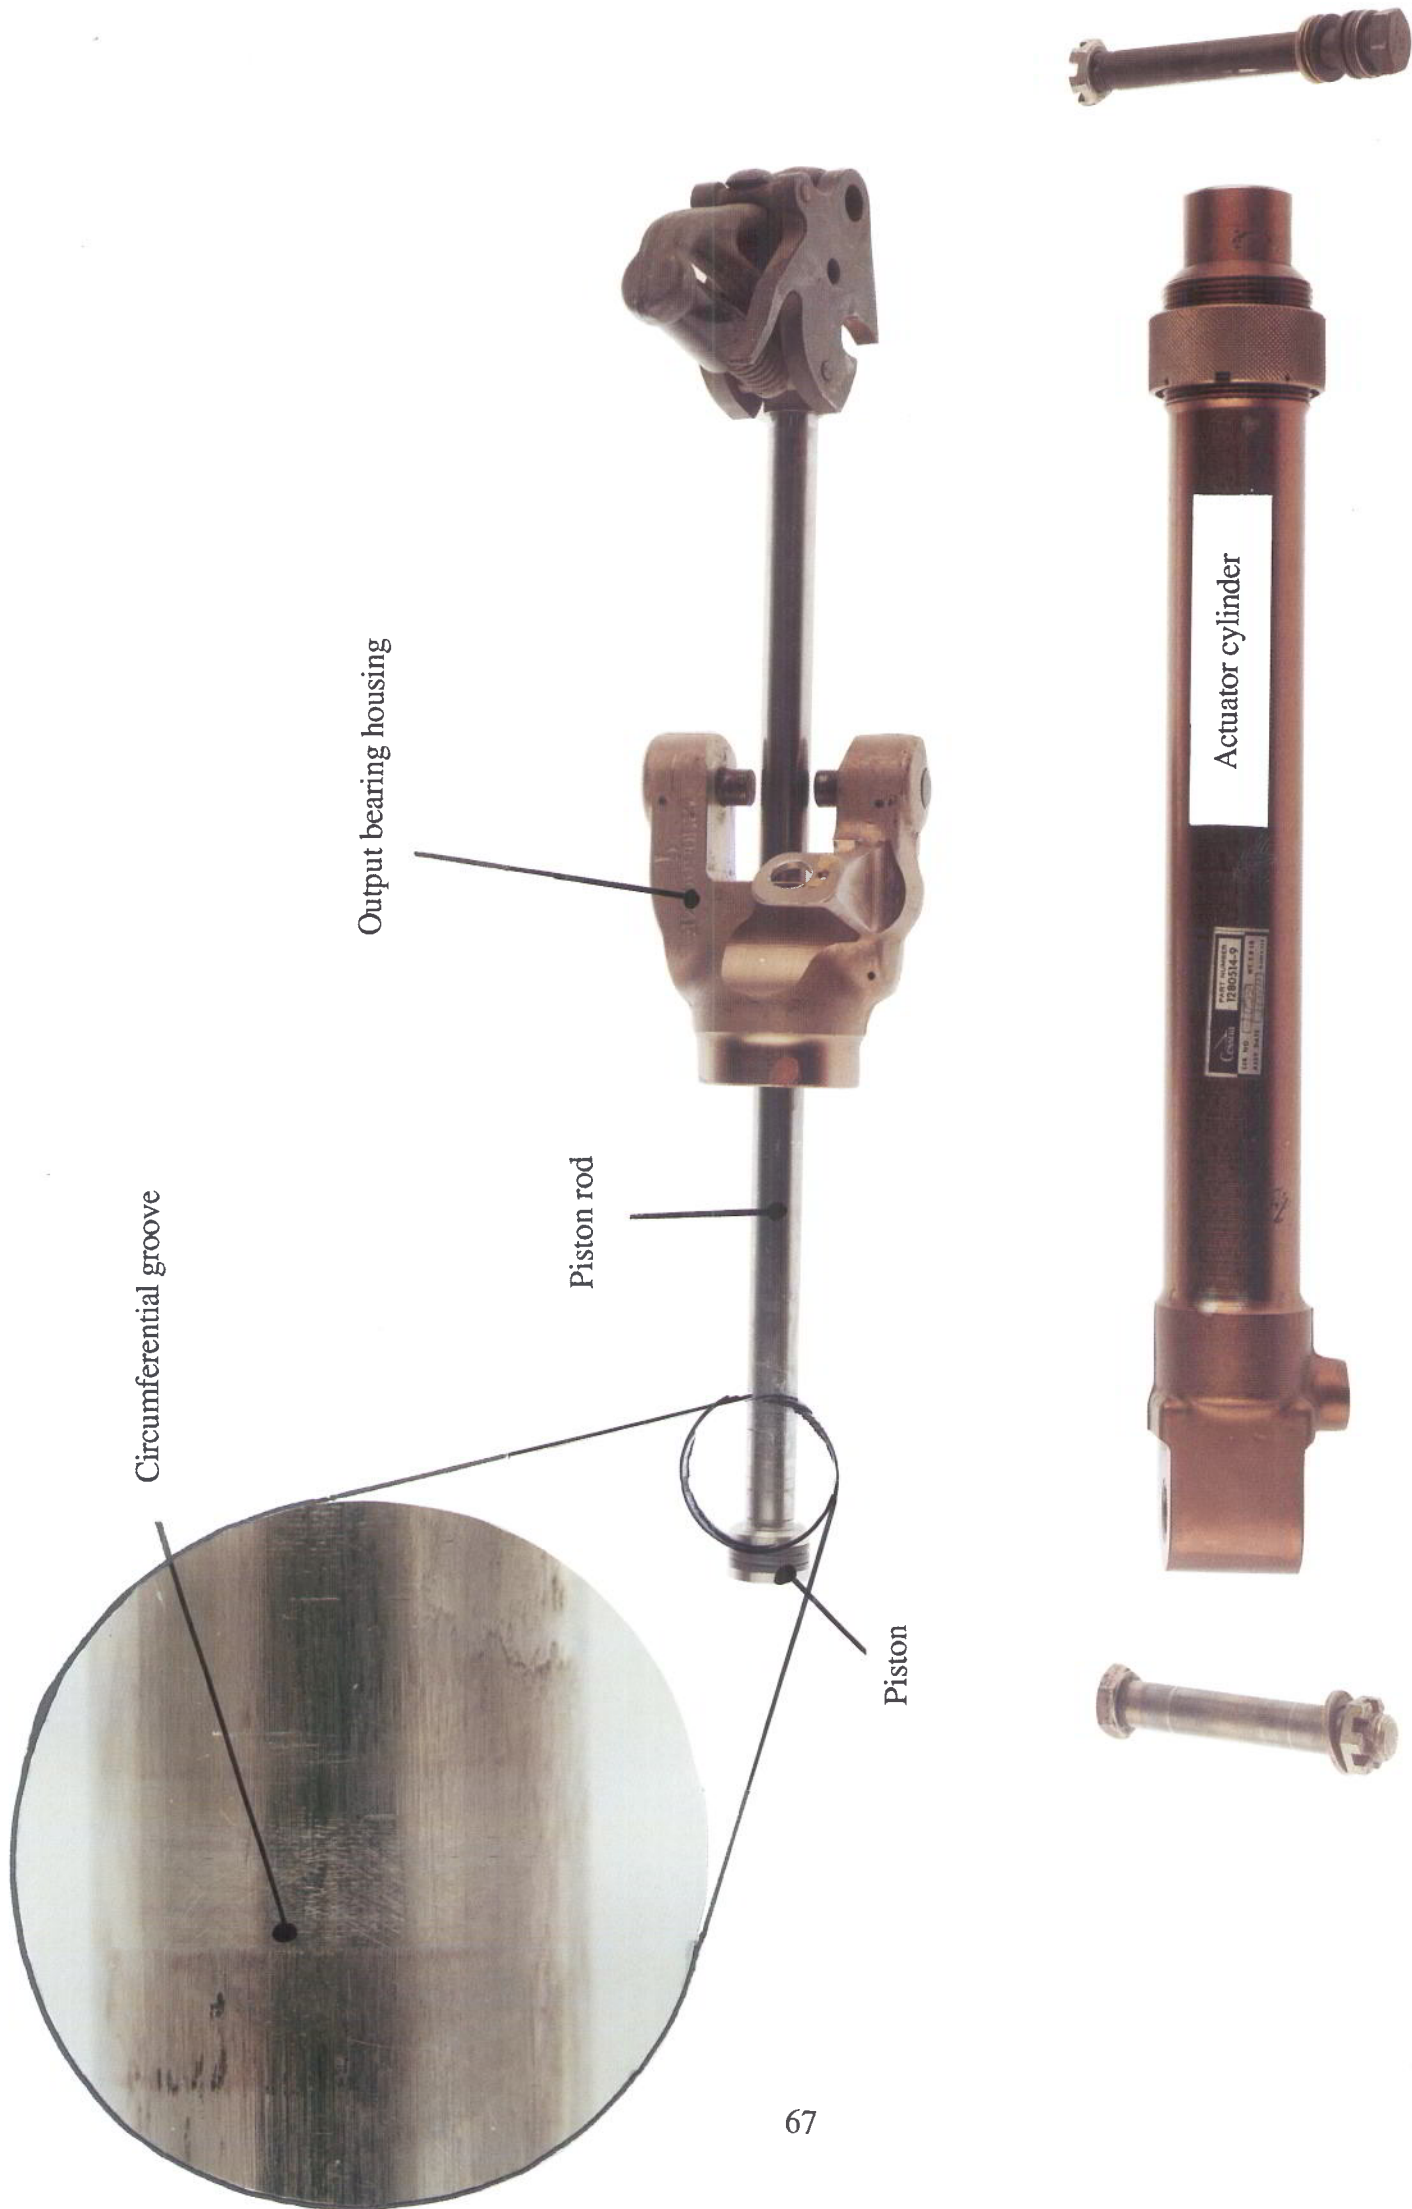
Photograph No 3 Nose landing gear hydraulic actuator

When the nose landing gear hydraulic actuator was stripped and examined it was found that a circumferential groove had been formed on the piston rod (photograph no 3) which went around approximately one third of the circumference. This groove corresponded to the position of the piston rod within the actuator's output bearing housing when the nose landing gear was retracted. Examination of the actuator bore revealed a circumferential groove in the inner cylinder wall that had been made by the metal edge of the piston. This groove was approximately the same length as that on the piston rod, but was orientated 180° around the circumference from it. The position of this groove also corresponded to the position within the actuator of the piston when the nose landing gear was retracted. The orientation of these two grooves relative to each other within the actuator indicated that, over a period of time, the nose landing gear actuator had been subject to some resistance during the initial part of the landing gear extension cycle.

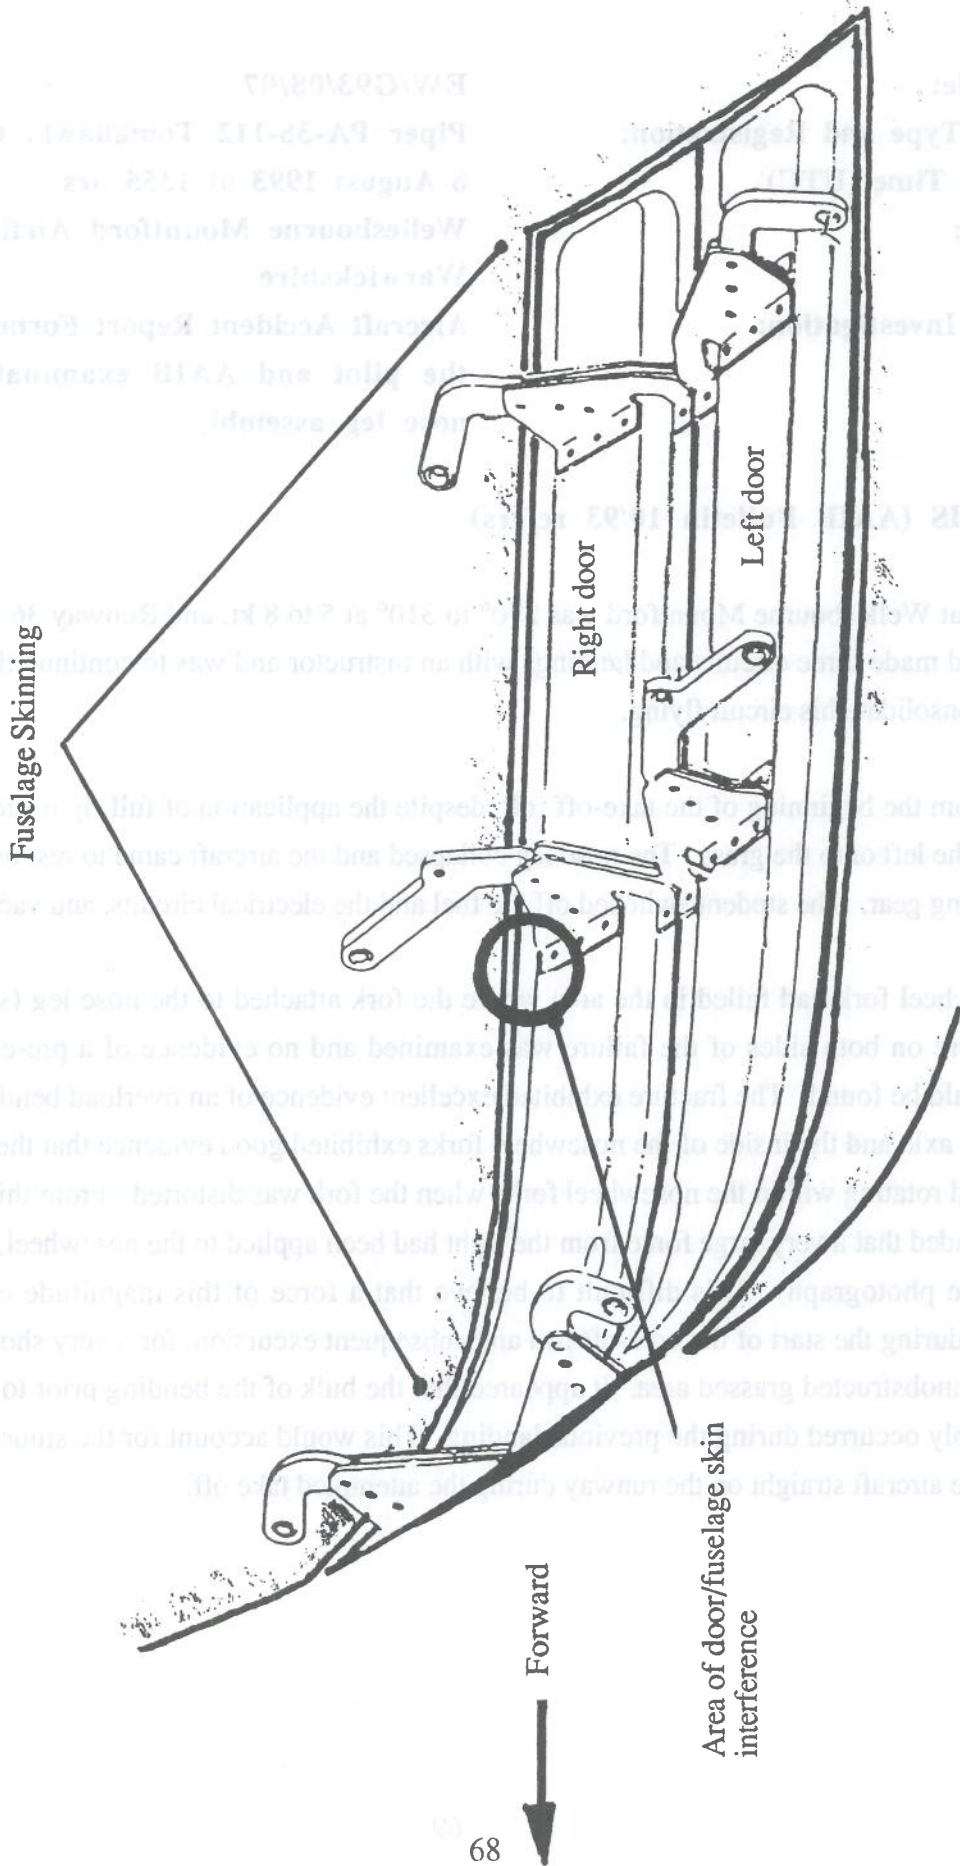
Examination of the nose landing gear doors showed evidence that when they were in the closed position there had been minor interference between the doors. On one of the door edges that abutted the fuselage skin in the area of the middle door hinge a section, approximately 0.75 inches x 0.5 inches, of the outer aluminium skin had been peeled back (photograph nos 1 and 2). It was not possible to attribute this damage to the landing. It was noticed that on the inside of both nose landing gear doors there were black rubber marks indicating that doors had been in contact with the tyre whilst in the closed positions.

Figure No 1 Nose landing gear doors in the closed position
