No: 1/91

Ref: EW/C1181

Aircraft Type and Registration: (1) Aerospatiale AS350B Ecureuil, G-MARC
(2) Bell 206B, G-BNIT

Location: Loch Moidart, Scotland

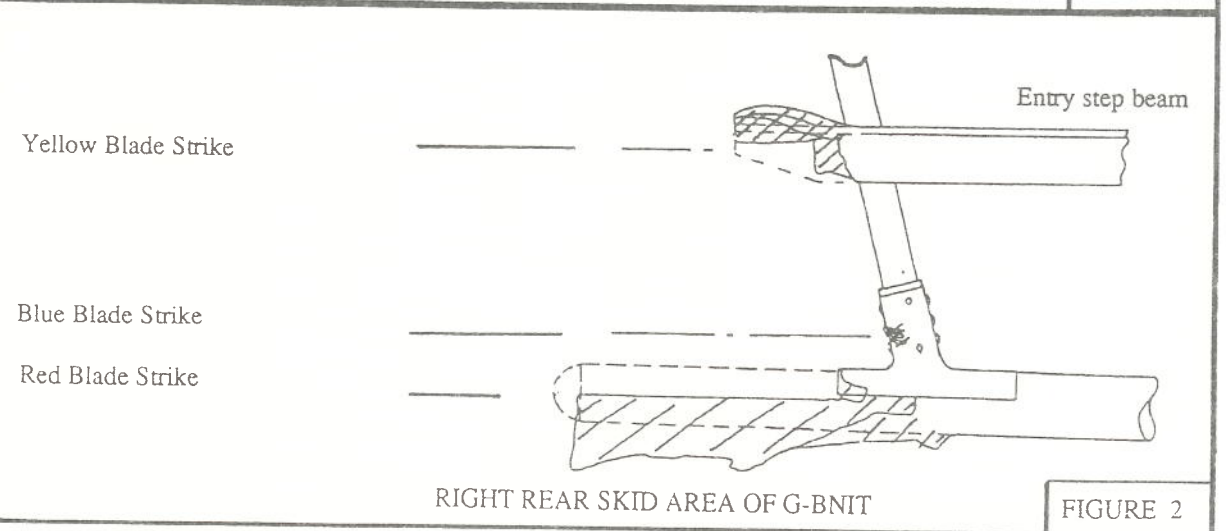
FIGURE 2

Nature of Damage: (1) Damage to the tips of all three main rotor blades
(2) Three rotor blade slashes on the rear of the right landing skid

The damaged components of the helicopters were examined; the Bell 206 landing skids at Inverness after their removal from G-BNIT; and the AS350 main rotor blades at Plockton. From this it was established that all three rotor blades had struck the right rear skid area of G-BNIT, once each, causing different levels of damage to each blade tip. By comparing the details of the damage to each blade with that on the skid structure, and considering the direction of rotation of the main rotor, it was established that the yellow blade had been first to strike, causing local severe damage to the aftmost 6 inches of the entry step beam which was clamped across the front and rear downtubes. The blue blade was the next to strike, making a relatively light contact with the skid mounting socket, followed by the red blade which sliced through the centre of the rearmost 14 inches of the skid tube itself. This damage is illustrated in Figures 2 and 3.

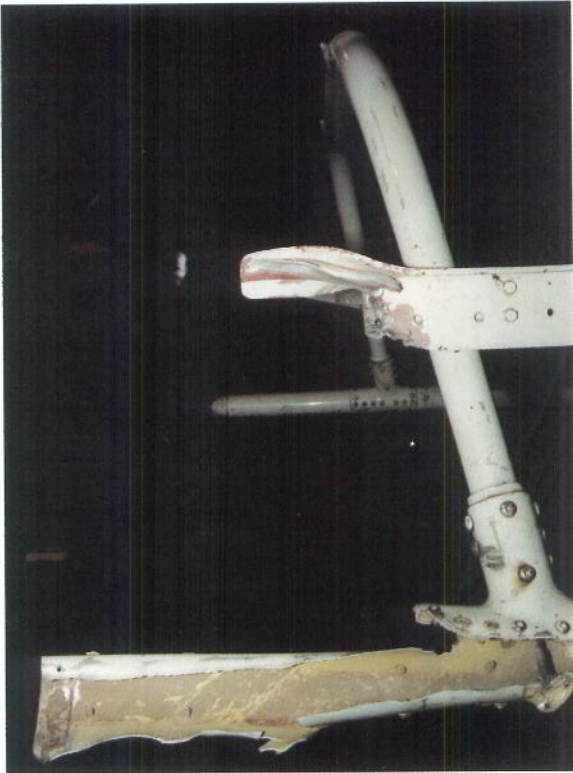
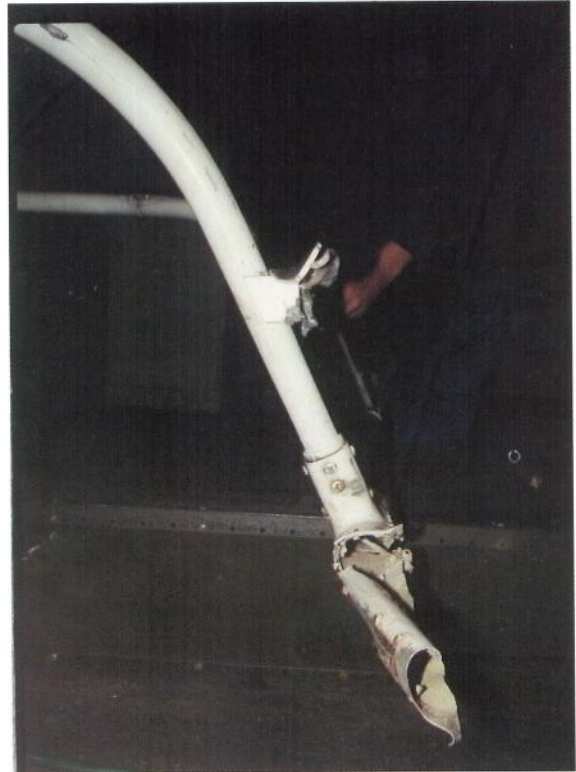
DAMAGE TO RIGHT REAR SKID OF G-BNIT, ABOVE, MADE BY MAIN ROTOR BLADE TIPS FROM G-MARC, BELOW
