No: 10/92

Ref: EW/G92/06/09

Aircraft Type and Registration: Piper PA-28R-200-2 Cherokee Arrow II, G-BBFD

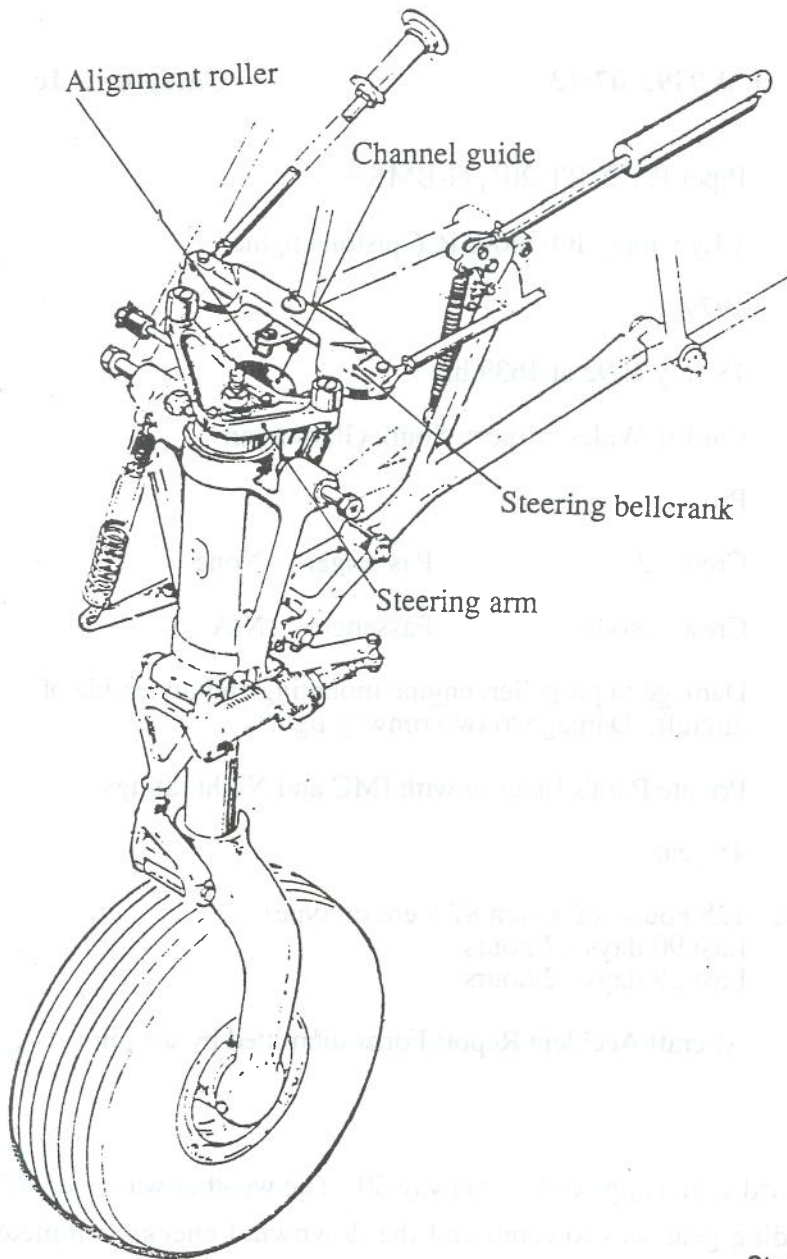
Subsequent examination revealed that a roller on the steering linkage, which is normally located within an alignment channel attached to the top of the nose leg, had ridden along the outside of the channel during landing gear extension. The steering linkage becomes separated from the leg during retraction, with the exception of the roller on the steering arm which should remain in the channel (see attached diagrams). It was thus evident that the roller had disengaged from the end of the channel during flight, allowing the leg to rotate slightly, with the result that on the next gear down selection the roller rode along the left hand side of the channel, causing the leg to twist, thereby preventing alignment between the steering bellcrank on the linkage and the steering arm on the leg. This, in turn, prevented the leg from reaching the fully extended position.

Nosegear installation

The subsequent repairs necessitated replacing the alignment channel, and it was observed that the new component was 0.3 inches longer than the old item, although there was no paperwork, such as a Service Bulletin, which recorded any such change. The reason for the roller having disengaged from the channel was not established. However, it was noted that the increased length of the new channel reduced the scope for the roller to suffer disengagement.

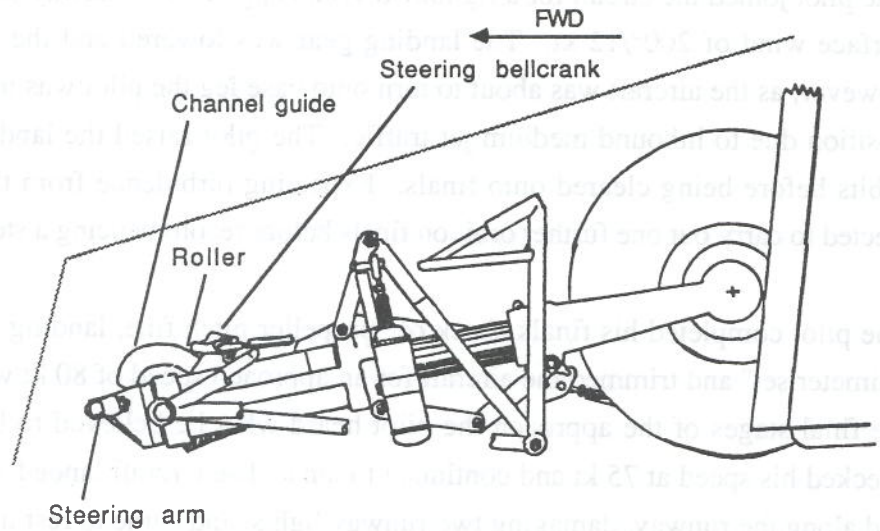
View of nosegear in retracted position
