SERIOUS INCIDENT

Aircraft Type and Registration:	ATR72-202, EI-SLG	
No & Type of Engines:	2 x Pratt and Whitney PW124B turboprop engines	
Year of Manufacture:	1990	
Date & Time (UTC):	15 March 2011 at 2130 hrs	
Location:	Near Edinburgh Airport	
Type of Flight:	Commercial Air Transport (Non-Revenue)	
Persons on Board:	Crew - 2	Passengers - None
Injuries:	Crew - None	Passengers - N/A
Nature of Damage:	None	
Commander's Licence:	Airline Transport Pilot's Licence	
Commander's Age:	45 years	
Commander's Flying Experience:	4,092 hours (of which 3,500 were on type) Last 90 days - 72 hours Last 28 days - 29 hours	
Information Source:	AAIB Field Investigation

Synopsis

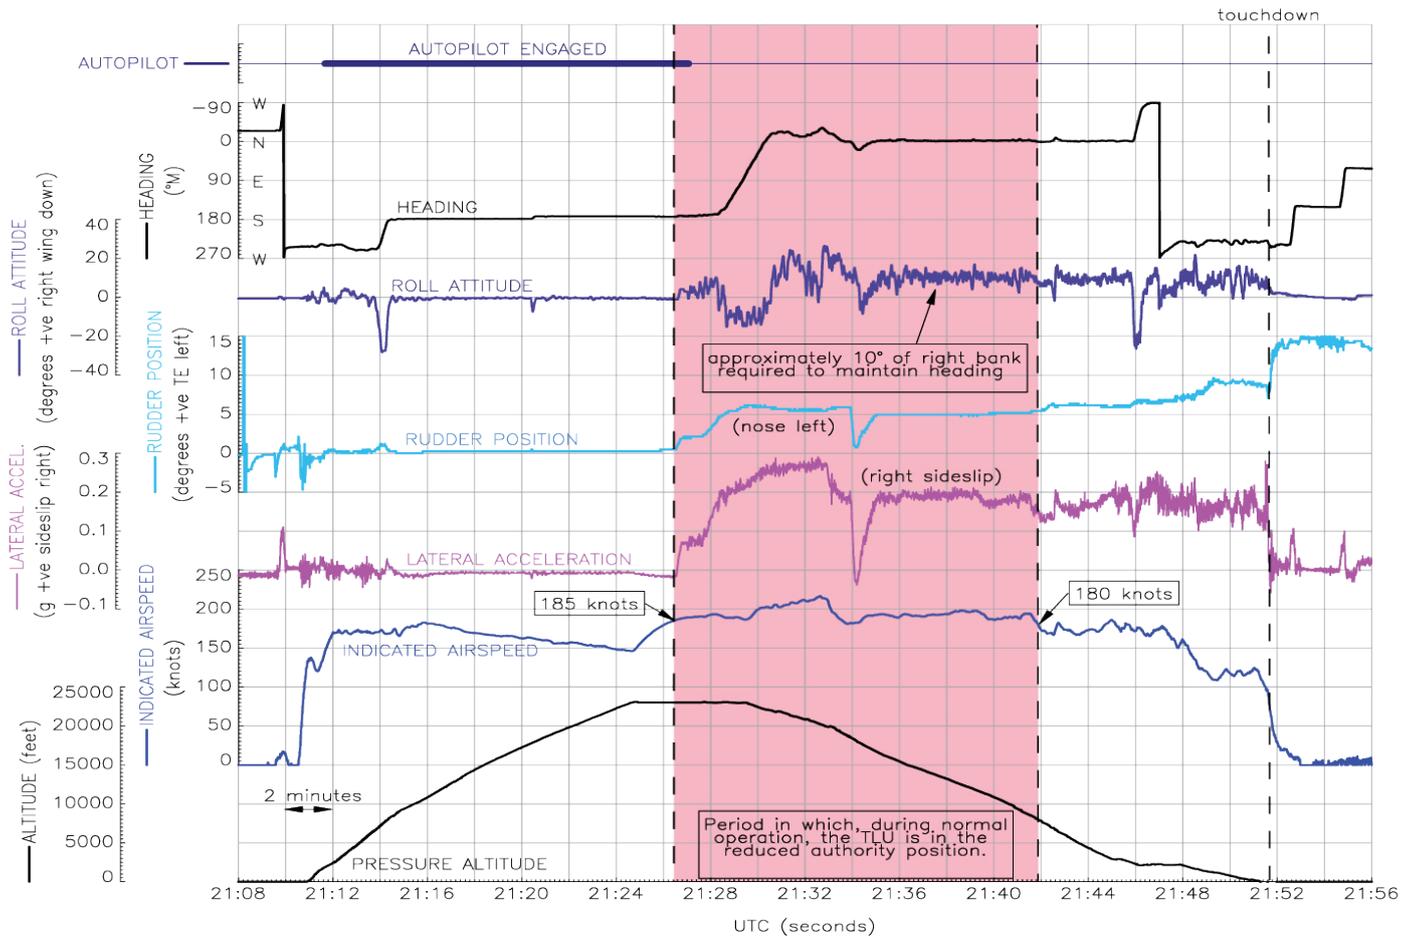
Figure 2

A history of salient (and available) parameters from the QAR for the incident flight is shown in Figure 2. Highlighted (in pink) is the portion of the flight during which the aircraft had accelerated through 185 kt (2126:25 hrs) and then decelerated to below 180 kt (2141:54 hrs). In normal operation, during this period, the TLU would have been in the reduced authority position.

As the aircraft accelerated through 185 kt, the rudder position moved to 2° left (ie aircraft nose-left) at a

Salient QAR parameters

constant rate of $0.12^\circ/\text{s}$ causing the aircraft to sideslip to the right. The autopilot then rolled the aircraft 4° right-wing-down to maintain the heading. The autopilot was disengaged shortly thereafter.

Over the next two minutes the rudder deflected further to the left (to 6°), during which time the aircraft was turned through 180° for a return to Edinburgh. At 2134 hrs, the rudder deflection decreased rapidly to below 1° left ($0.55^\circ/\text{s}$) following a reduction in airspeed to 180.75 kt², before deflecting back to 5° (at $0.07^\circ/\text{s}$). The rudder remained in this position, with approximately 10° of right bank required to maintain

heading, until the aircraft airspeed decreased to below 180 kt, seven minutes later (2141:54 hrs). At this point the rudder gradually deflected further to the left, reaching 8° at touchdown. Coincident with the touchdown, rudder deflection increased up to 15° left, where it remained until the end of the QAR recording.
