Bell 206B, Jet-Ranger III, G-BTFY

AAIB Bulletin No: 12/2003	Ref: EW/C2003/01/04	Category: 2.3
Aircraft Type and Registration:	Bell 206B, Jet-Ranger III, G-BTFY	
No & Type of Engines:	1 Allison 250-C20 turboshaft engine	
Year of Manufacture:	1974	
Date & Time (UTC):	17 January 2003 at 1536 hrs	
Location:	Cudham, Kent	
Type of Flight:	Private	
Persons on Board:	Crew - 1	Passengers - 1
Injuries:	Crew - 1 (Fatal)	Passengers - 1 (Fatal)
Nature of Damage:	Helicopter destroyed	
Commander's Licence:	Private Pilot's Licence	
Commander's Age:	45 years	
Commander's Flying Experience:	965 hours (of which 112 hours were on type)	
	Last 90 days - 12+ hours	
	Last 28 days - 3+ hours	
Information Source:	AAIB Field Investigation

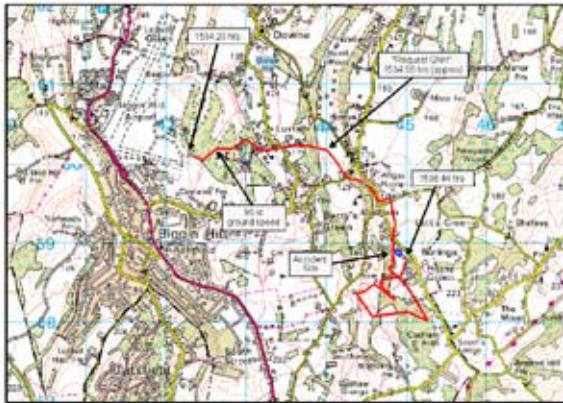
Figure 1 Radar derived track and groundspeed

Primary radar data obtained from the Heathrow and Gatwick radars, first painted the helicopter just north-east of Runway 29, and then recorded it following an easterly track (see Figure 1) and quickly accelerating to a groundspeed of about 100 kt. About 45 seconds after takeoff the radar data shows the helicopter turned on to a generally south easterly track, and the pilot made the last recorded RTF call requesting the latest QNH. Shortly thereafter the radar records the helicopter turning toward the south. About one and a half kilometres south of Cudham the helicopter turned on to a westerly track, shortly followed by a north-westerly track before finally tracking to the east-north-east. The last recorded radar return is from the vicinity of Horn's Green just south of Cudham and is timed at 1536:44 hrs.

The radar data indicates that the initial departure from Biggin Hill went as planned. The general direction was easterly and the fact that the helicopter quickly accelerated to cruise speed suggests that the weather, at least for the first half minute of the departure, was reasonable. However, about 45 seconds into the flight the helicopter turned onto a south-easterly heading and shortly thereafter, was seen near Cudham to be either in or above fragments of low cloud before leaving the area to the south. Since it was the pilot's stated intention to depart to the north-east, the turn on to a south-easterly and then southerly track was probably unplanned and may have been caused by a perception of worse weather to the north-east. The pilot's familiarity with the route in and out of Biggin Hill via Sevenoaks may have been a factor in his decision to turn to the south, and the southerly route would have been the shortest route to significantly lower ground. However, the track along Cudham Lane involved flying over rising ground where the cloudbase was likely to have been lower.

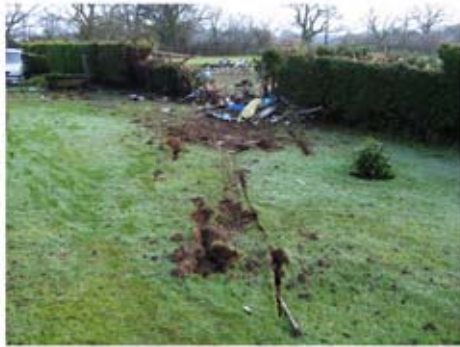
Figure 2 Initial impact site (hedge trimmed by main rotor)

It was evident that the main rotor had sliced through the top of the hedge (see Figure 2) and there were also slash marks on the ground either side of the hedge where the main rotor had hit. The main rotor mast had broken just below the rotor head and the main rotor blades, still connected to the rotor head, were found resting against a tree 90 feet beyond the main wreckage. The tail rotor and tail rotor gearbox were found 10 feet beyond the main wreckage. One tail rotor blade was damaged but complete and the other tail rotor blade had broken into two pieces. The outboard section of this blade was found 230 feet away from the aircraft initial impact point (ahead of and to the left of the wreckage trail centreline) while the inboard section of the blade was found close to the initial impact point.

in addition to the slash marks in the ground and the trimmed hedge were clear indications that both the main rotor and tail rotor had significant rotational energy at impact.

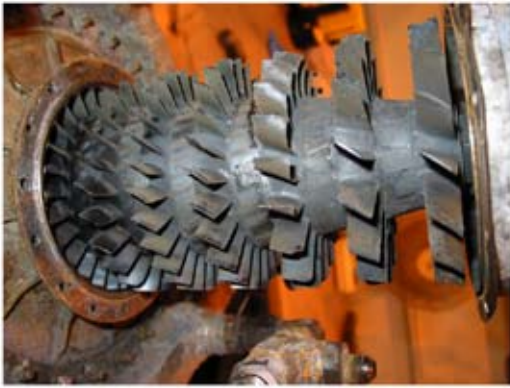
Figure 3 Compressor wheel with third stage bent blades

The strip examination revealed that the third stage compressor wheel blades were bent in a direction opposite to that of rotation (see Figure 3). The location of the damaged third stage blades coincided with one of the punctures on the external surface of the compressor case lining. The third stage turbine nozzle displayed rotational scoring and the third and fourth stage turbine wheels showed evidence of blade tip rub 360 degrees around. The combined evidence of these rotational signatures indicated that the engine was operating and producing power at the time of impact.

The engine examination revealed no major failures and the rotational signatures on the compressor wheel, turbine wheels and turbine nozzle indicated that the engine was operating and producing power at impact. The abnormal amount of oil in the outer combustion case and the discharge tubes may have been a result of the incorrect installation of the power output seal during maintenance. There

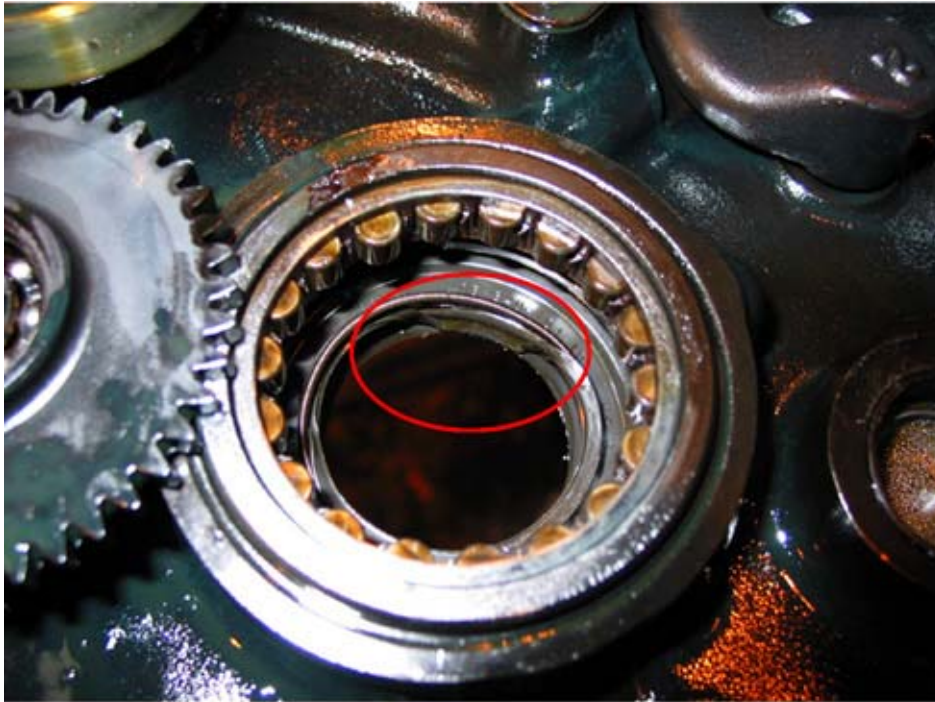
Figure 4 Front power output seal folded back upon itself

Two anomalies were found during the strip examination. The front power output seal, between the engine accessory gearbox and the freewheel unit, was found folded back upon itself in one area (see Figure 4).

This is one of the two seals that was replaced during the last maintenance prior to the accident flight. In addition, the inner surfaces of the discharge tubes (which pass air from the compressor to the combustor) and the outer combustion case were unusually coated in oil. The engine manufacturer considered that the presence of this oil was an indication that the engine oil system had been above its maximum total capacity at some point during operation. It appeared most likely that the oil entered through the folded power output seal. The seal is designed to prevent main transmission oil migrating from the freewheel unit into the engine accessory gearbox. However, since main transmission oil and engine oil are of the same type the mixing of the two oils would not have had a damaging effect. Moreover, the additional quantity of oil would not have unduly affected the performance of the engine. The engine manufacturer thought it possible that the engine might have produced some smoke although not necessarily so. The bleed air pickup from the engine compressor was upstream from any oil leakage and therefore any smoke generated inside the engine could not have easily passed into the heated air for the cabin.

It appears that the aircraft left maintenance with the same oil leak problem that it arrived with because the replacement front power output seal had been installed incorrectly. However, this anomaly does not appear to have been a direct factor in the accident as the engine strip examination revealed clear indications that the engine was operating and producing power at impact.
