**AAIB Bulletin No: 9/95**

**Ref: EW/G95/06/21**

**Aircraft Type and Registration:** Agusta Bell 206B Jet Ranger II, G-BHXU

**Nature of Damage:** Unknown damage within engine gearbox; aircraft ditched in sea and lost

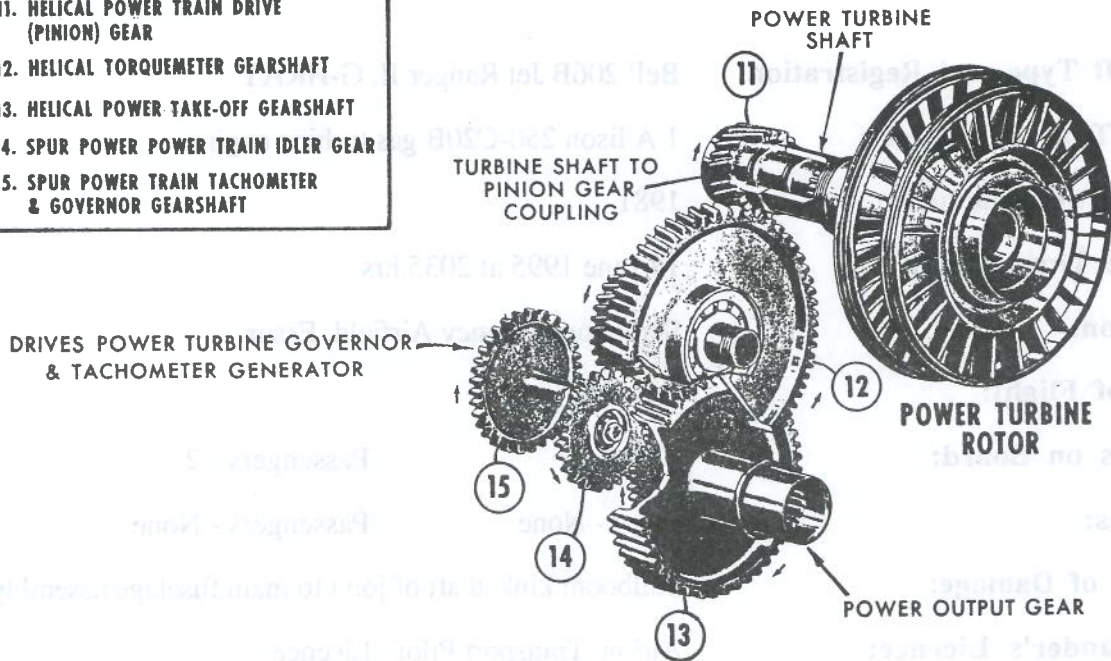
# POWER TURBINE GEAR TRAIN 250-C18, -C20, -C20B

From the symptoms described by the crew, it would appear that failure of the engine and its control systems, lubrication system, and main rotor gearbox (in view of the successful autorotation) may be discounted. The fact that the torquemeter at one point was seen to indicate excessive torque, that the ENG CHIP light illuminated (the sensor for which is in the accessory gearbox), suggested that the failure might have occurred downstream of the torquemeter assembly in the gearbox, but before the main rotor gearbox.

Two non-mandatory but recommended 'Commercial Engine Bulletins' (CEBs) issued by the manufacturer are possibly relevant. CEB1150 is a Bulletin which concerns the replacement of the power take-off helical gearshaft assembly (item 13, Figure 1) with one of a larger hub diameter. This reduces stress in the shaft by 50% when compared to the earlier standard, as several were known to have fractured in service at the forward internal spline. According to the manufacturer, this failure could result in loss of power or uncontrolled power turbine overspeed. This modification had been embodied. CEB 1226 addressed the problem of the securing bolt of the spur power train idler gear (item 14), which has been known to come loose in service. This modification had not been embodied.
