No: 5/90

Ref: EW/G90/03/04

and Registration: Aerospatiale SA341G Gazelle 1, G-RIFF

Nature of Damage: Severe damage to the airframe and rotors

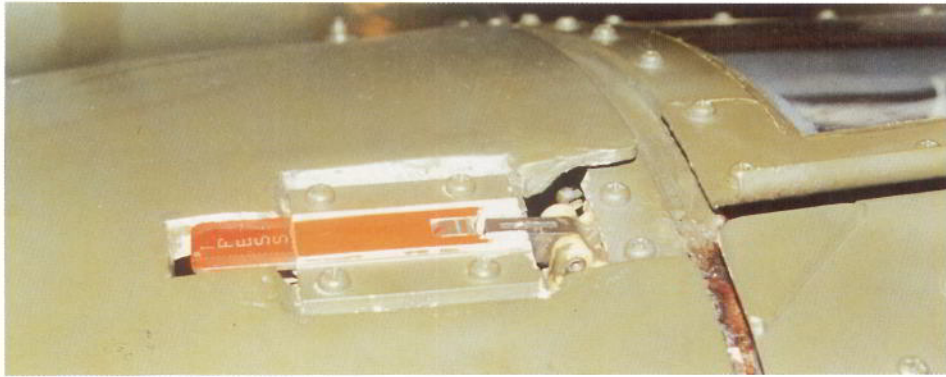
It was noted during the tests that the visual difference between the latch operating lever being closed enough to lock the fairing and being pressed fully home, such that the lever itself was locked and flush with the surface, was small, ref. Figure 1.

FRONT LATCH - a) correctly latched

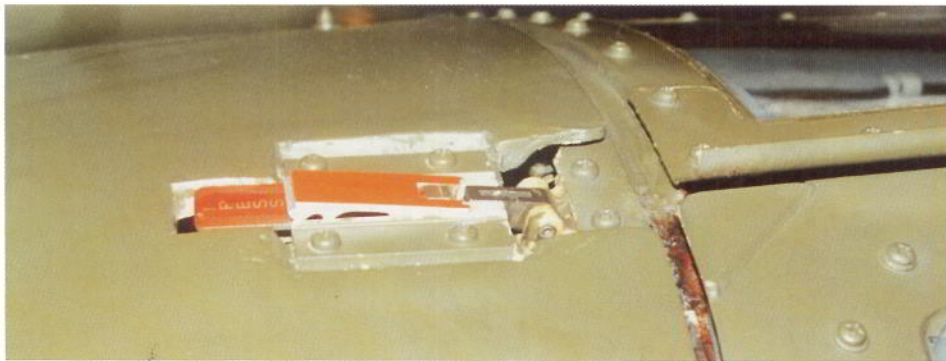
Without all of the latching components from the front and side latches it was not possible to determine if these had suffered any failure in flight. However, close examination of the airframe mounted section of the front latch, which contains most of the mechanism, failed to reveal any abnormalities, unusual wear or witness marks consistent with overstressing. As its precise adjustment could not be derived, it was not possible to determine whether it had unlocked due to vibration in flight, or had not been locked beforehand.

b) latched but unsafe

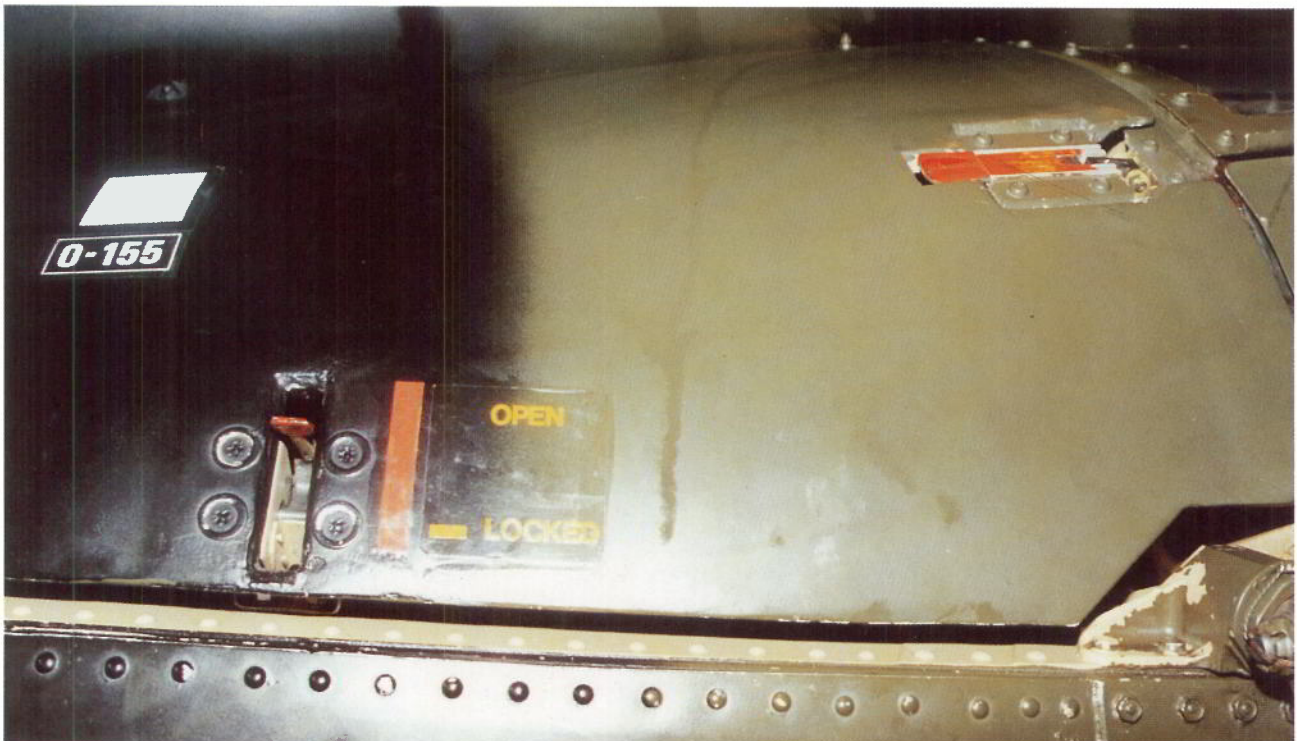
Secondly, the airframe mounted latching bar for the fairing edge spring latch exhibited no witness marks or signs of distress such as might have been expected if the latch had been engaged when the fairing was torn from the helicopter. In addition, the amount of surface corrosion on this bar (whilst in itself not a direct cause for concern) suggested that in comparison to those seen on the AAC helicopters, whose bars were generally polished through use, that this spring latch had only infrequently been operated, and/or that the helicopter had a very low utilisation. When these fairings are closed and latched correctly, a clearance exists between the bar and latch. Tests were carried out which showed that it was possible to close the fairings and correctly latch the front and rear, but with this spring latch not engaged and with its own locking lever in the open position.

Cowling closed and latched front and rear
Sprung latch not engaged
