APPENDIX A

Figure 1: Showing general layout of AS332L.

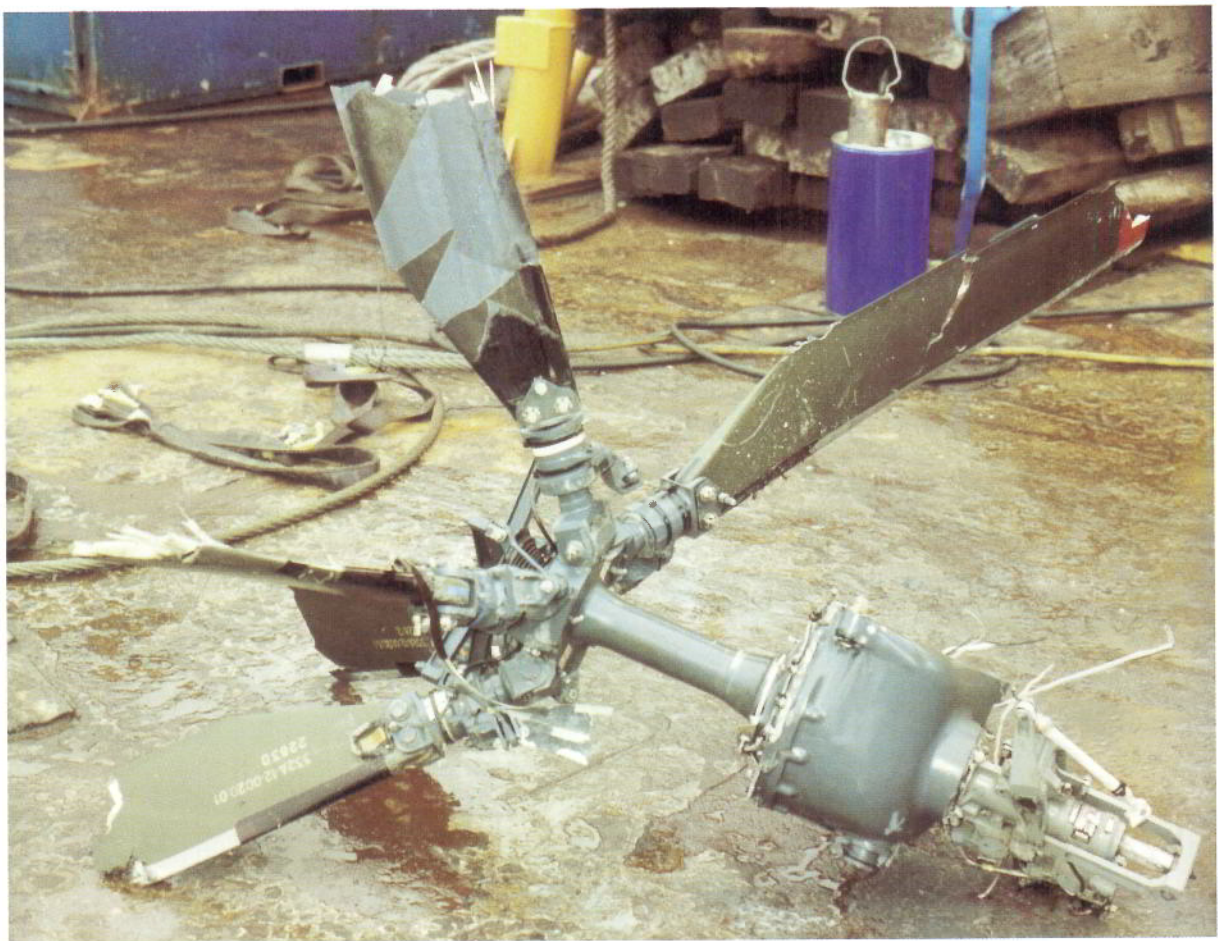
Figure 4A: Showing recovered tail rotor, gearbox and pitch servo assembly, with 'White' blade root section uppermost.

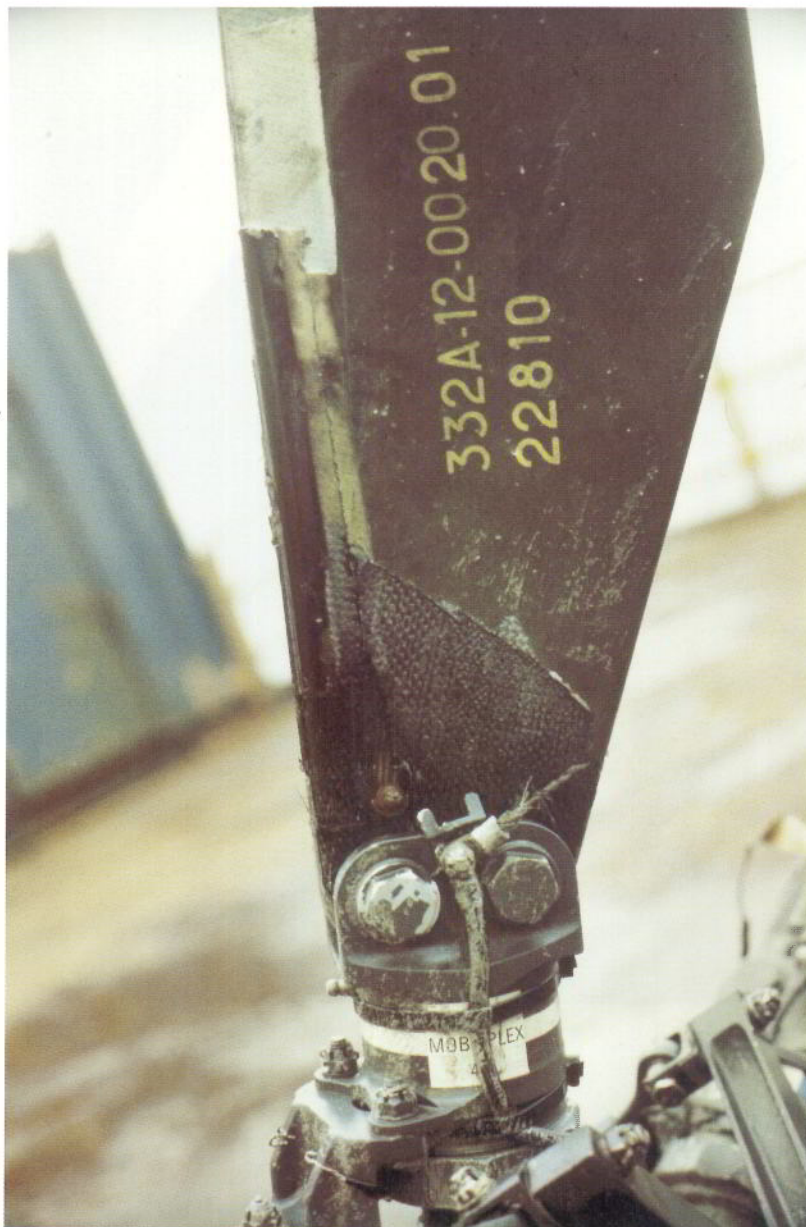
Figure 4B: Showing outboard side of 'White' tail rotor blade root with leading edge erosion shield and brass strip missing, and failed braided bonding strap.

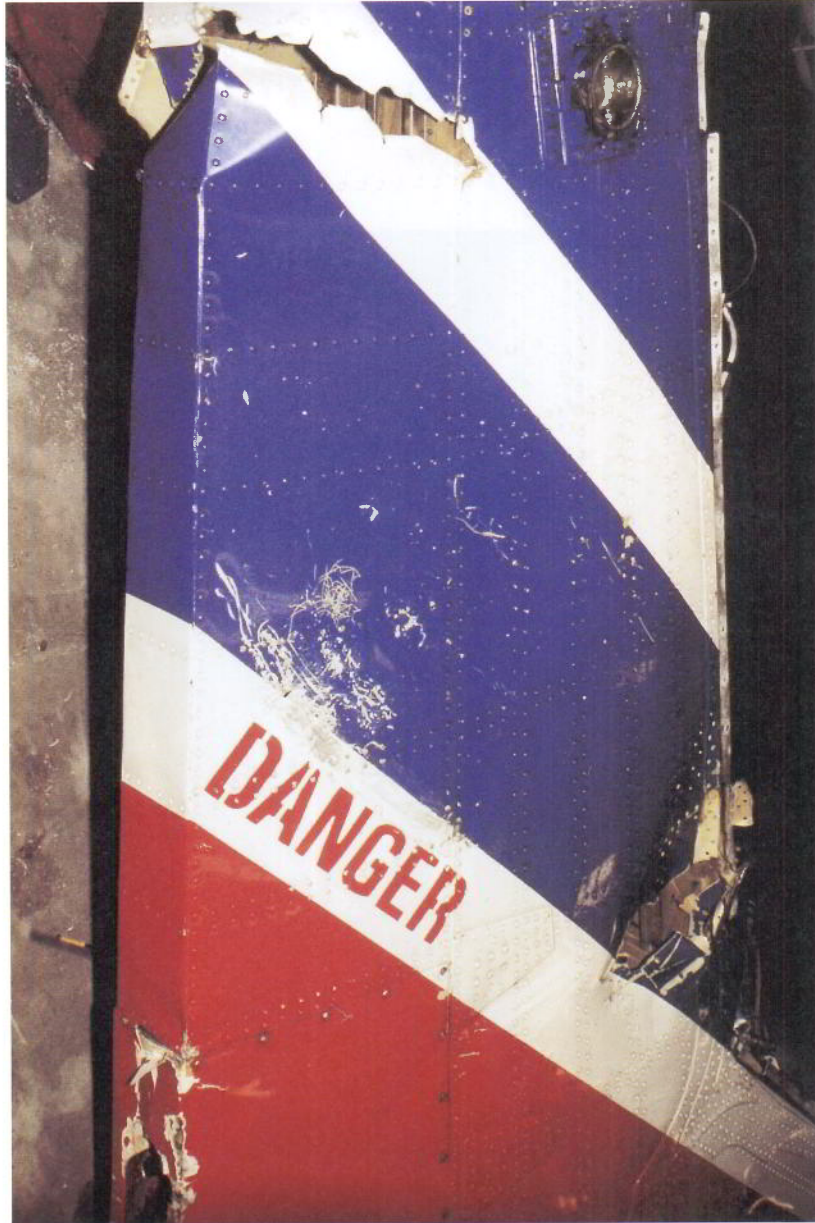
Figure 5: Showing deep gash in trailing edge of tail boom pylon and tail rotor blade impact damage on right side.

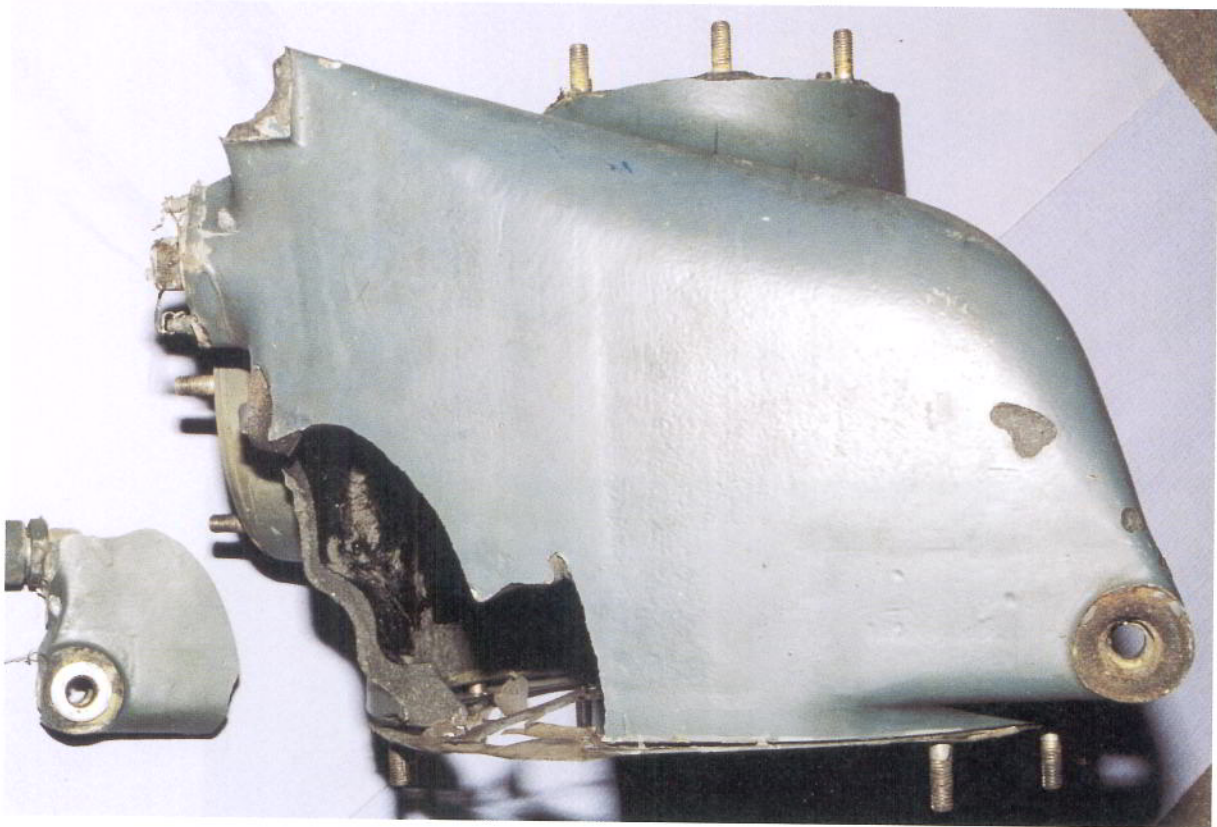
Figure 6: Showing failed lower attachments of gearbox (left attachment is upper one in this photograph, right is lower).

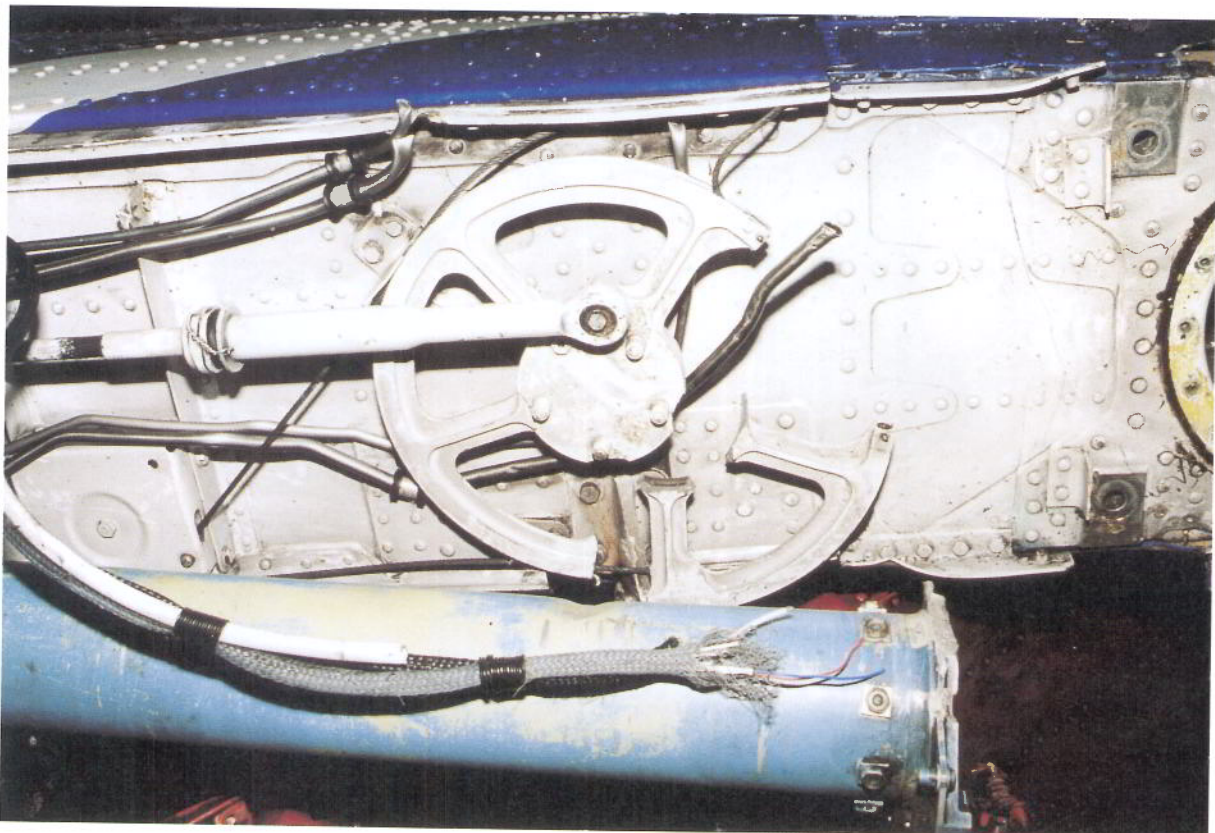
Figure 7: Showing the four severed hydraulic pipes, with two right side pipes sharply bent around damaged right support flange.

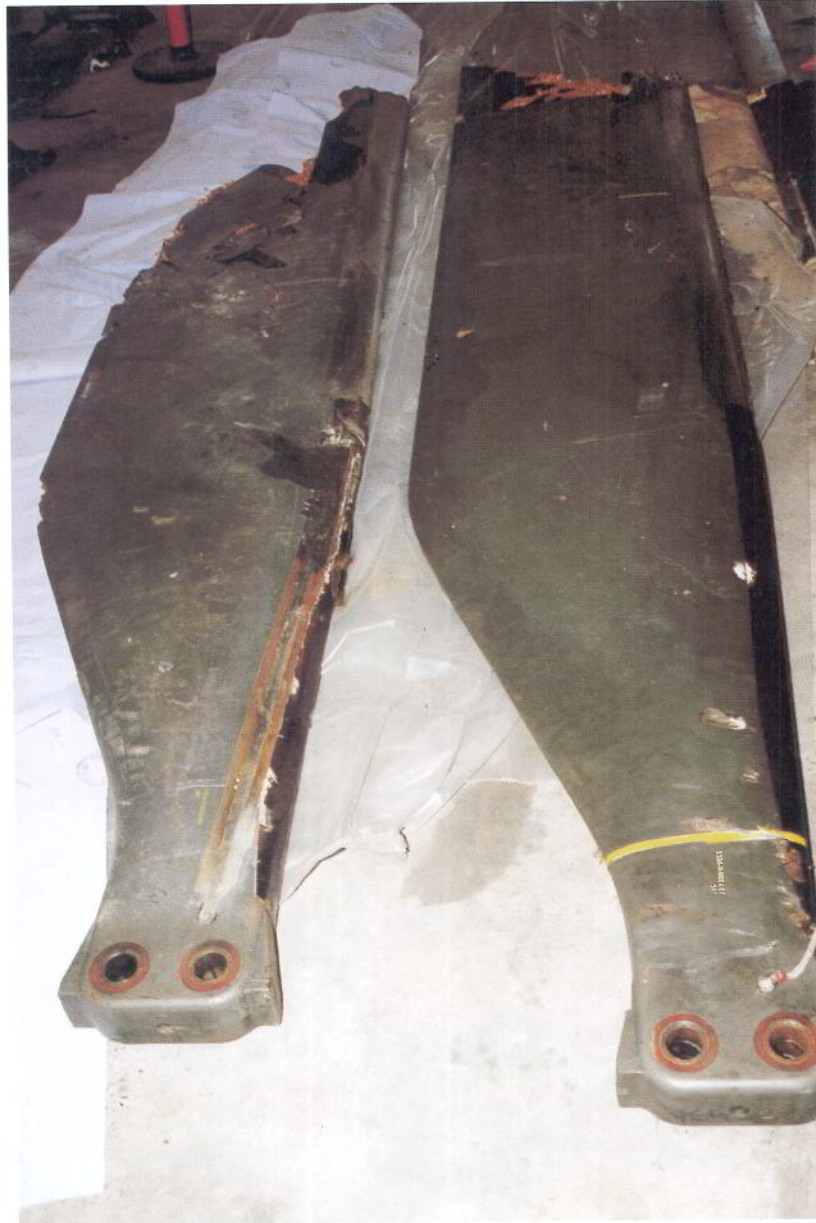
Figure 8: Showing recovered inboard section of 'Blue' main rotor blade with bonding strip missing, alongside 'Yellow' MRB for comparison.

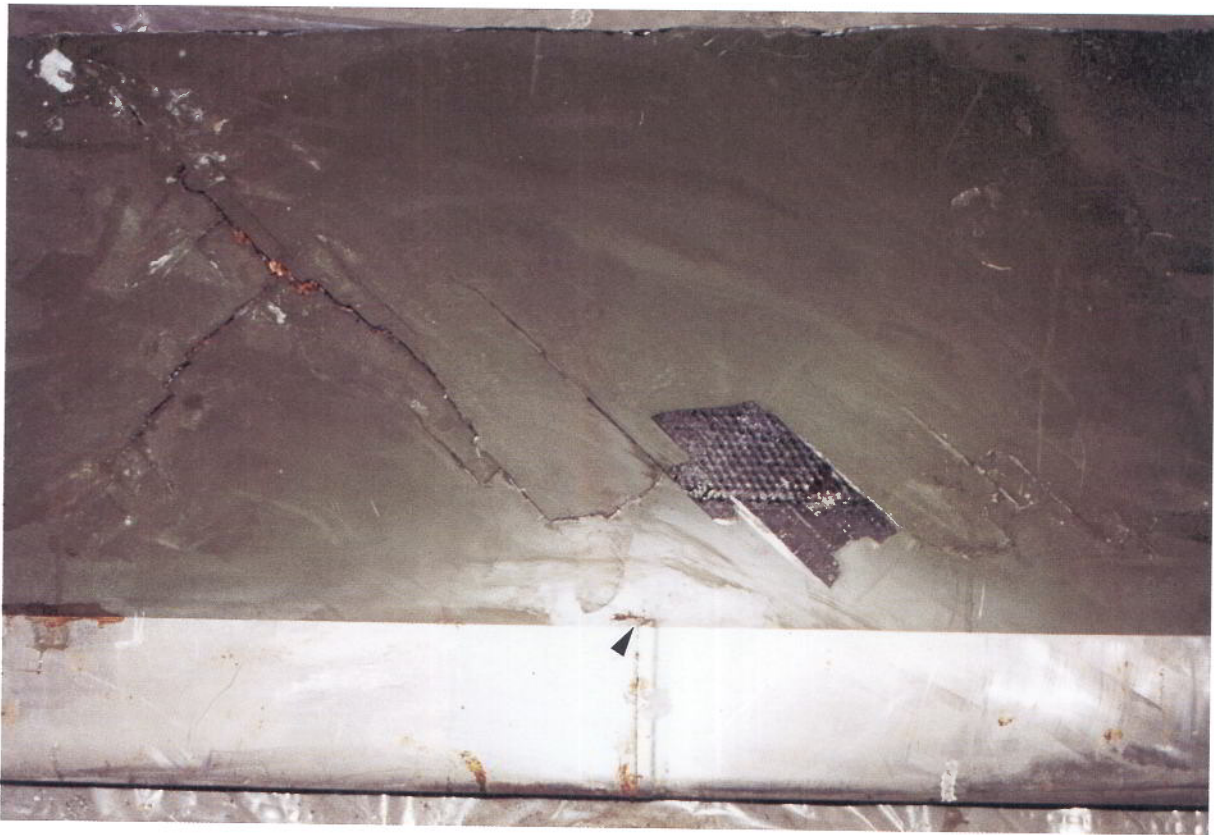
Figure 9A: Showing localised blade skin damage at overlap of leading edge anti-erosion shield sections due to related arcing on 'Black' MRB.

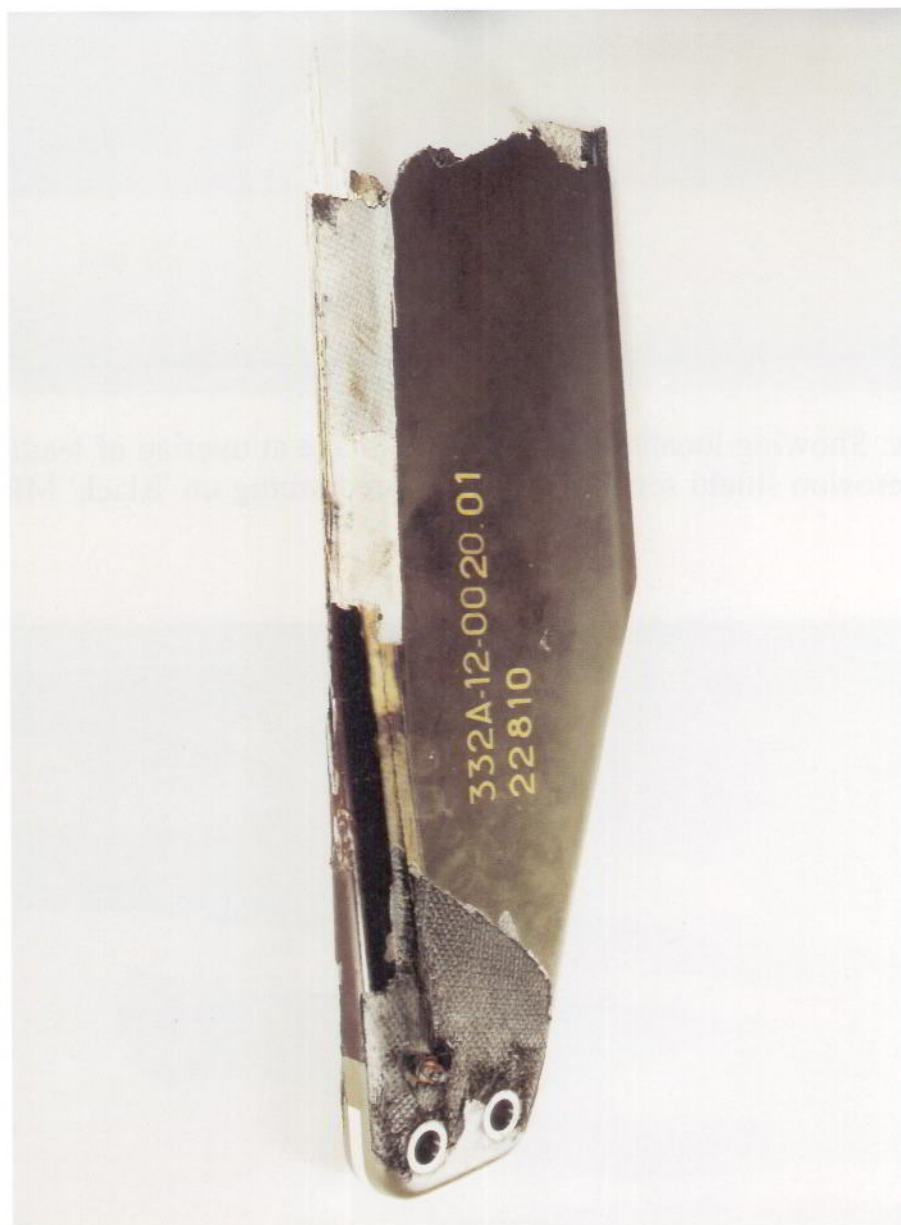
Figure 10: Showing damaged outboard (right) side of 'White' tail rotor blade, with thermal delamination of root area, full length fissure of composite within bonding strip recess and removal of leading edge skin layer under deatched anti-erosion shield.

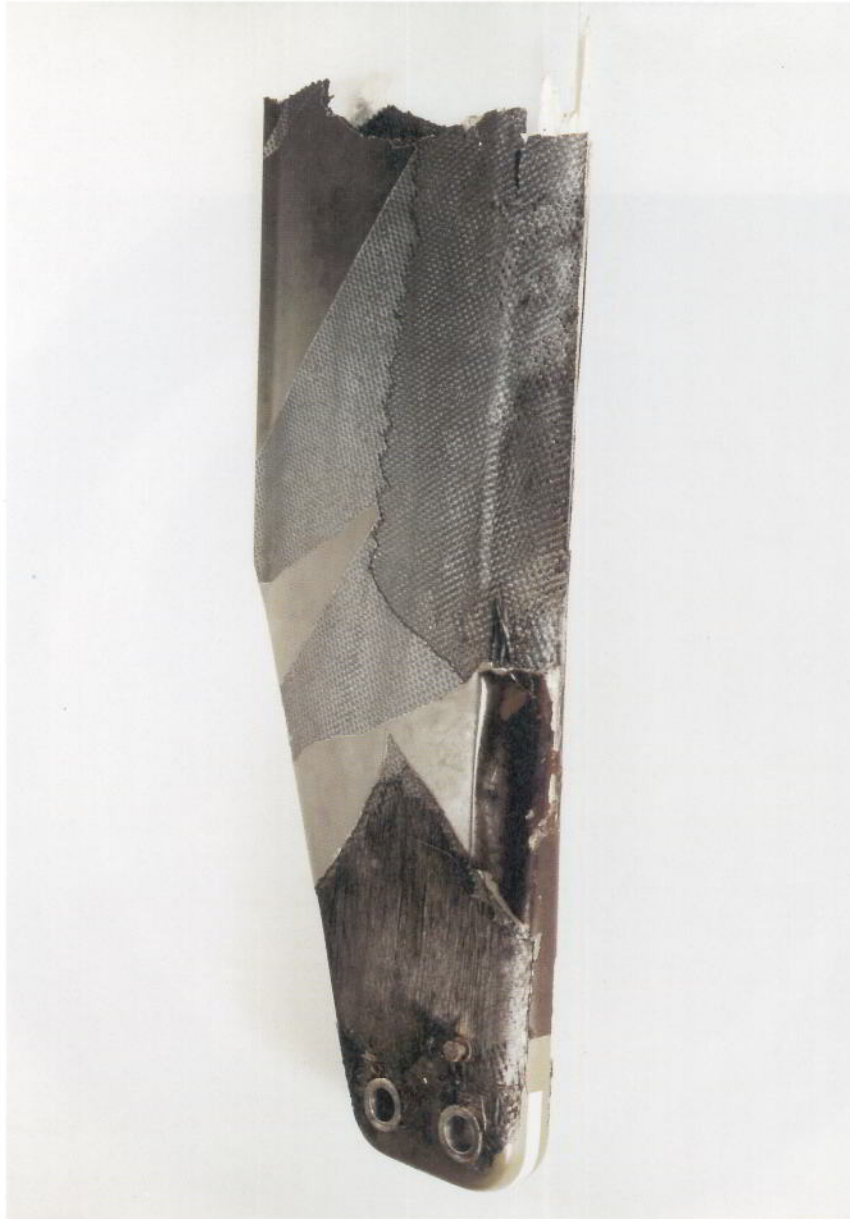
Figure 11: Showing damaged inboard (left) side of 'White' tail rotor blade, with thermal delamination of root area and general delamination outboard, including the leading edge from which the anti-erosion shield detached.

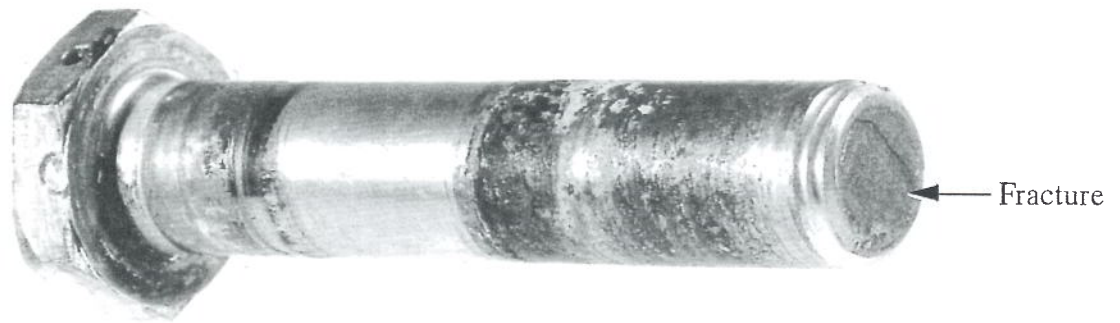
Figure 12A: Showing upper length of tail rotor gearbox upper attachment bolt with fracture face arrowed.

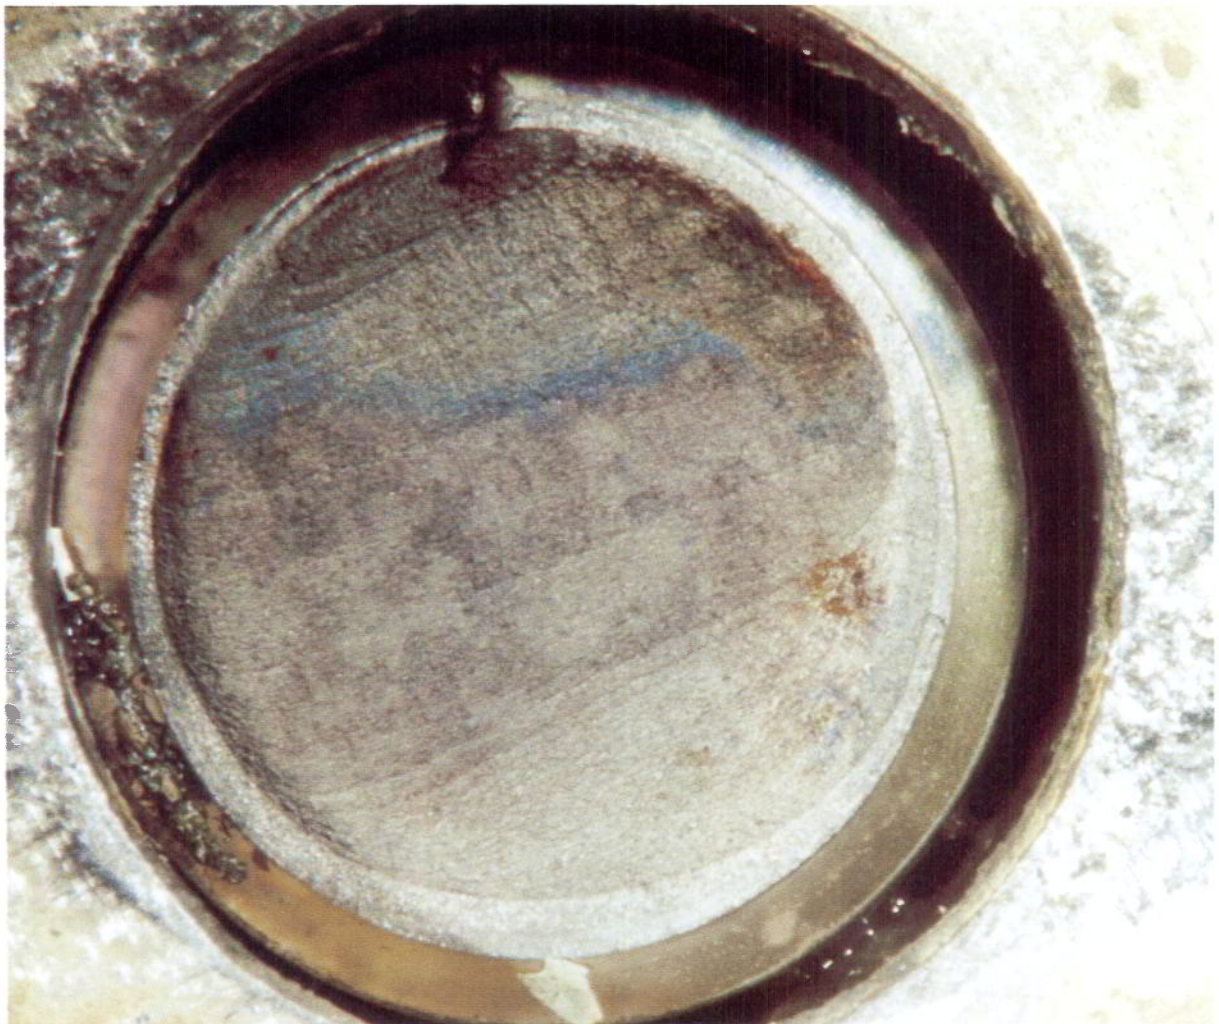
Figure 12B: Showing fracture surface of lower (threaded) end of tail rotor gearbox upper attachment bolt, with shallow (bright) annular band of initial radial fatigue propagation from the thread root, and secondary bending fatigue striations clearly evident emanating from upper arc, before the final overload failure evident within lower segment of fracture.

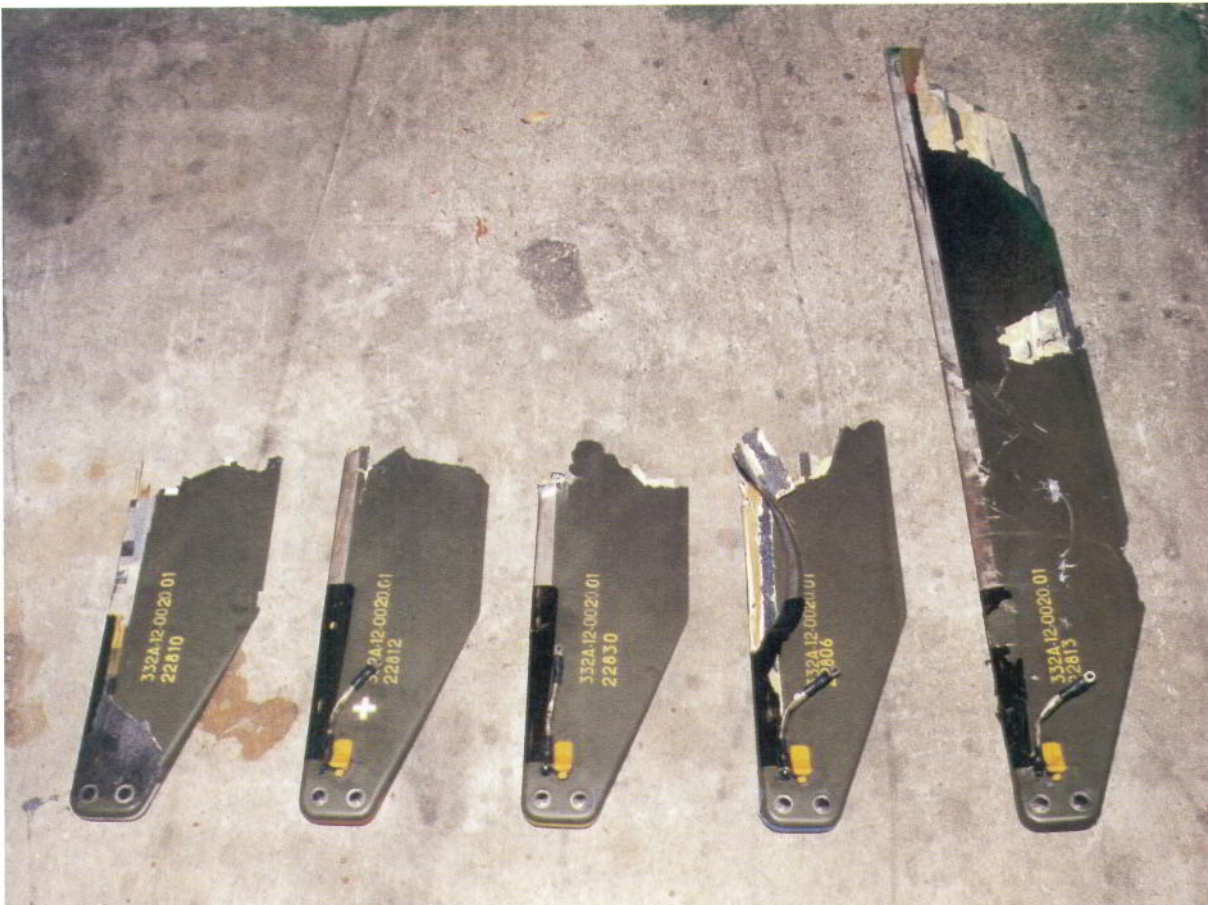
Figure 13: Showing the recovered tail rotor blade sections with, left to right in this photograph, 'White', 'Red', 'Blue' and 'Black' blades, outboard (right) sides uppermost. Note similar lengths of first four severed blades, caused by rotational penetration into aft side of pylon (Figure 5, A-6).

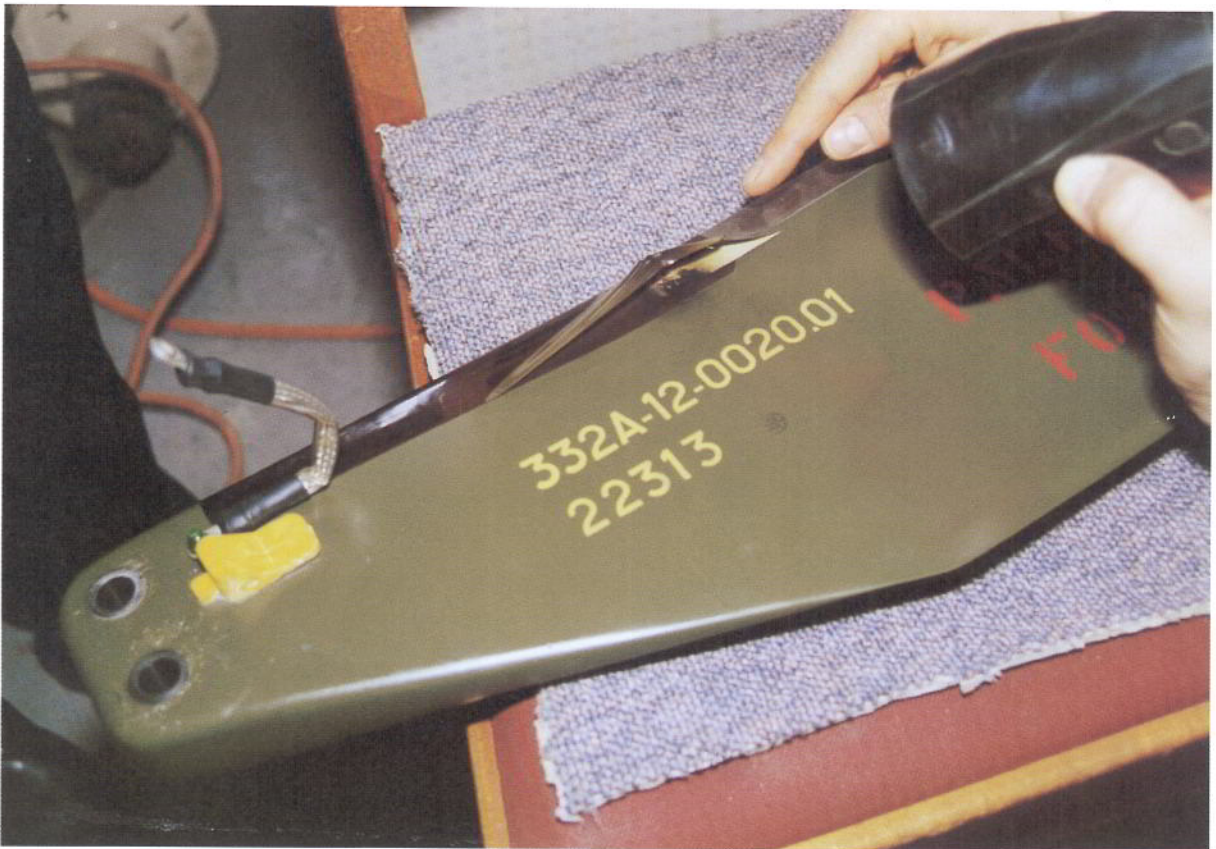
Figure 2: Showing 'peel-back' of inboard end of anti-erosion shield from brass conducting strip after 12.7kA low energy test (shield tip input).

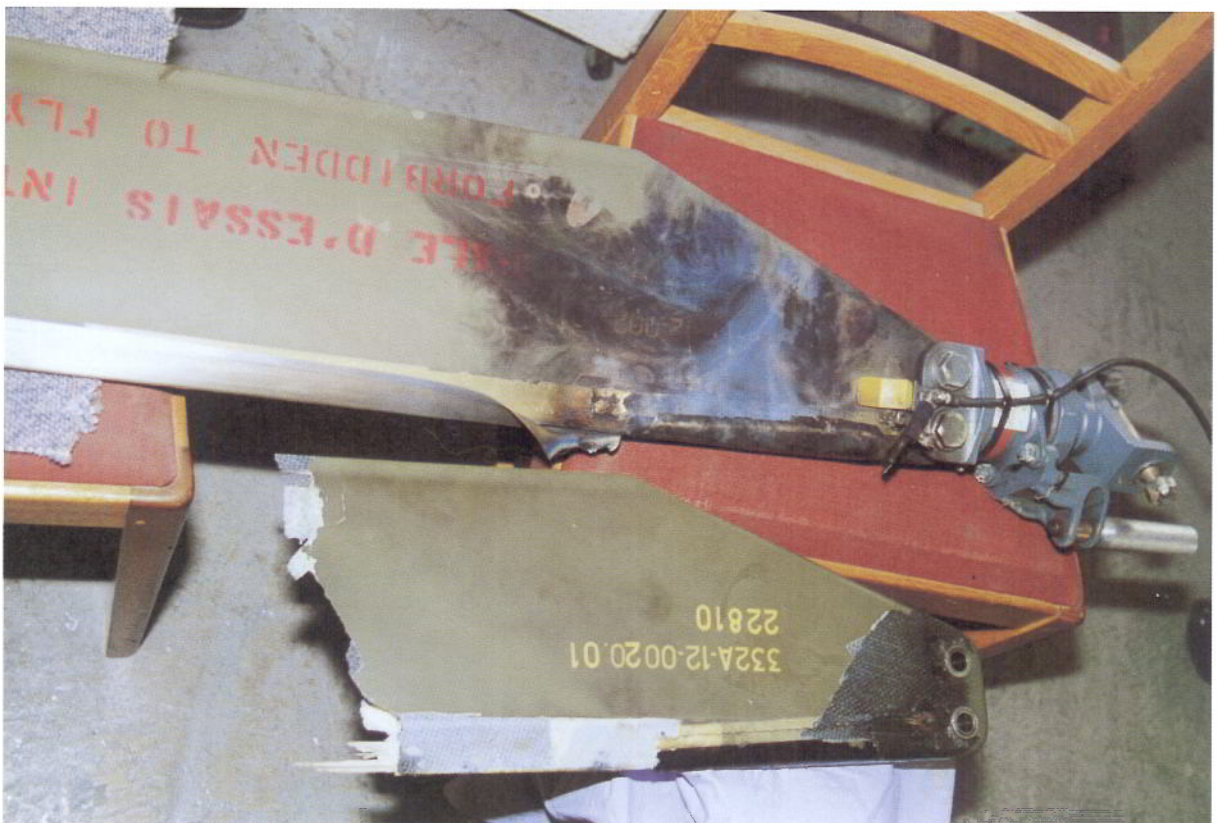
Figure 3: Showing post-test damage to inboard span of TRB s/n 22200 after 190.9kA input to shield tip, with White TRB section for comparison.

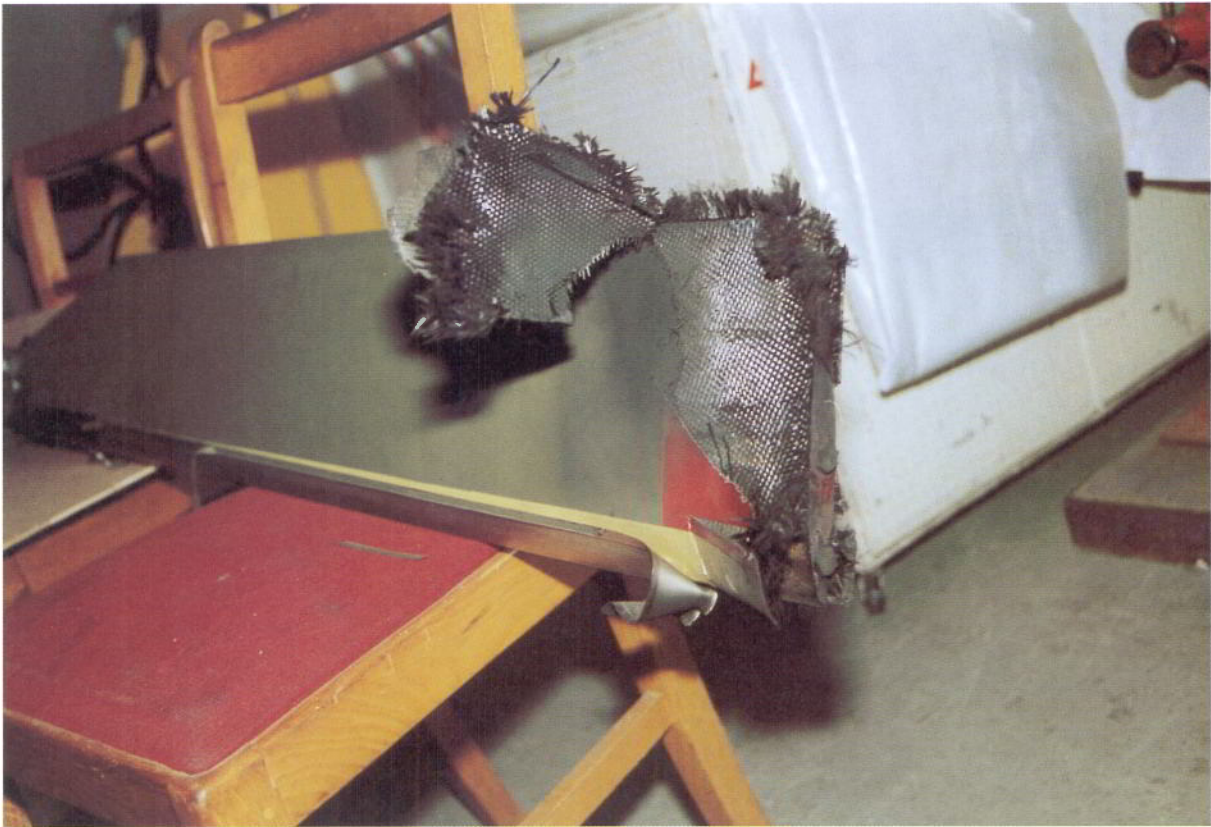
Figure 4: Showing tip damage to TRB s/n 20667 after 180.1kA input to trailing edge tip, with peel-back and general debonding of erosion shield.

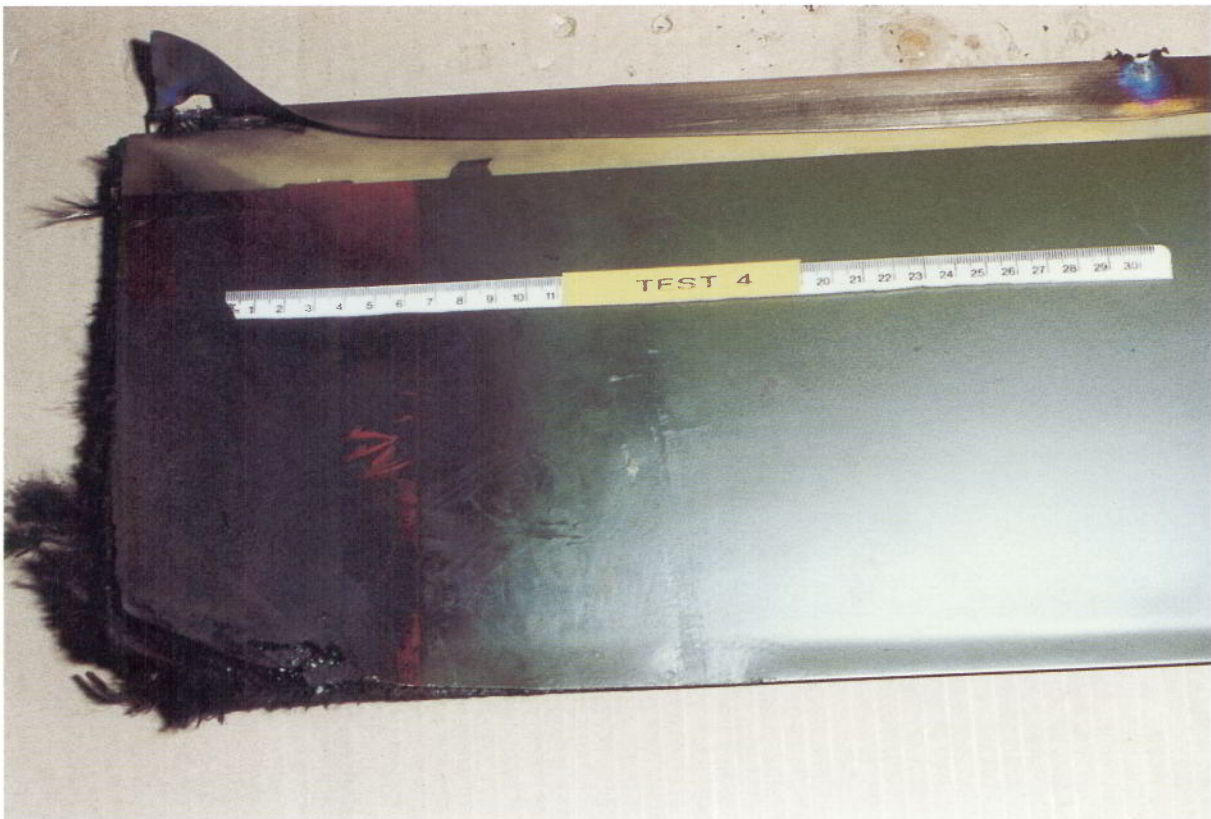
Figure 5: Showing tip damage to TRB s/n 21667 after 253.7kA input to trailing edge tip, with debonding of erosion shield and 'burn-holes'.

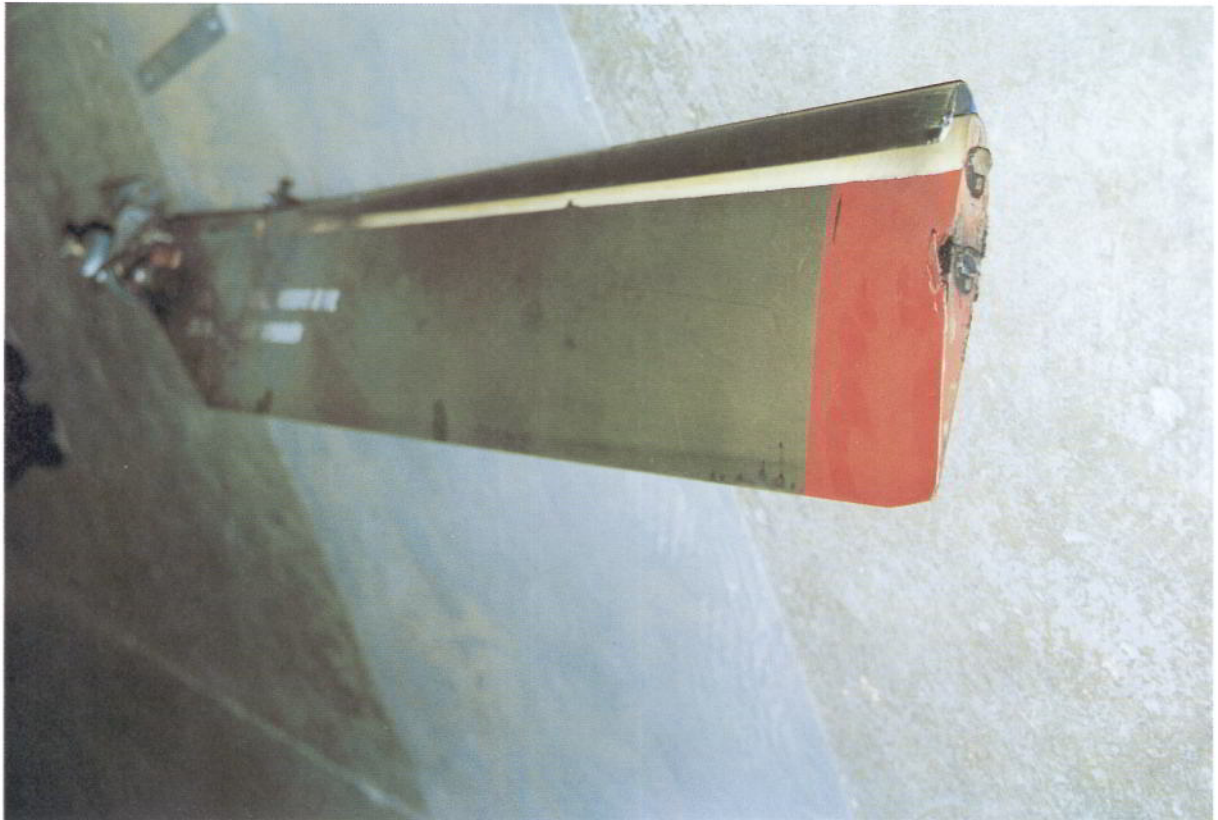
Figure 6A: Showing TRB s/n 20636 after 198.9kA input to aft tip bolt with minor damage around bolt, but almost complete separation of shield.

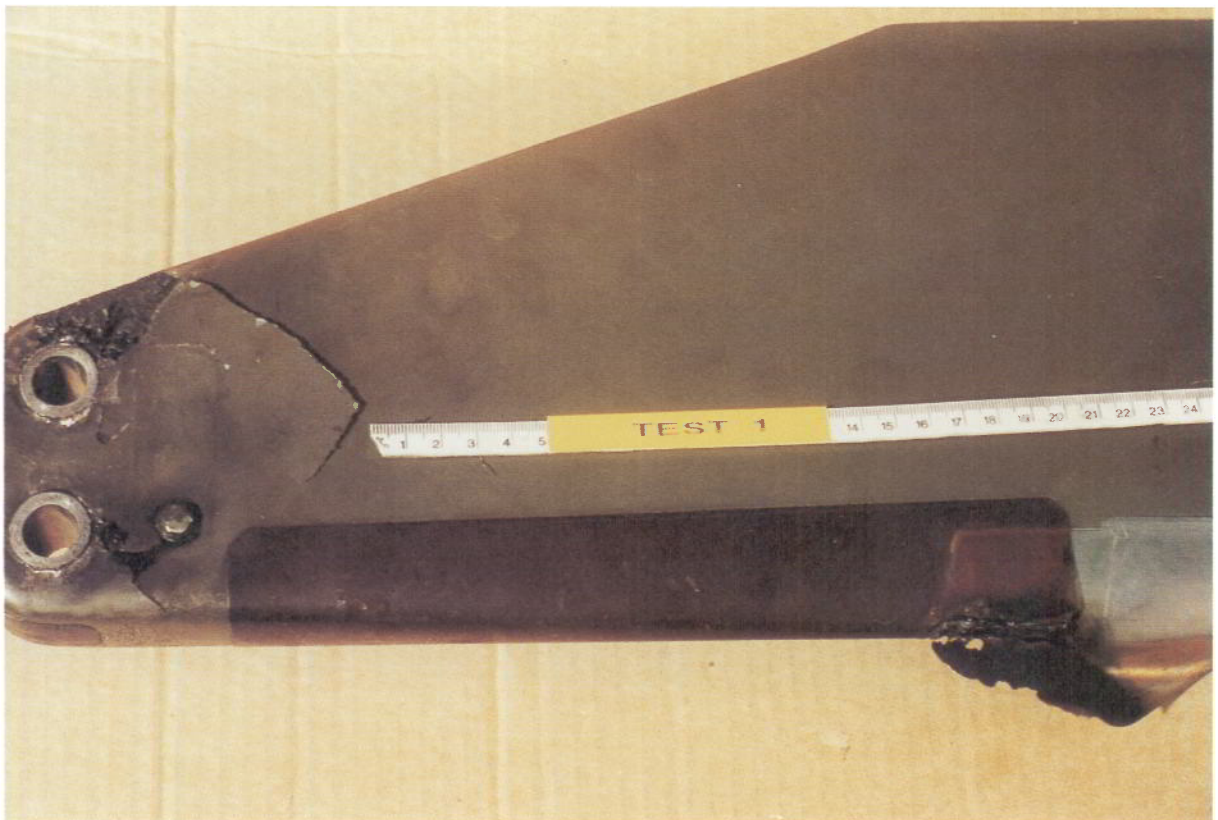
Figure 6B: Showing thermal delamination damage to root area of above TRB.

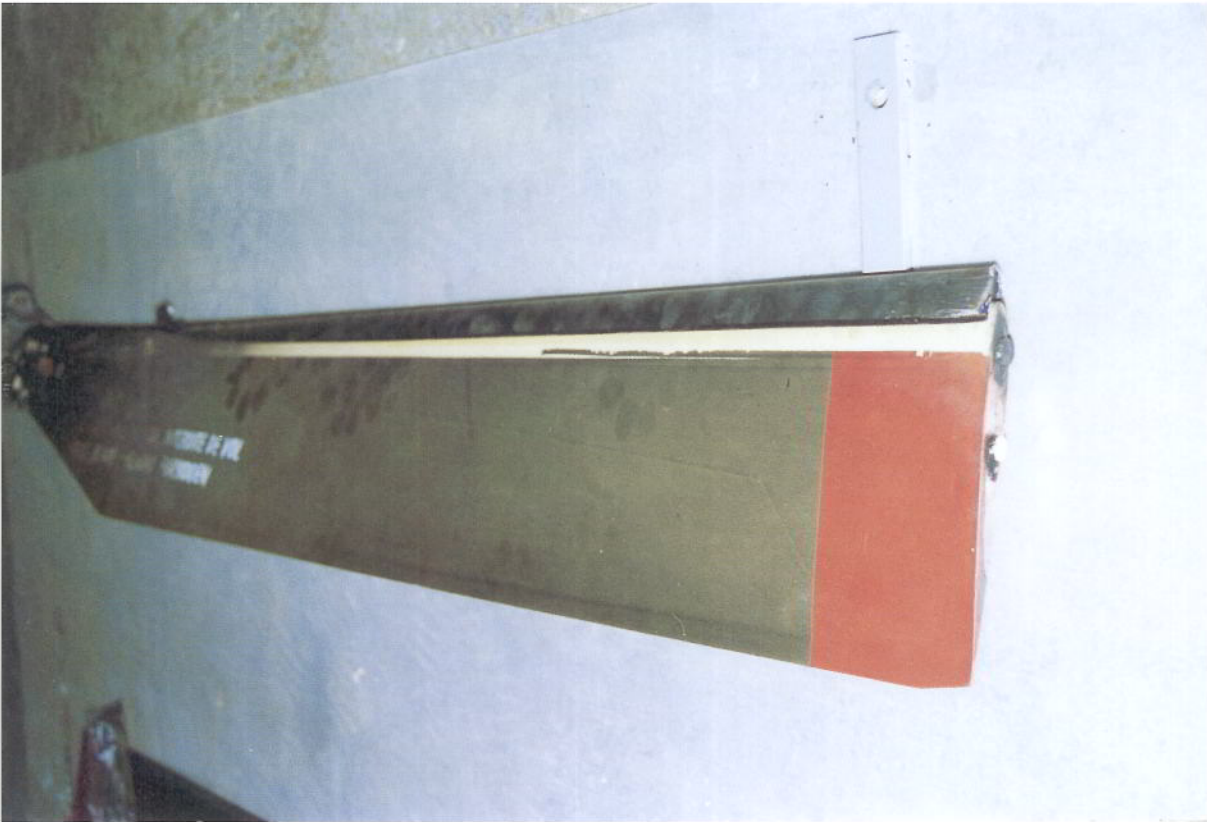
Figure 7A: Showing TRB s/n 20625 after 194.9kA input to forward tip bolt with minor damage around bolt and to erosion shield tip, but almost complete separation of shield.

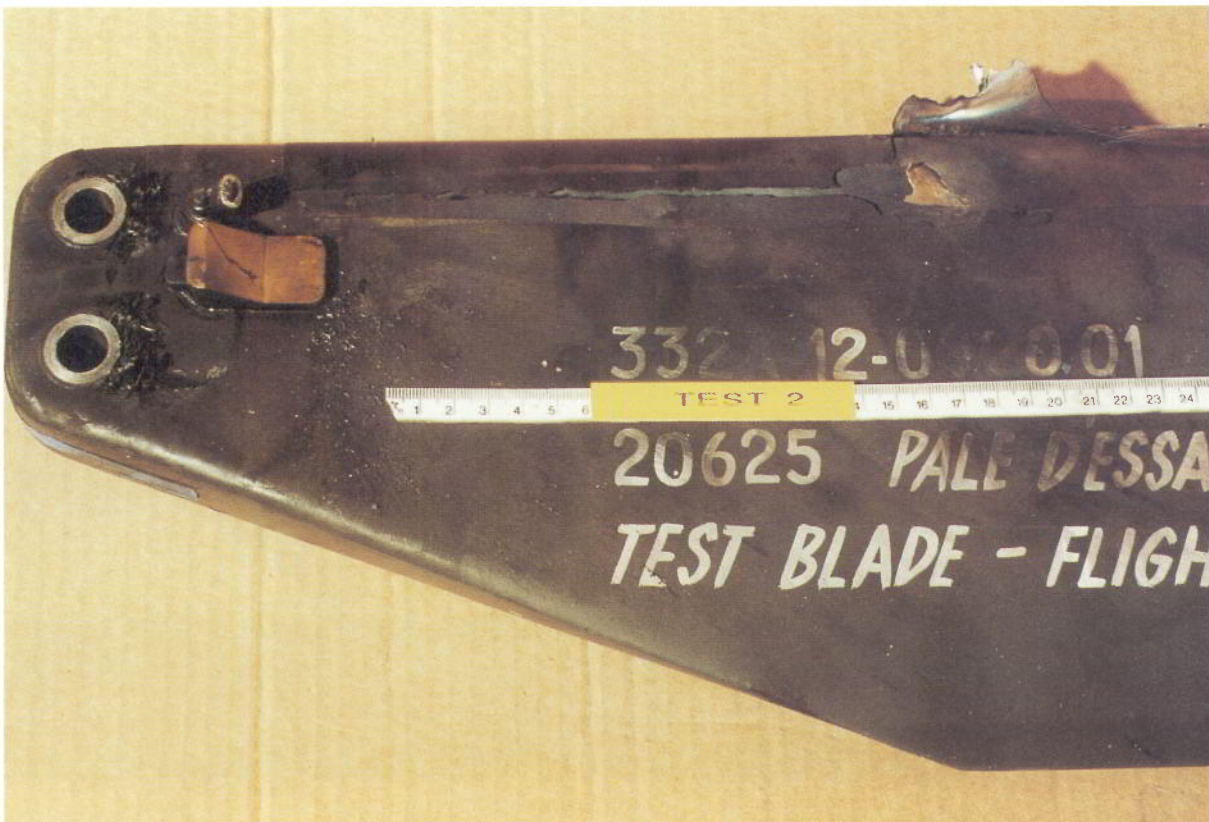
Figure 7B: Showing damage to inboard area of above TRB.

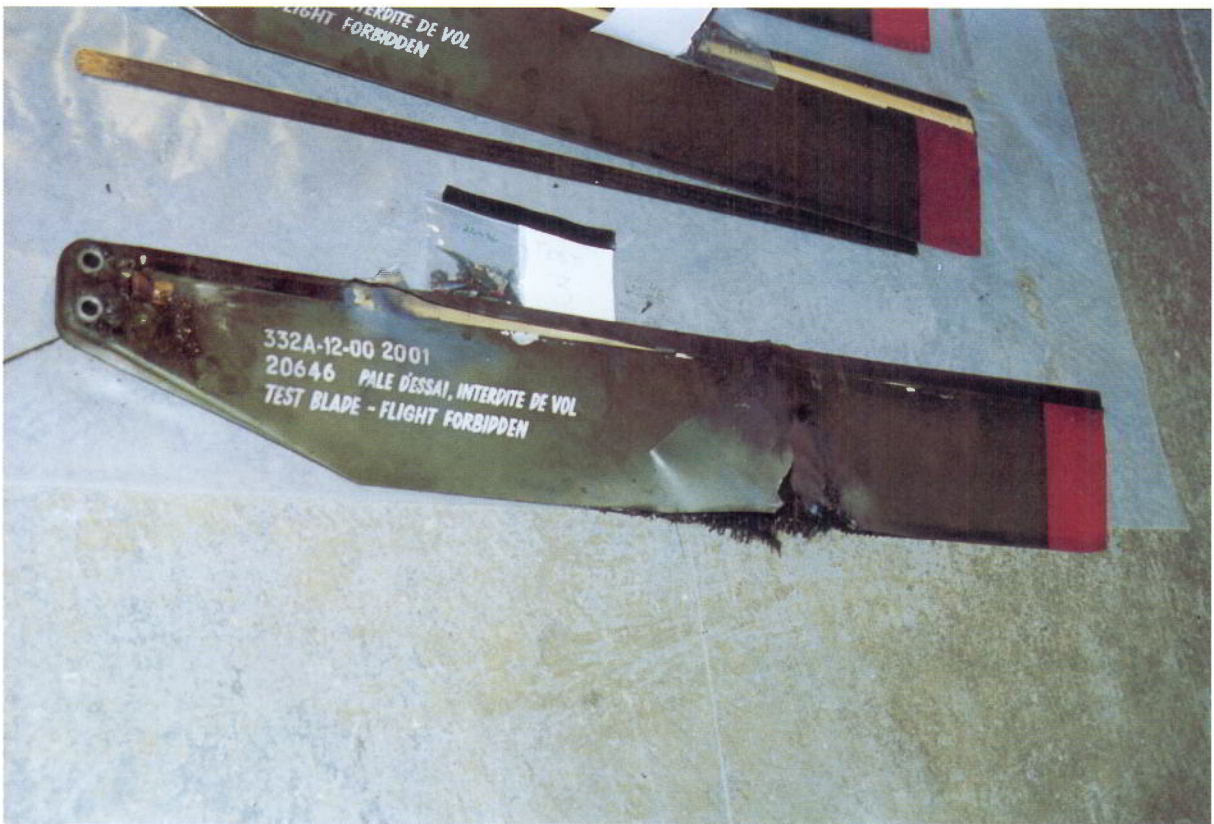
Figure 8A: Showing general marked damage to TRB s/n 20646 after 188.2kA input to trailing edge, 0.5 metre from tip.

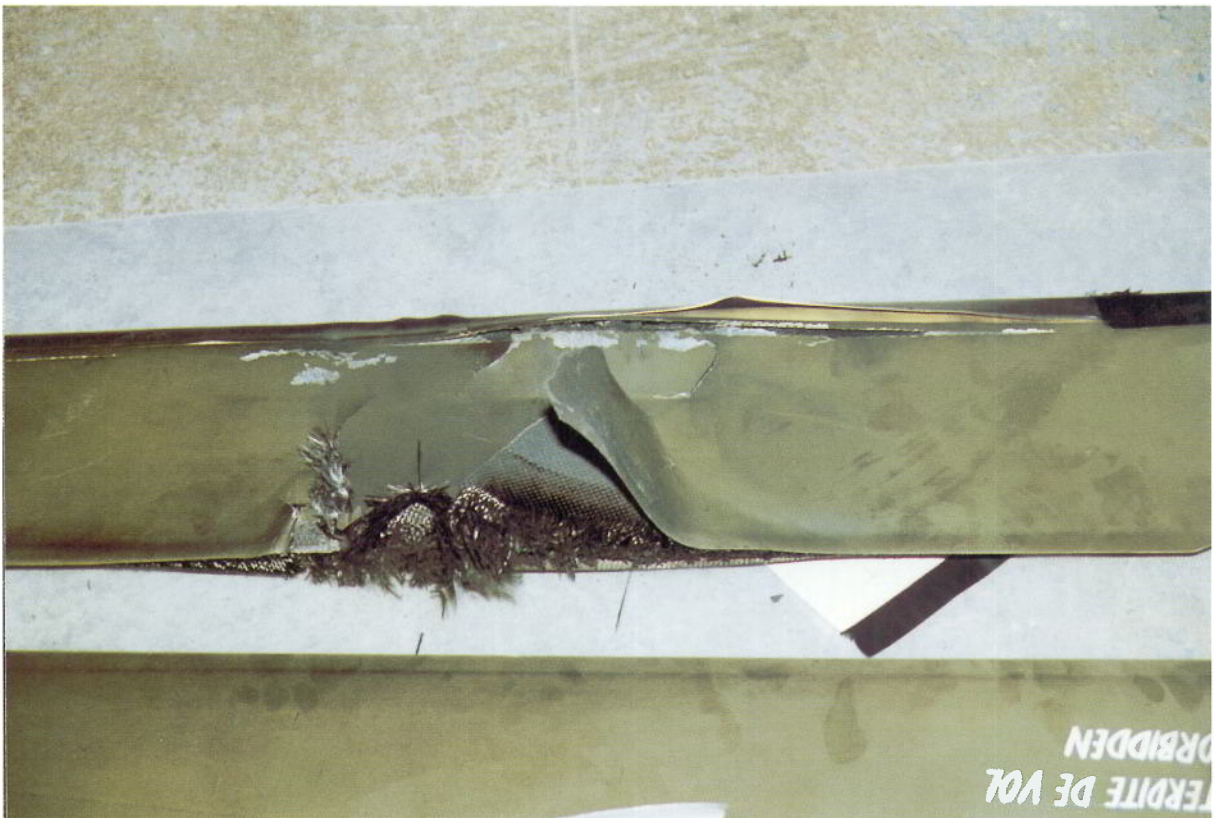
Figure 8B: Showing gross disruption of mid-aerofoil on above TRB and spanwise cracking of skins just aft of erosion shield.
