APPENDIX A

Figure 1: Showing general layout of AS332L.

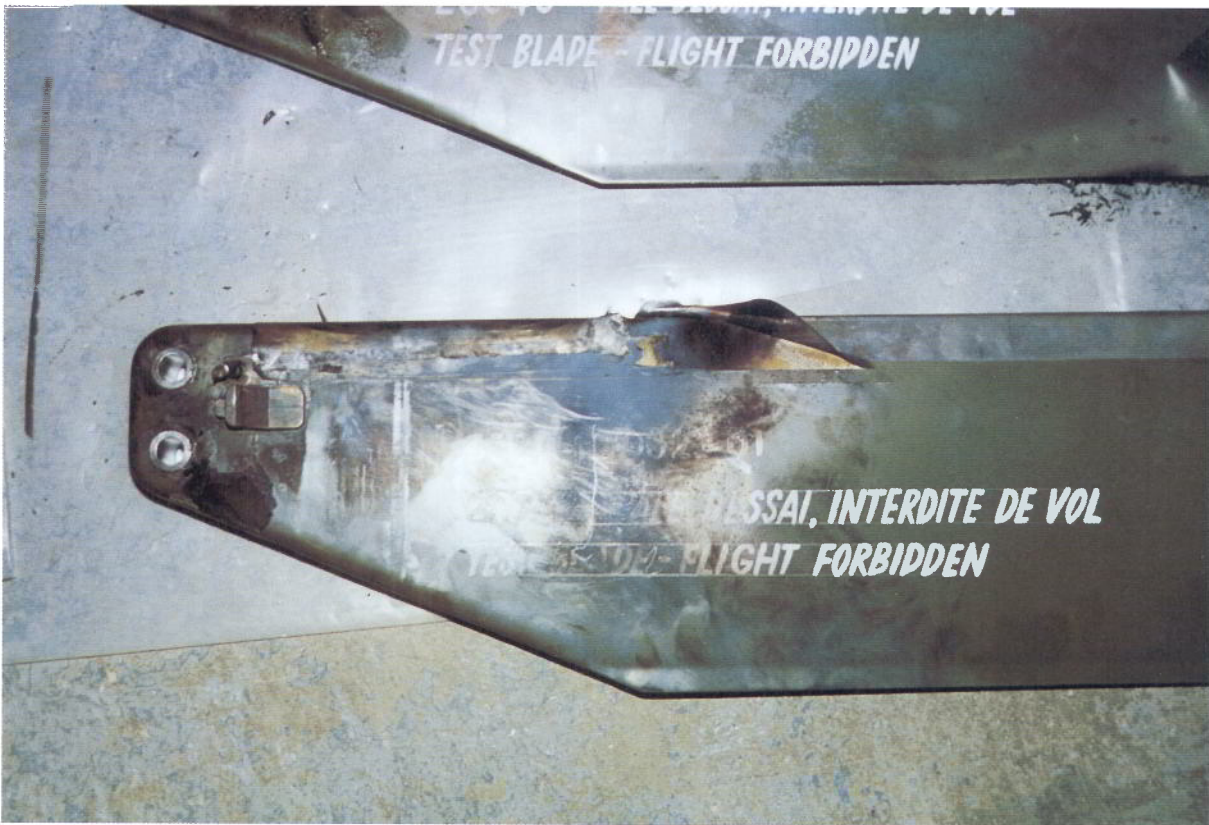
Figure 9A: Showing damage to TRB s/n 20732 after 206.9kA input to inboard end of erosion shield, with local peel-back of shield.

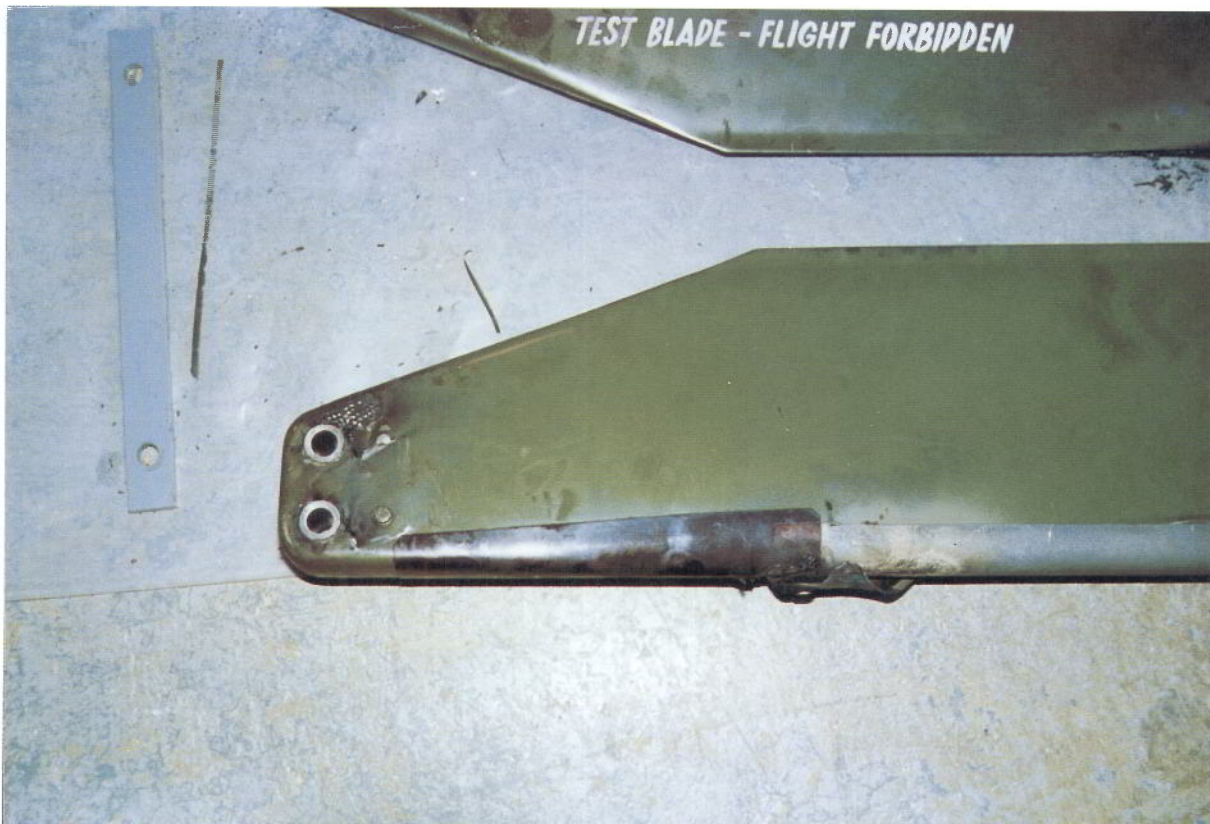
Figure 9B: Showing skin delamination and disbonding outboard of both steel bushes in root area (inboard side) of above TRB.

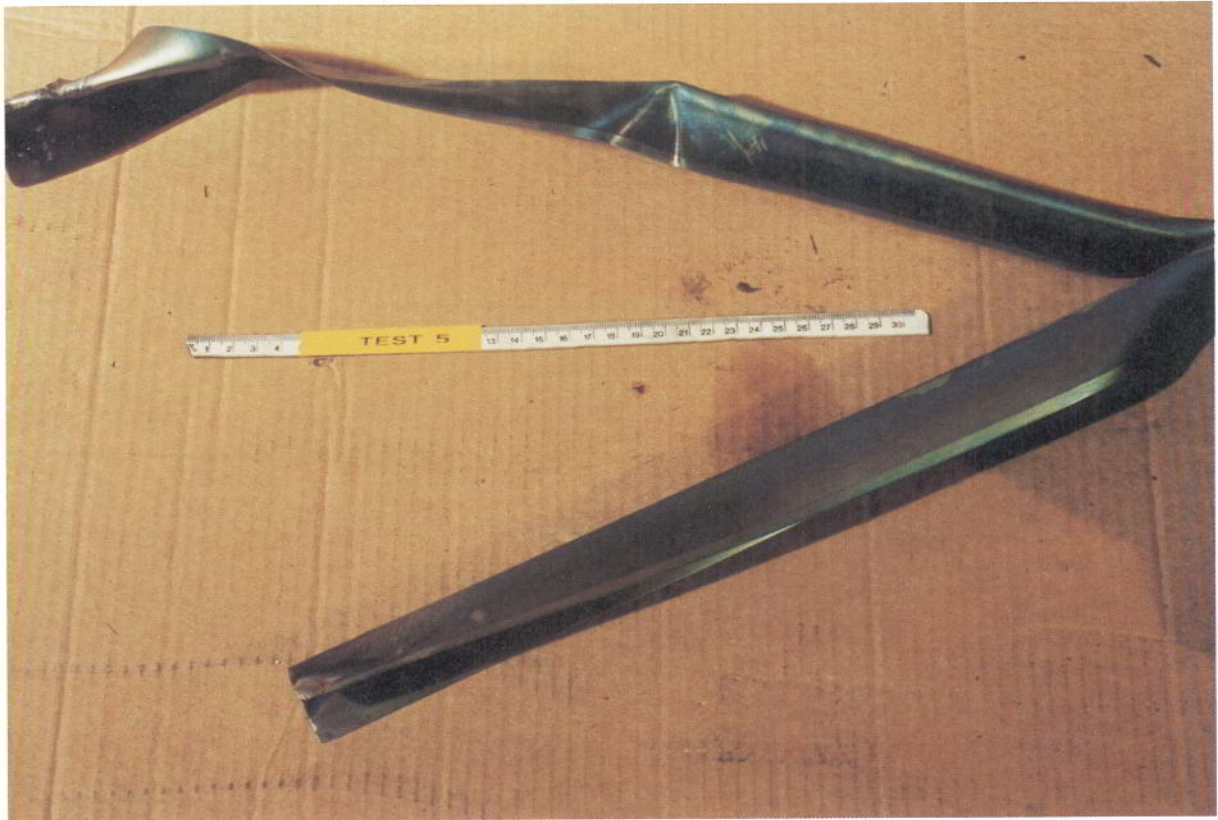
Figure 10A: Showing detached and badly deformed erosion shield after 275.5kA input to aft tip bolt on TRB s/n 20662.

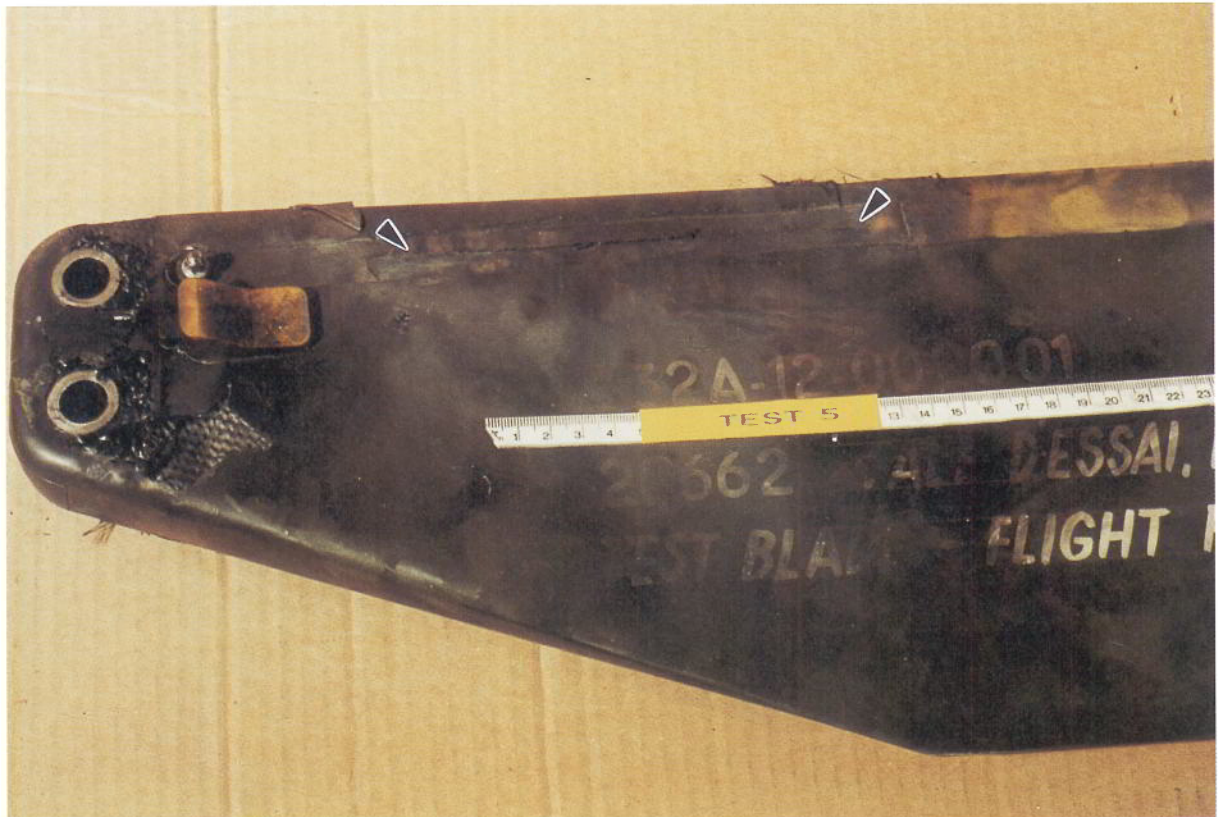
Figure 10B: Showing longitudinal 'fissure'(arrowed) within blade substrate uncovered by loss of brass bonding strip, and root damage on above TRB.

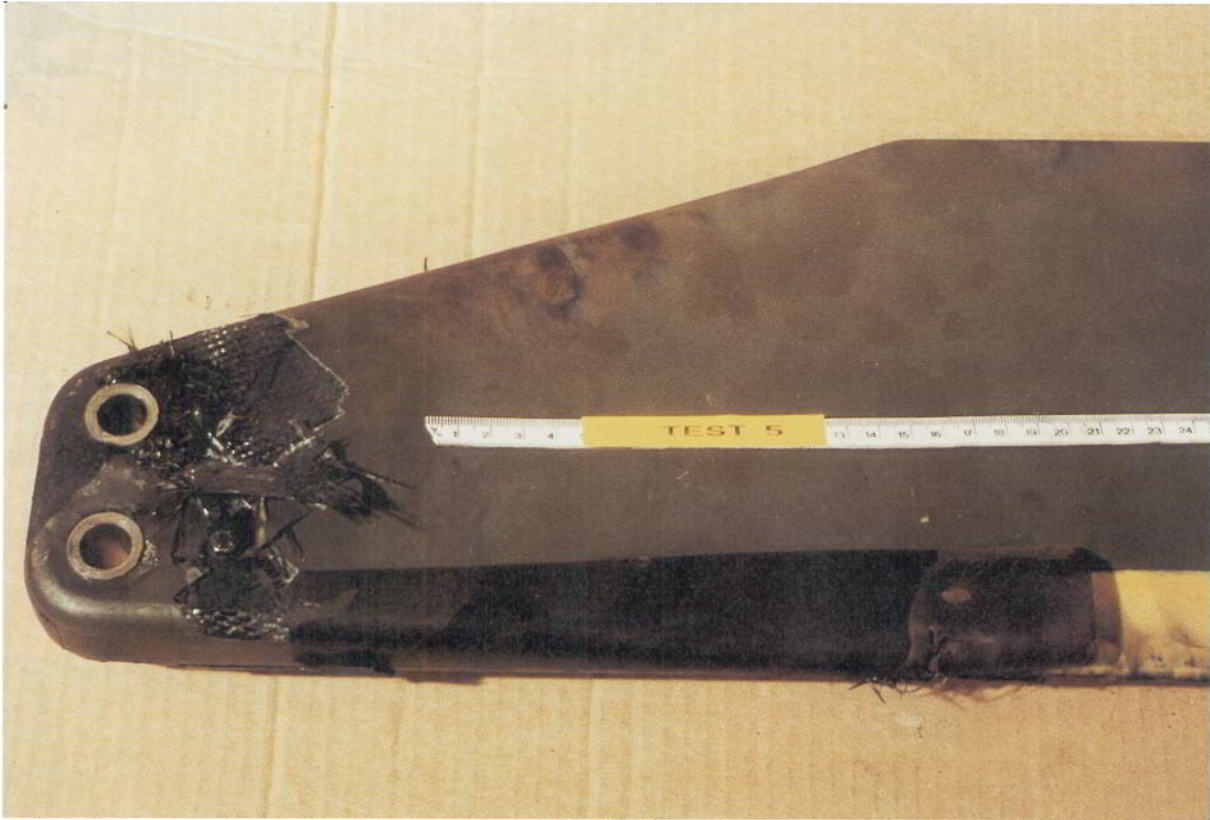
Figure 10C: Showing marked delamination and disbonding of inboard(left) surface of the root of TRB s/n 20662 after 275.5kA input to aft tip bolt.

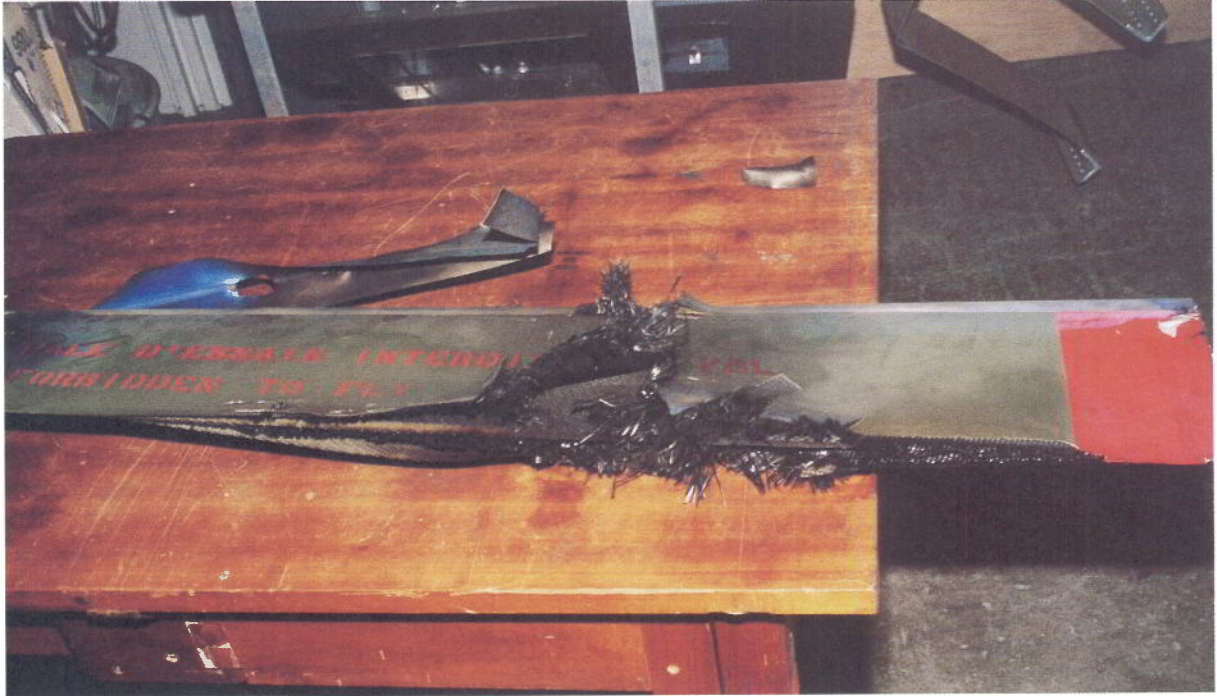
Figure 11A: Showing gross damage to aerofoil of TRB s/n 22313 after 253.3kA input to trailing edge, 34cm from tip.

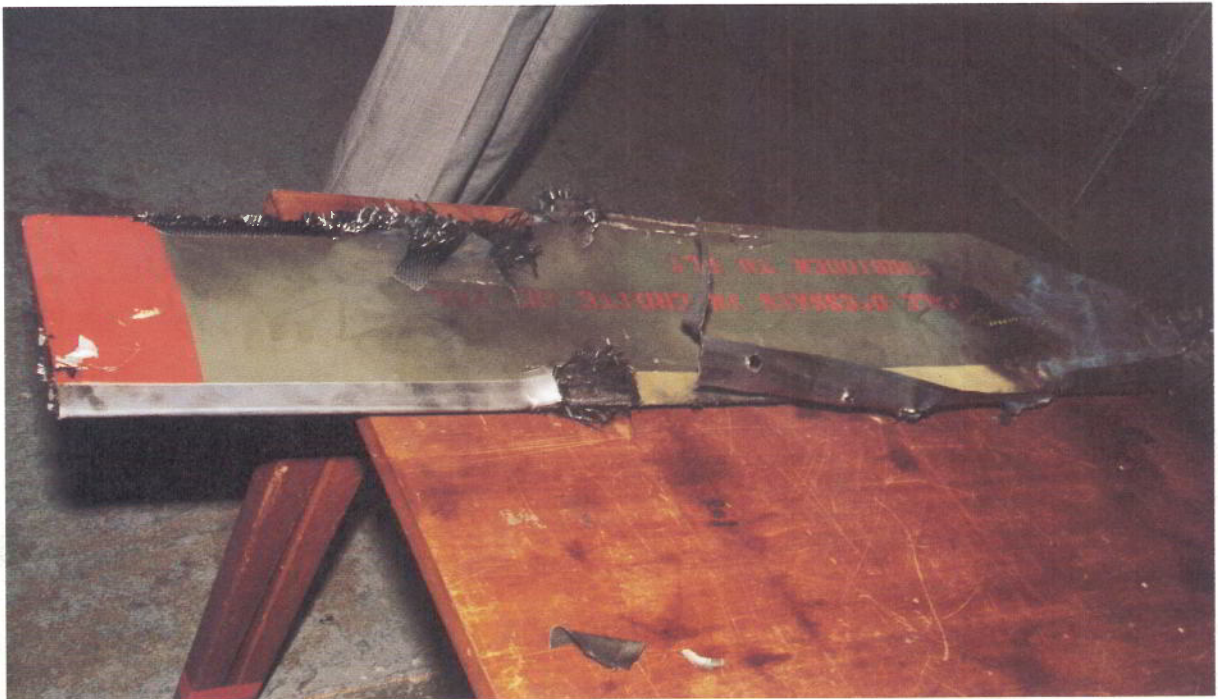
Figure 11B: Showing localised damage to leading edge composite and detached inboard length of shield, with 'burn-holes', on above blade.

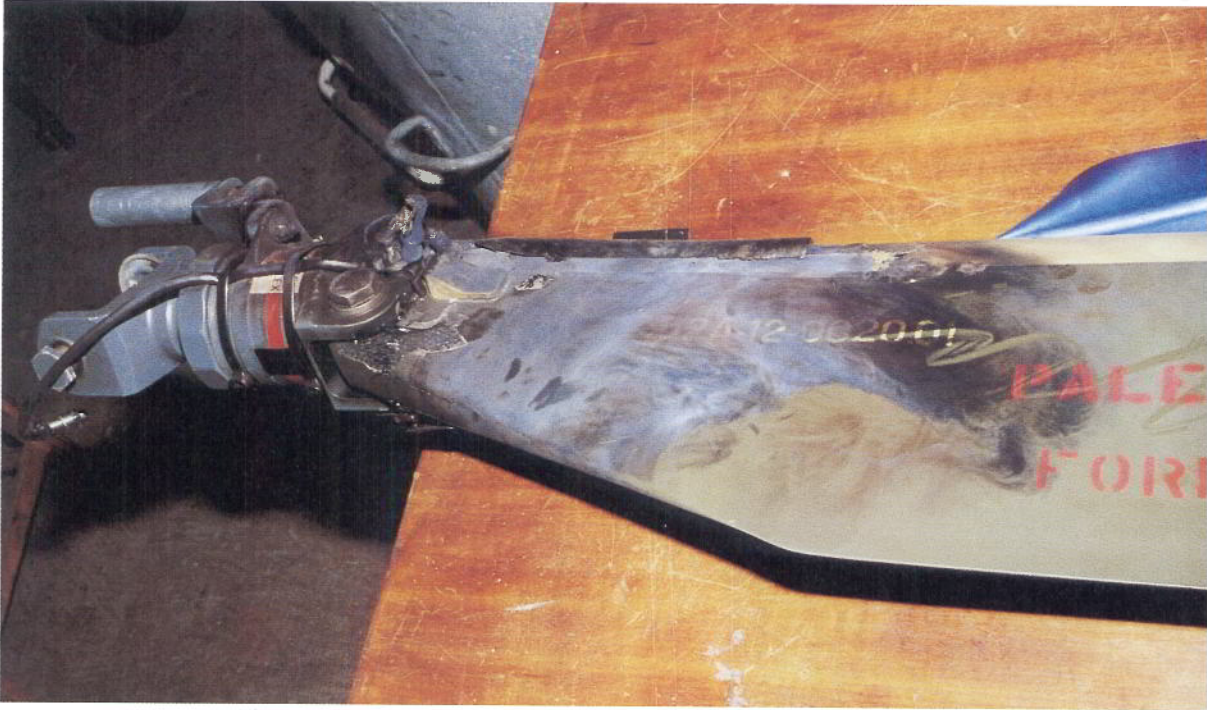
Figure 11C Showing marked thermal affects on outboard side of root on TRB s/n 22313 with carbon fibre damage adjacent attachment bolts.

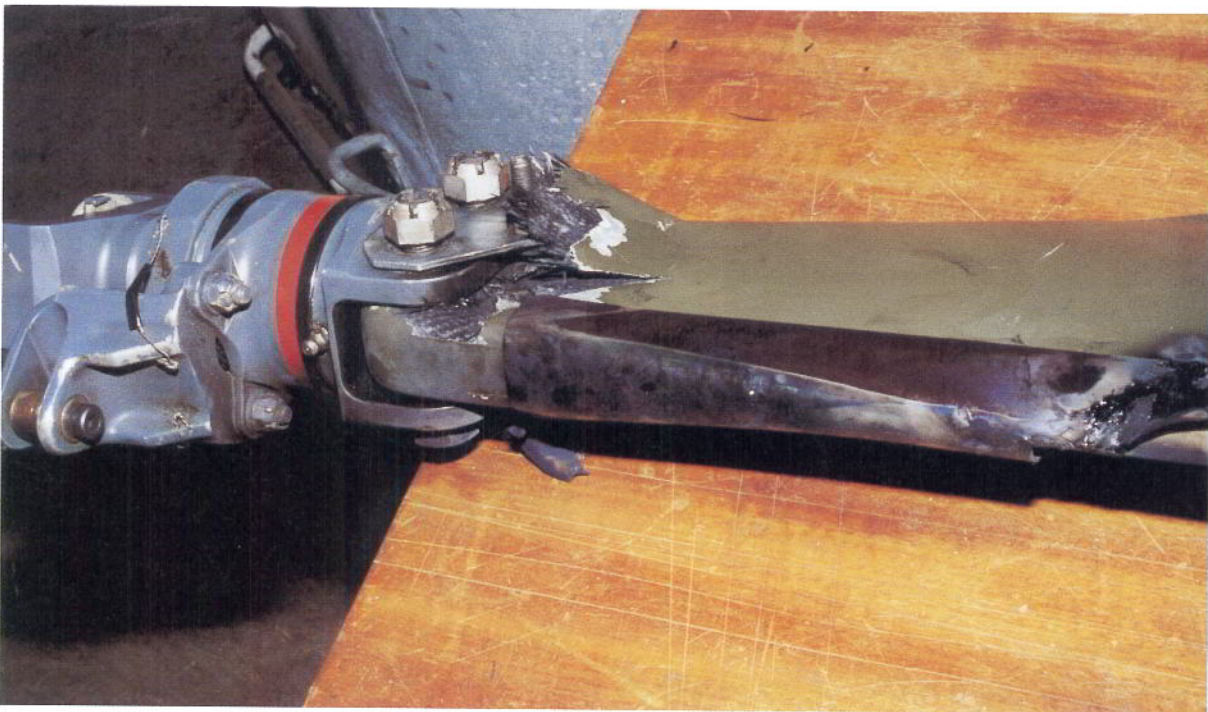
Figure 11D: Showing very marked carbon fibre disbonding and delamination adjacent attachment bolts on inboard side of above blade.

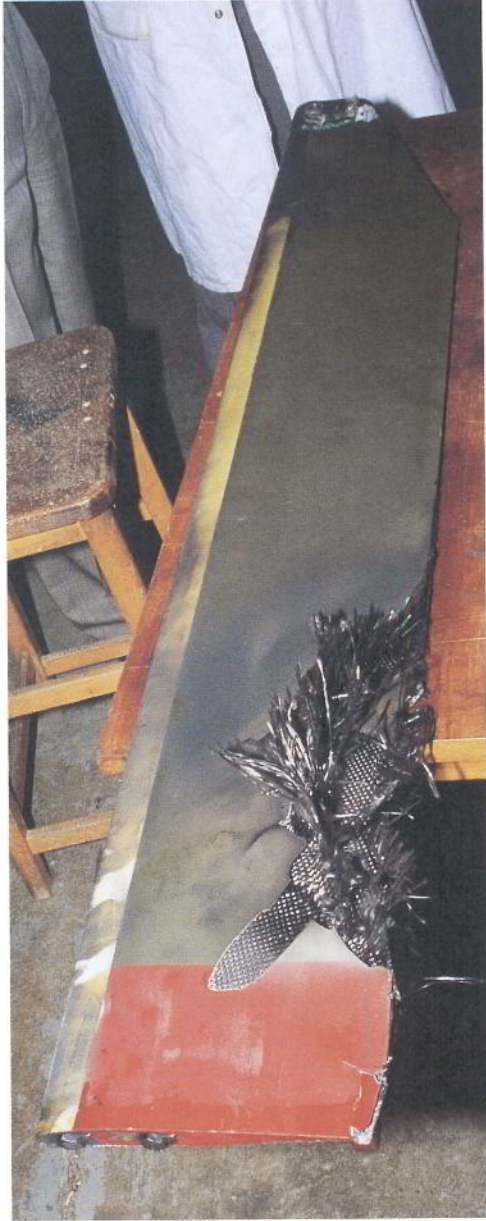
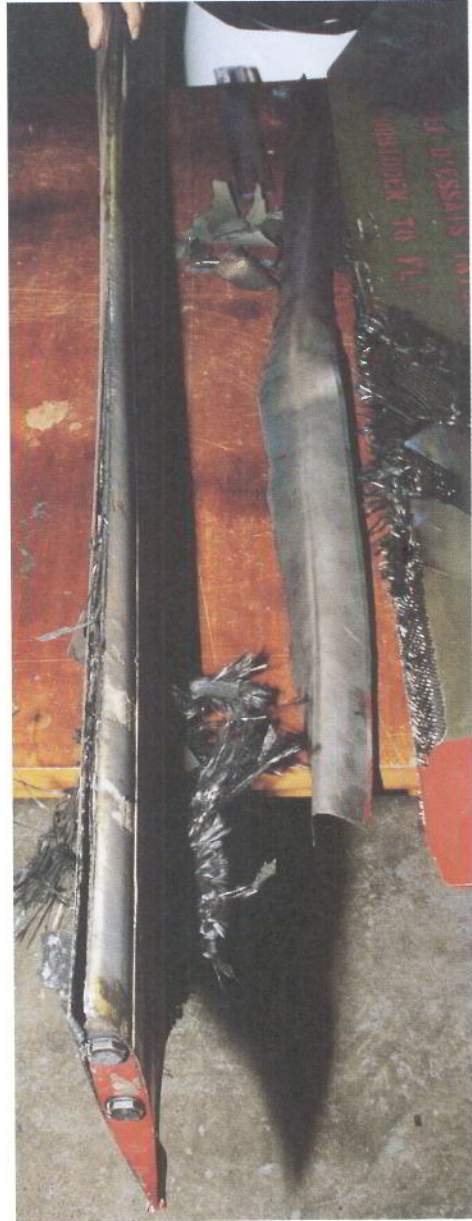
Showing (Figure 12A) gross damage to aerofoil with (Figure 12B) 'split' in leading edge and detached erosion shield lying alongside TRB s/n 20697 after 253.8kA input to trailing edge, 20cm from tip.

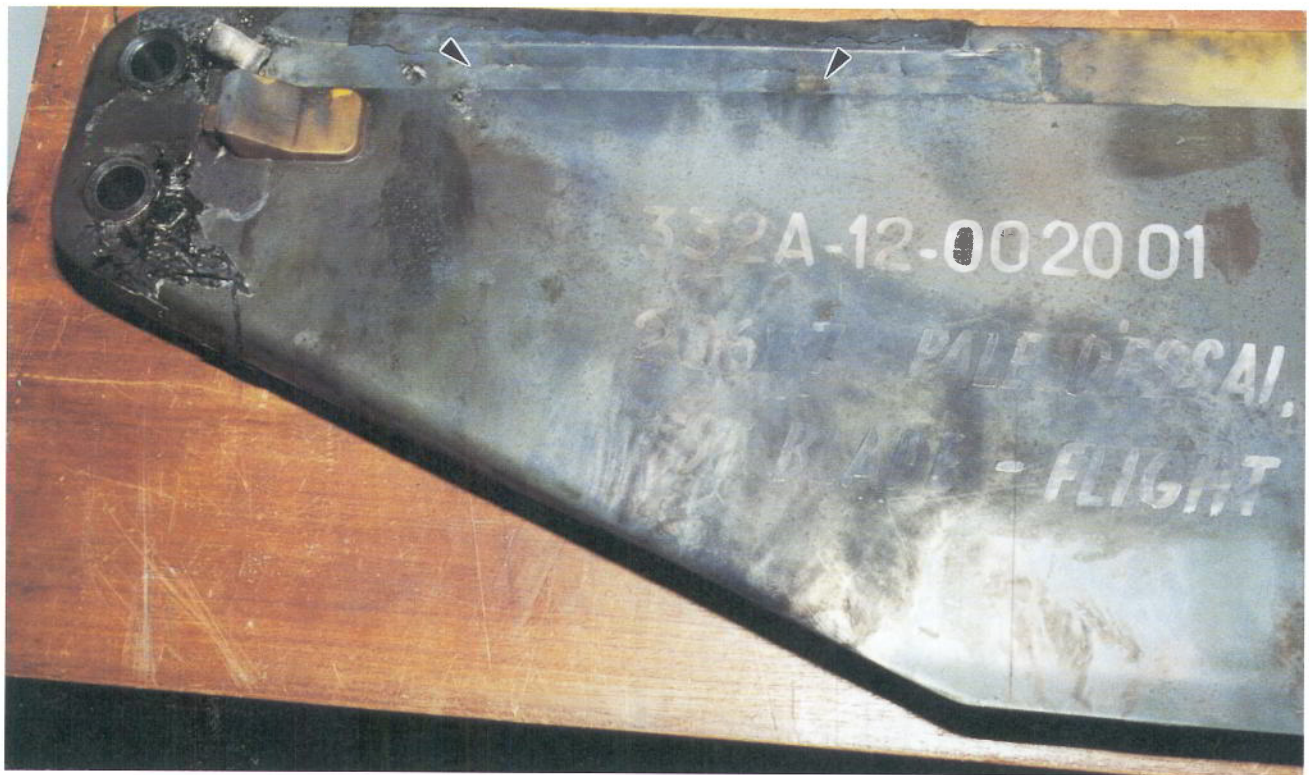
Figure 12C: Showing almost full length 'fissure'(between arrows) within substrate uncovered by loss of brass conducting strip, and root damage adjacent attachment bolt bushes on TRB s/n 20697.

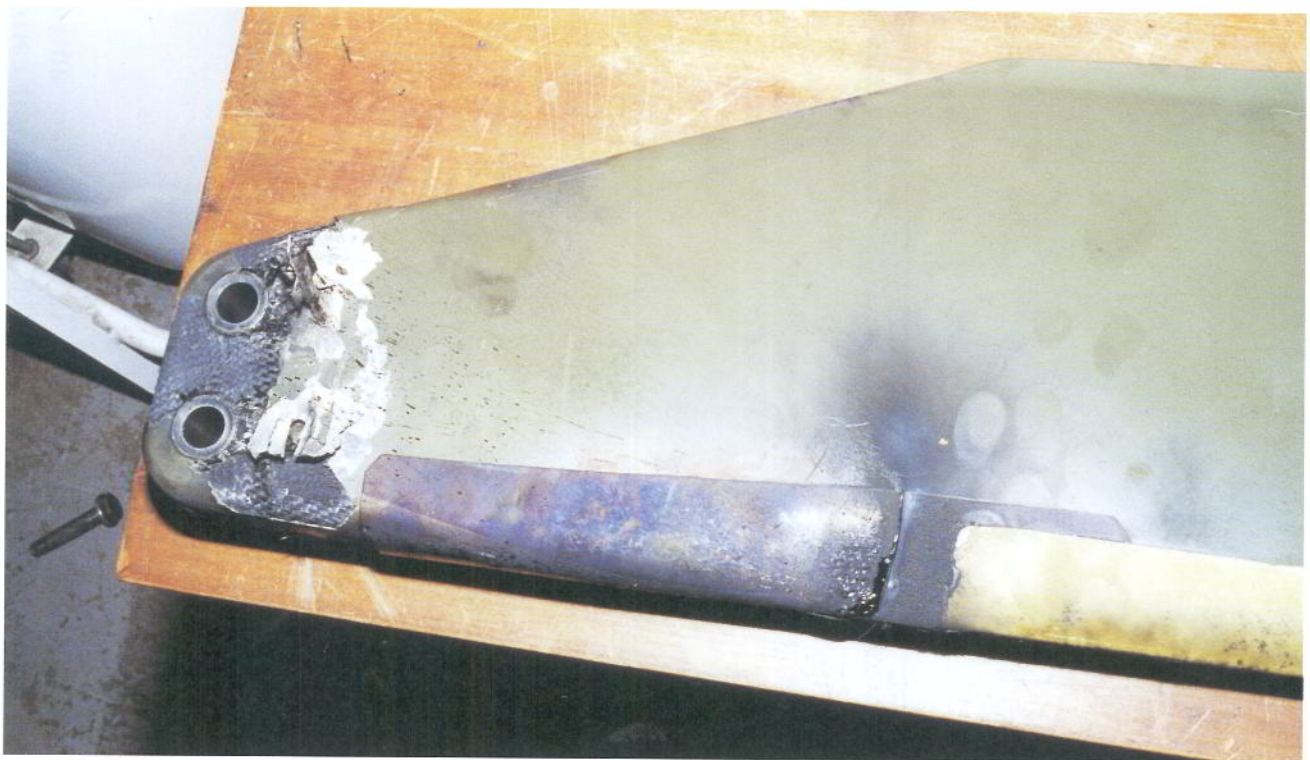
Figure 12D: Showing thermal disbonding and delamination damage to inboard side of root adjacent bushes on TRB s/n 20697.
