**INCIDENT**

<b>Aircraft Type and Registration:</b>	Boeing 737-377, G-CELA	
<b>No &amp; Type of Engines:</b>	2 CFM56-3B2 turbofan engines	
<b>Year of Manufacture:</b>	1986	
<b>Date &amp; Time (UTC):</b>	7 July 2006 at 2350 hrs	
<b>Location:</b>	En-route from Newcastle Airport to Stansted Airport	
<b>Type of Flight:</b>	Public Transport (Cargo)	
<b>Persons on Board:</b>	Crew - 2	Passengers - None
<b>Injuries:</b>	Crew - None	Passengers - N/A
<b>Nature of Damage:</b>	None	
<b>Commander's Licence:</b>	Airline Transport Pilot's Licence	
<b>Commander's Age:</b>	33 years	
<b>Commander's Flying Experience:</b>	3,395 hours (of which 2,575 were on type) Last 90 days -122 hours Last 28 days - 50 hours	
<b>Information Source:</b>	AAIB Field Investigation

**Synopsis**

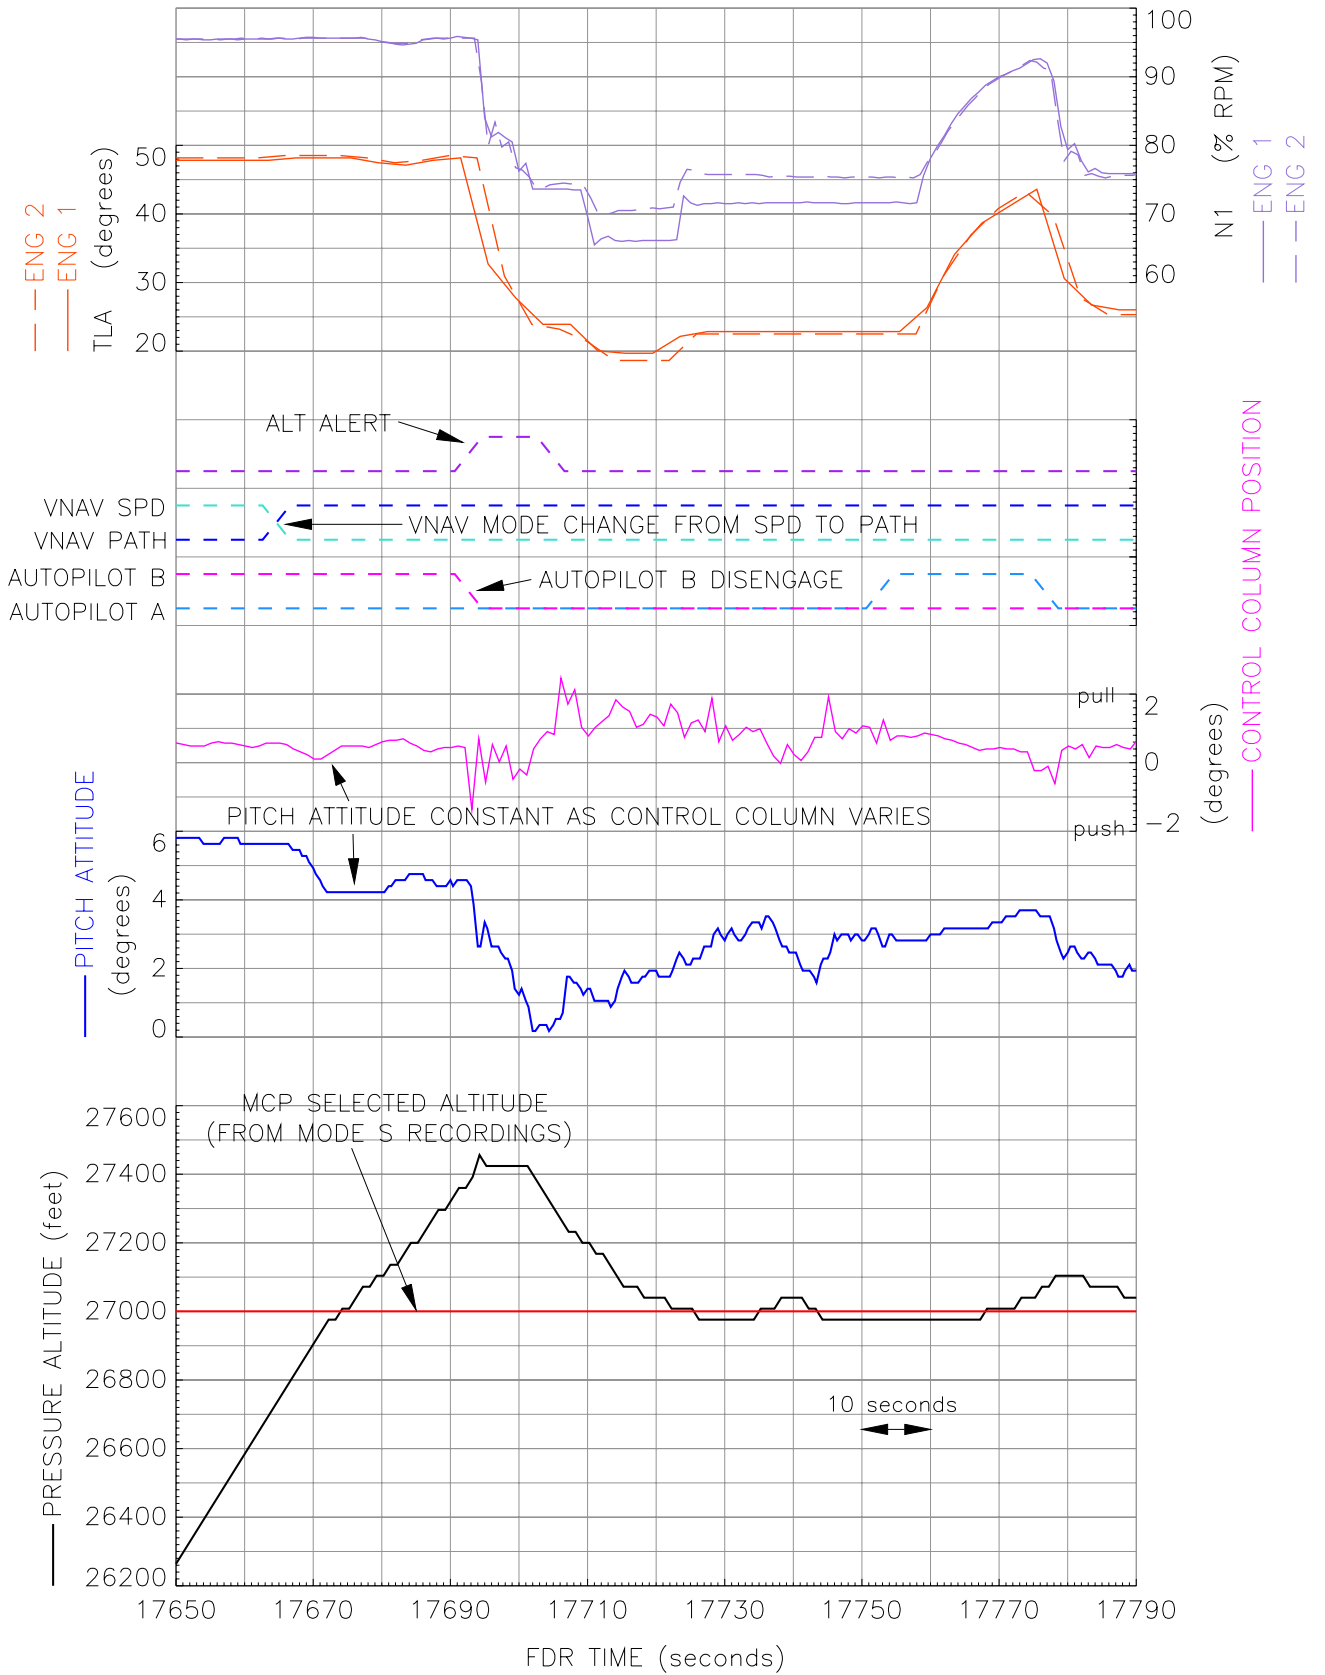
Figure 1

A time history of the relevant parameters recorded during the cleared altitude exceedance is given at Figure 1. The data starts with the aircraft climbing through 26,000 ft at 1,650 ft/min, an airspeed of 272 kt and autopilot 'B' engaged in 'VNAV PATH'. The Mode Control Panel (MCP) selected altitude, obtained from the Mode S recording, was 27,000 ft.

At 26,700 ft, the VNAV mode changed from 'PATH' to 'SPD' and the control column moved forward (from a nominal value of +0.6° pull used for the climb to +0.1°), reducing the pitch attitude from 5.6° to 4.2° nose up and slowing the climb rate to 1,100 ft/min. The pitch attitude remained at 4.2° for just under ten seconds while the control column moved back to the +0.6° position.

As the aircraft continued to climb between 27,300 and 27,400 ft, autopilot 'B' disengaged and an 'ALTITUDE ALERT' activated. The control column was then pushed forward momentarily to -1.4° and the thrust levers were pulled back from 48° to 30° thrust lever angle and then to about 20°, with corresponding reductions in engine N1s.

The aircraft achieved a peak altitude of 27,450 ft before descending to 27,000 ft.

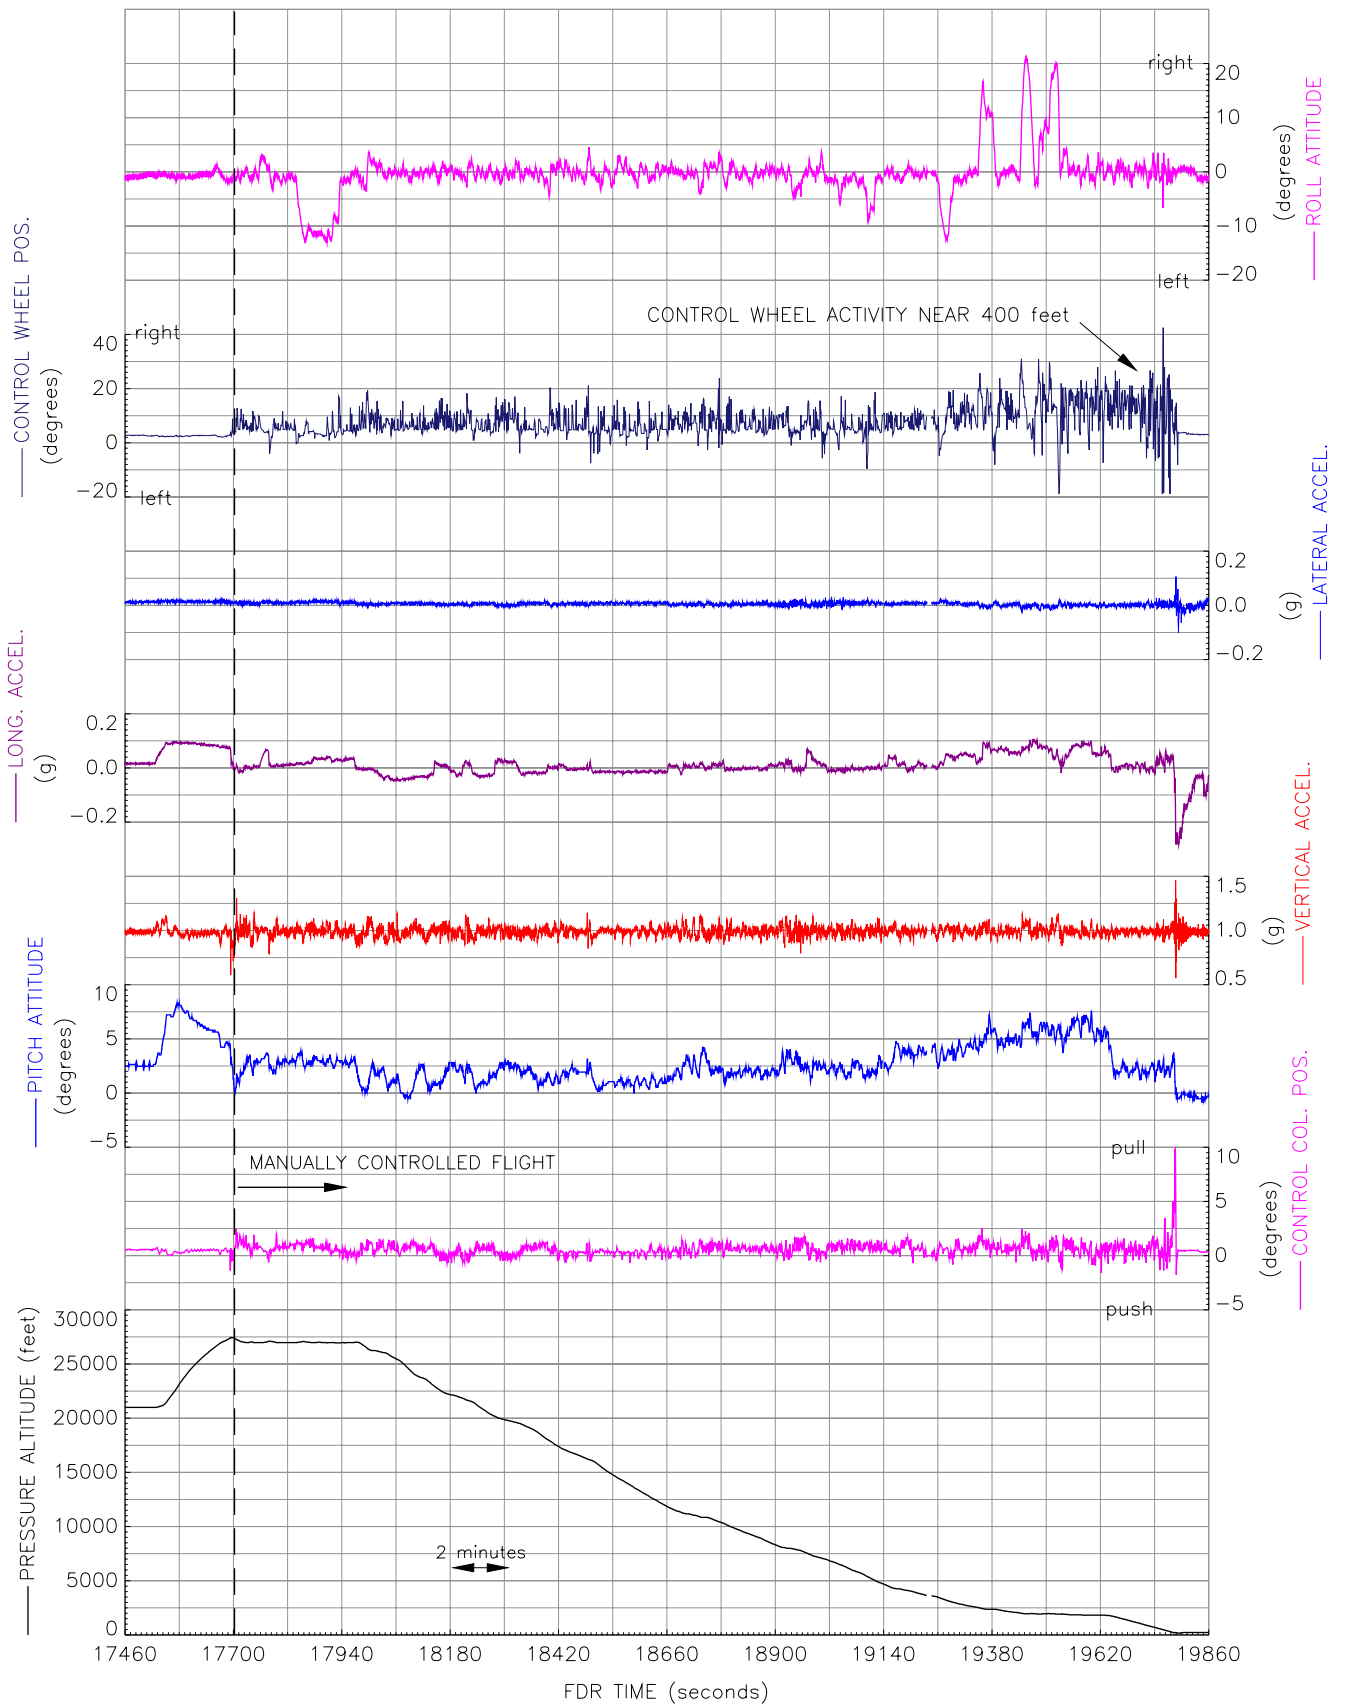
Figure 2

A time history of the relevant parameters during the manually controlled descent to Stansted is given at Figure 2.

During the manually controlled flight, considerably more activity was recorded on control column position compared to when autopilot 'B' was engaged and flying the aircraft. A similar increase in activity was also recorded in pitch attitude and normal load factor. This indicated that basic control column/elevator inputs were driving the activity.

Several large and rapid control wheel inputs were recorded around 400 ft agl but with no corresponding large roll attitudes.

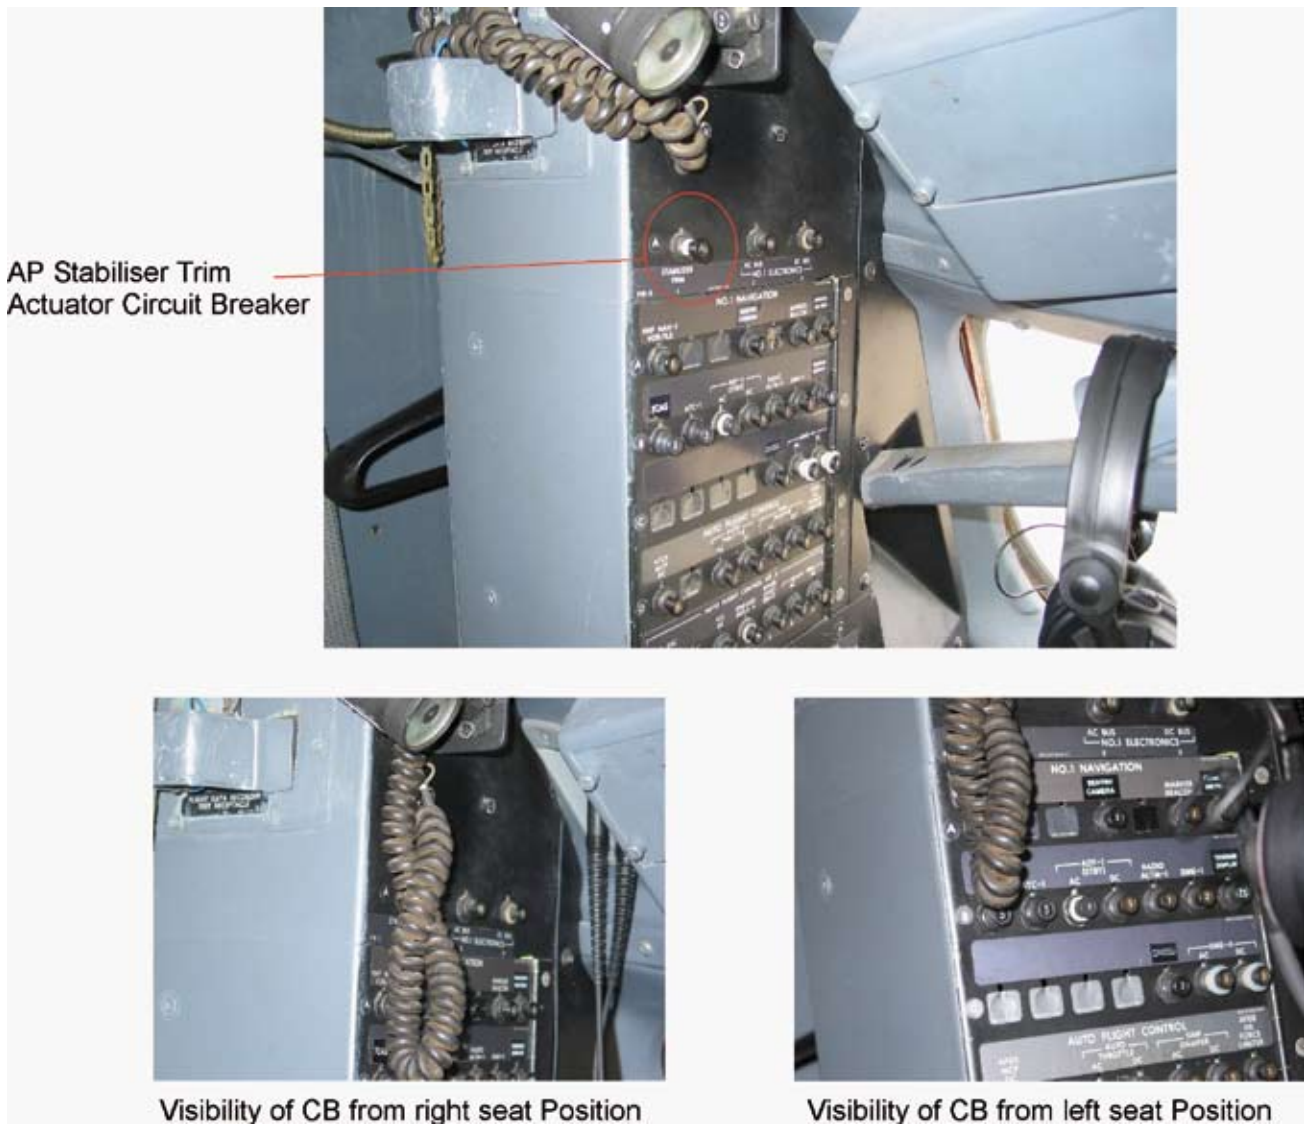
**Figure 3**

The autopilot stab trim actuator CB is located on the P18 panel behind the commander. It is the uppermost CB on the panel, which makes it difficult to see from the seating position of the commander and first officer. Furthermore, a map light is mounted to the right of the

CB panel with its lead dropping down in a loop beside the panel. This coil of lead to the light is in such a position that it obscures the CB. Refer to Figure 3 below.
