# AIB Bulletin

No: 5/85

Ref: EW/G84/07/28

<b>Aircraft type and registration:</b>	Cessna 340 G-BALM (light twin engine fixed wing aircraft)
<b>Year of Manufacture:</b>	1972
<b>Date and time (GMT):</b>	24 July 1984 at 1000 hrs
<b>Location:</b>	Leeds-Bradford Airport
<b>Type of flight:</b>	Private (business)
<b>Persons on board:</b>	Crew — 1                      Passengers — None
<b>Injuries:</b>	Crew — None                      Passengers — None
<b>Nature of damage:</b>	Slight right wing damage, severe right propeller damage, right engine shock loaded
<b>Commander's Licence:</b>	Private Pilot's Licence
<b>Commander's Age:</b>	50 years
<b>Commander's total flying experience:</b>	800 hours (of which 110 were on type)
<b>Information Source:</b>	Aircraft Accident Report Form submitted by pilot, discussions with repairers and examination of some failed components.

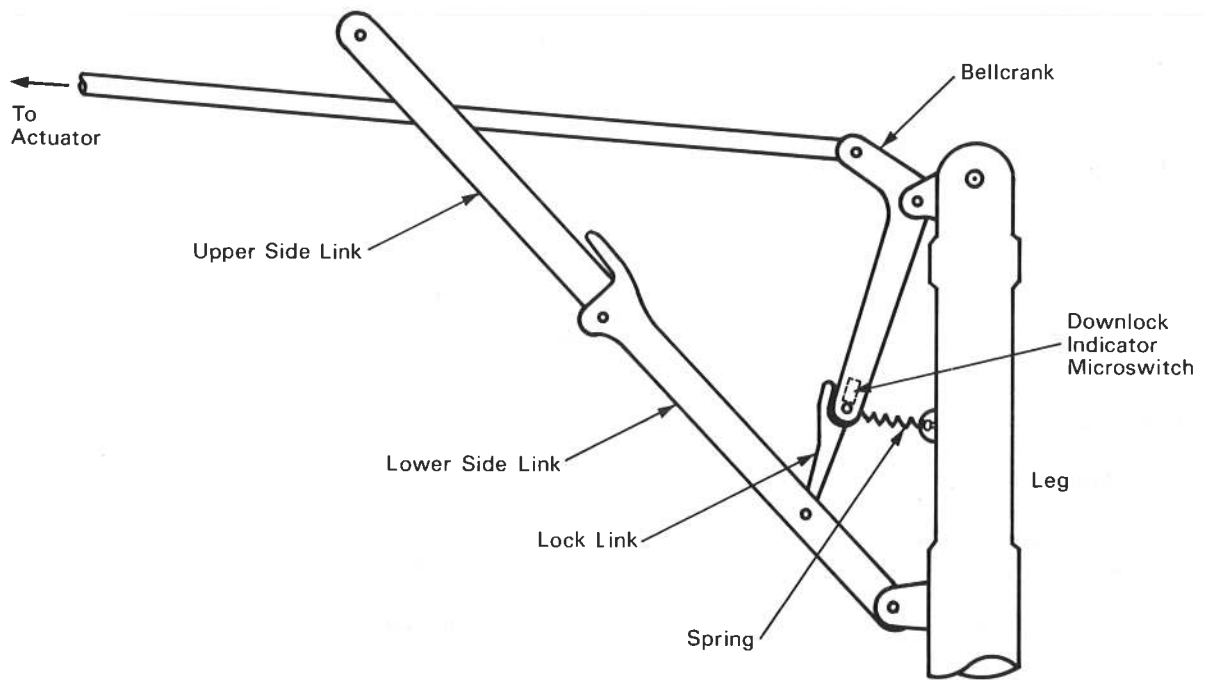
**Fig 1 Main Landing Gear Schematic**

Inspection showed that the leg had partially retracted. The downlock comprises (Fig 1) a folding side link between aircraft structure and the leg, held in an overcentre position by a lock link. The lock link and its actuating bell-crank are themselves held over-centred by tension in the landing gear operating mechanism, assisted by a spring. A microswitch, sensing lock link/bellcrank overcentring, operates the cockpit gear down indicator.

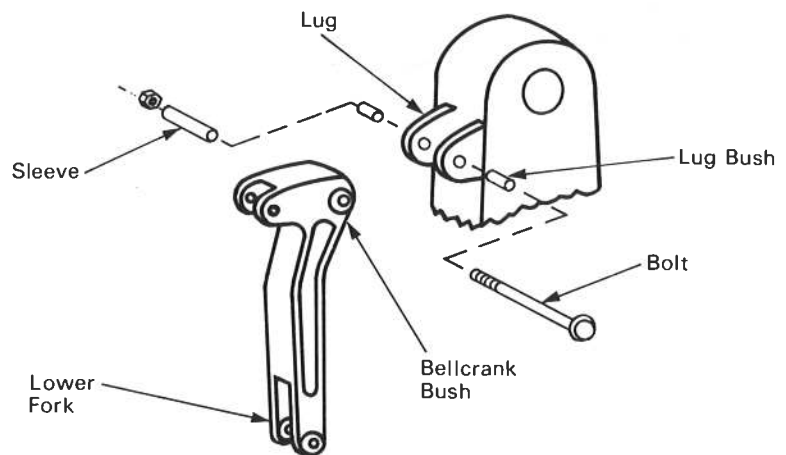
**Fig 2 Bellcrank Pivot Detail**

The bellcrank lower fork (Fig 2) was found fractured causing disconnection of the bellcrank from the lock link. The failure was consistent with the effects of overload applied by the side link folding from a non-overcentred position under the influence of ground reaction forces on the undercarriage. The bellcrank had also detached from its pivot point on the leg by virtue of fracture of both the pivot bolt and the forward pivot attachment lug. These failures had clearly resulted from overload applied during gear collapse when the leg contacted the bellcrank.

It was noted that the bellcrank pivot bearing was extensively corroded. The bolt, sleeve and bushes comprising this bearing are of steel. The pivot was not fitted with a grease nipple and could only be effectively lubricated following dis-assembly. The Maintenance Manual reportedly does not specify any lubrication or inspection requirements. The repairers reportedly found on checking four other aircraft with a similar undercarriage type (subsequent to the accident) that all bellcrank pivots were stiff and required re-working.

The evidence from the examination of G-BALM indicated that the sleeve had seized to the bellcrank bushes some time prior to the accident, and that bellcrank rotation during gear operation had caused the normally static bolt to rotate in the pivot attachment lug bushes. The associated stiffness could possibly have prevented the gear from entering downlock, although a gear locked down indication should not have been obtained in this case. However, some variability in downlock microswitch operating position was noted with a similar assembly, possibly because of the long spring leaf used to actuate the switch.
