Piper PA-38-112 Tomahawk, G-BOCC

| AAIB Bulletin No: 5/2004 | Ref: EW/C2003/07/05 | Category: 1.3 |

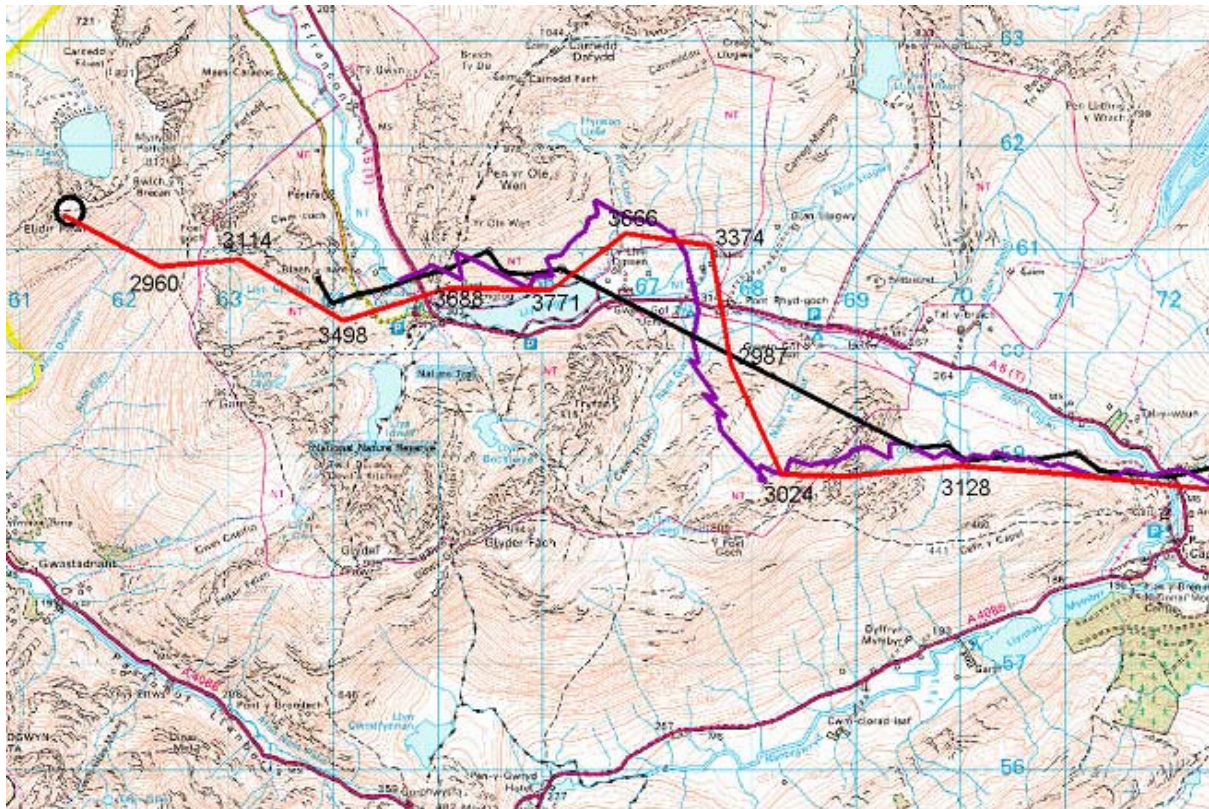
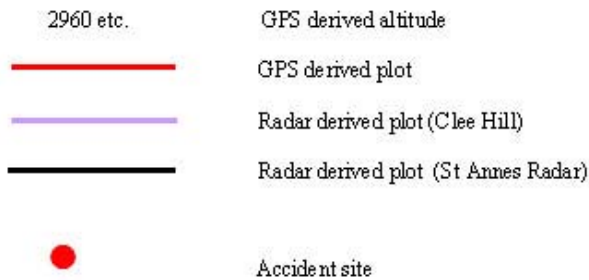
Figure 1

Data recovered from the aircraft's GPS receiver (see Figure 1) showed that just after leaving the Liverpool ATC frequency, at 0941 hrs, the aircraft descended from 4,000 feet to 3,000 feet about five nautical miles to the west of the Conway valley. The aircraft continued on its westerly track for a further 1½ minutes, before turning on to a northerly heading, and shortly thereafter commencing a climb.

G-BOCC - Plot of GPS and Radar Derived Track and Altitude

The aircraft maintained the northerly heading for about one minute before resuming its roughly westerly track and levelling off at about 3,800 feet. The aircraft maintained this altitude for 1½ minutes before again descending. Two minutes after commencing this descent, the GPS data ceased in the area of Elidir Fawr, a mountain that rises to 3,029 feet above sea level.
