AAIB SAFETY RECOMMENDATION EMBRAER 145 DFDR PERFORMANCE

Recommendation 2002-01

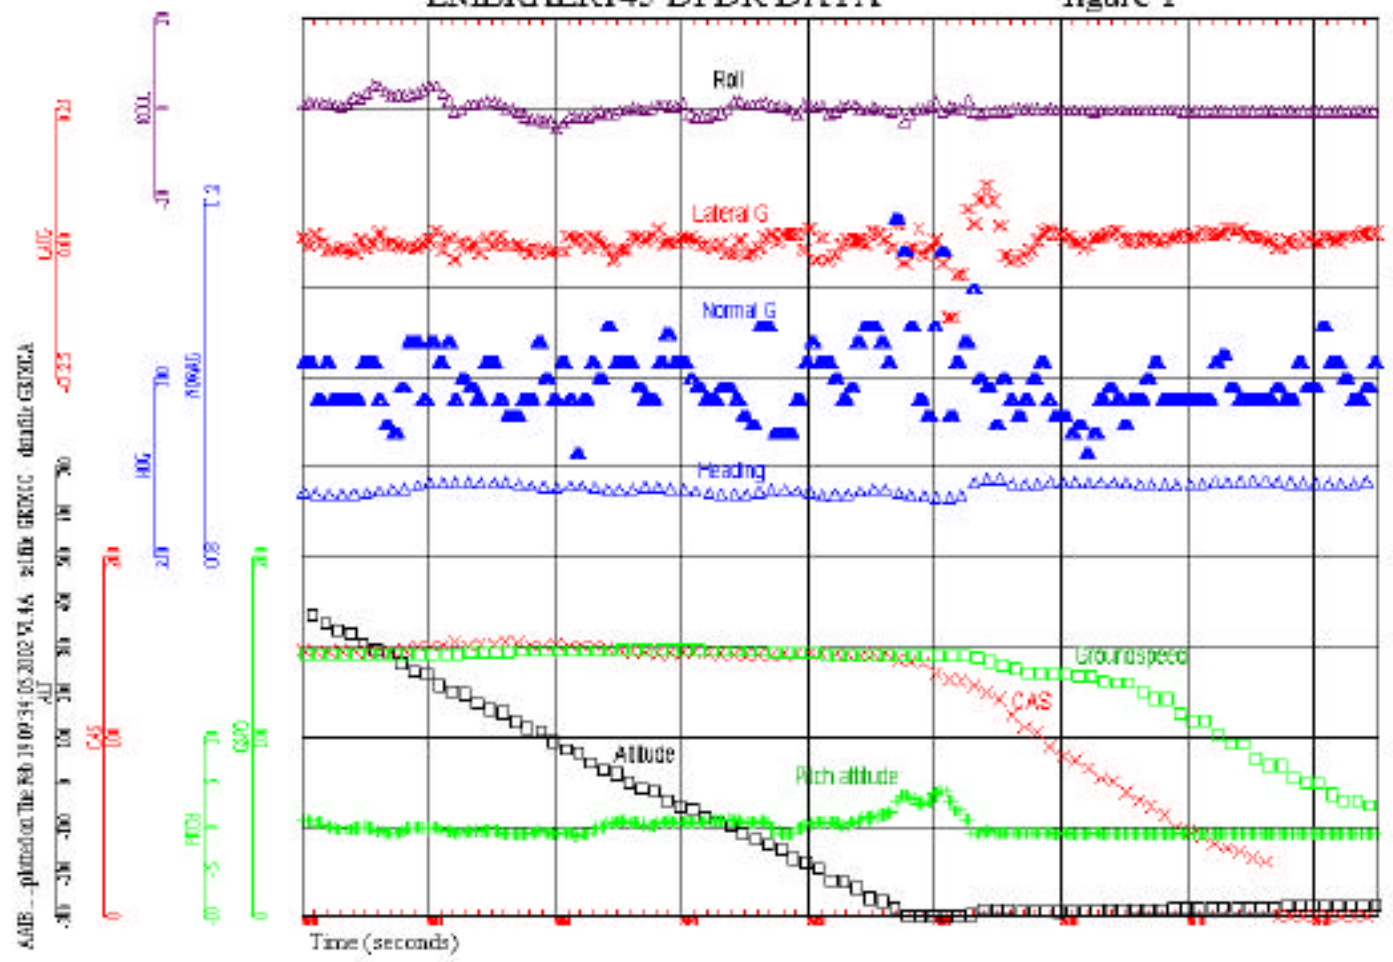
figure 1

Figure 1 shows a time history of selected parameters recovered from the DFDR fitted to G-RJXC recorded during the incident landing. Pitch Attitude and Lateral Acceleration are sampled at 0.25 second intervals, Normal Acceleration at 0.125 second interval, Roll Attitude at 0.5 second interval and Altitude, CAS, Groundspeed and Heading at 1 second intervals.

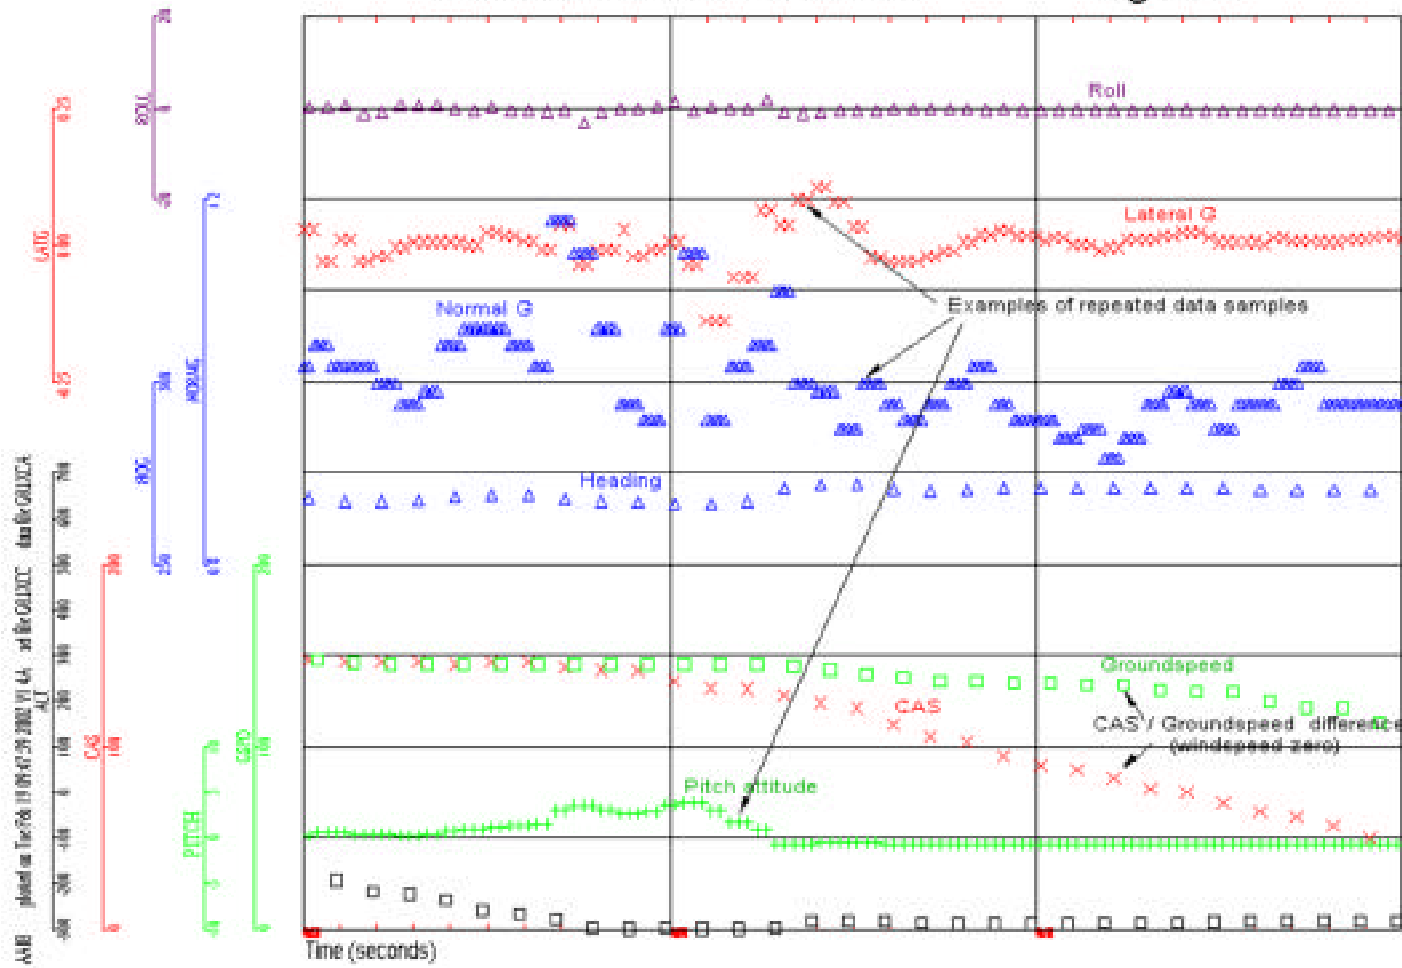
figure 2

Figure 2 shows the data recorded during the “flare” in an expanded form and figure 3 shows similar data in the form of a numerical listing. The stepped nature of the time histories and the number of times a data sample is repeated are inconsistent with the dynamic conditions that existed immediately before the aircraft landed. Of concern is the repetition of the same data value. In one of the other incidents a Normal Acceleration value remained constant for 34 samples (in excess of 4 seconds) whilst the aircraft was flaring. This repetition of values is an indication that the

resolution in recording is variable and inadequately low. It is possible that the samples are not being updated as they should be and this is causing the effective inadequate resolution.

Whilst it is certain that there are errors in the recording of the above parameters. It is also possible that anomalies exist in parameters recorded at 1 sample or less per second. In particular Groundspeed appears on many occasions to be incompatible with recorded airspeed. Figure 2 shows possible repeated data values and a marked difference in the values of CAS and Groundspeed in conditions where there was no headwind component. On occasion the recorded engine N1 speed and Altitude also appear to be incompatible with the designed resolution and sampling rate.

As a matter of urgency, the Centro Tecnico Aeroespacial (CTA) of Brazil should require Embraer and the manufacturers of the flight data recording installation to investigate the nature and extent of the recording anomalies associated with the EMB145 DFDR installation, to correct them on existing and future aircraft, and subsequently demonstrate that the DFDR faithfully records the time histories of the data transducer outputs. The CAA as part of its JAA activities should monitor this process.
