Aircraft Type and Registration: Boeing 737-400, G-GBTA

Location: Aberdeen Airport

Nature of Damage: Fuselage skin pierced and dented near the forward service door

Information Source: AAIB Field Investigation

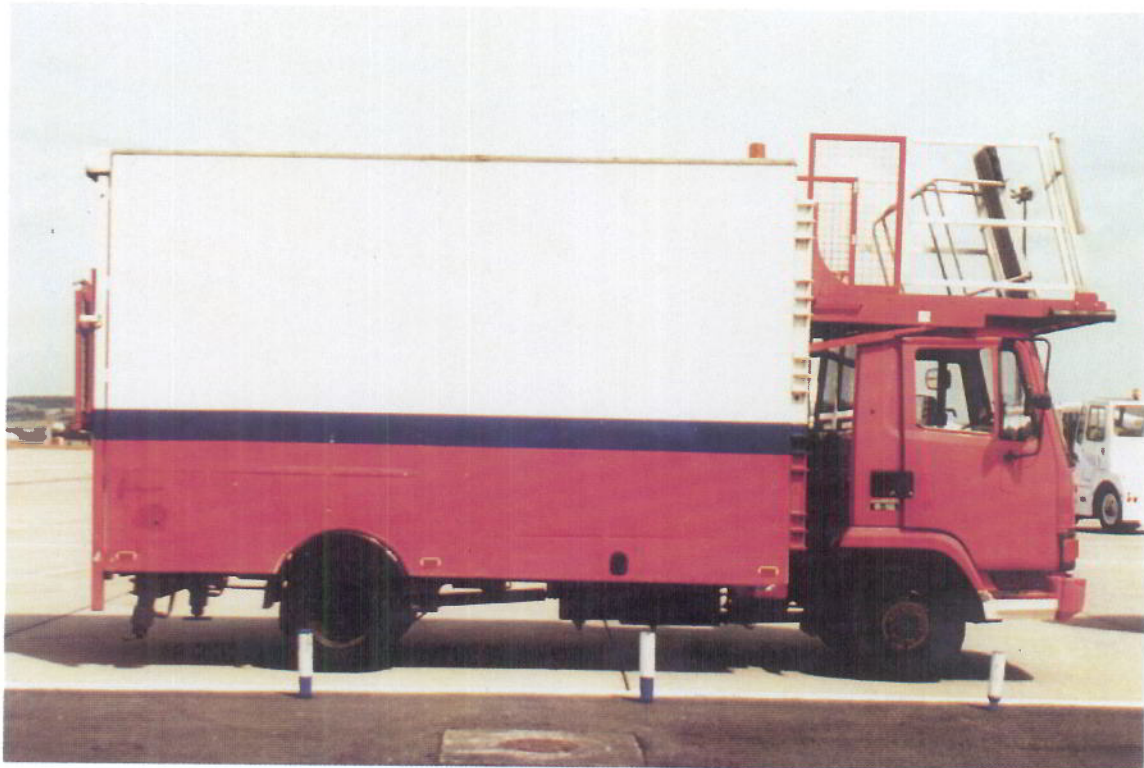
The catering vehicle was a Road Runner 8-12 four-wheeled vehicle as shown in the photograph below. It had a hydraulically operated 'hi-lift' body which could be raised to service the aircraft and lowered for driving. The chassis was equipped with two hydraulically extended jacks at the rearmost corners to stabilise the vehicle. Transfer of catering trolleys from the vehicle body to the aircraft was achieved via a loading platform above the vehicle cab which was raised and lowered in line with the body floor. There was no mechanism for horizontally extending the loading platform and its forward edge was vertically above the vehicle's front bumper. A small manually operated 'flip-over' bridge

was attached to the forward section of the loading platform to span the gap between the platform and the aircraft's cabin floor. This bridge and its safety rails were attached to the platform by vertical steel brackets supporting pivots. The bridge was capable of spanning a gap of at least two feet.

There was no damage to the catering vehicle which was examined by the AAIB. It was several years old and of an uncommon type no longer in production. It had no stabiliser jacks at the front of the chassis and no proximity sensors to alert the driver if he positioned it too close to the aircraft. When the jacks at the rear were extended, the back of the vehicle was raised by several inches. This transferred some of the vehicle's weight to the front wheels and tended to rotate the chassis around the front axles. The combined effect lowered the leading edge of the loading platform at the front of the vehicle by about four inches.

The loading ramp was positioned too close to the aircraft before transferring the stores. The weight of the vehicle then decreased as the stores were transferred and the platform rose due to offloading of the front wheel suspension. Also, the aircraft may have settled slightly with the increased weight of fuel and stores. These changes in weight reduced the gap between the platform and the aircraft such that as the stabiliser jacks were retracted, the front left corner of the platform rose sufficiently to close the gap and strike the fuselage. There were abrasions and paint marks on a vertically mounted metal bracket just above the leading edge of the platform which were consistent with the damage to the aircraft. Although the leading edge of the loading platform was fitted with a tubular rubber buffer, the rubber did not wrap around the corners of the platform and its diameter was smaller than that usually fitted to catering vehicles. Also, there was no padding or protection around the brackets which supported the safety rails and the flip-over bridge.

The catering contractor's staff were given additional training. The two vehicles of this type in the contractor's fleet were to be modified at the contractor's behest with larger radius rubber buffers which would extend across the full width of the loading platform and along either side for a distance of 6 inches. Moreover, the angle bracket joining the flip-over bridge to the platform (which penetrated the aircraft's skin) was to be cut back flush with the guard rails.
