INCIDENT

Aircraft Type and Registration: Boeing 747-436, G-BNLL

Date & Time (UTC): 28 March 1995 at 0231 hrs

Location: Seoul, South Korea

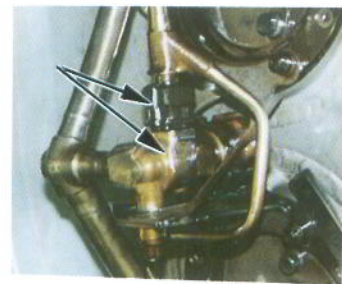
Fig 1a Union nut after tightening to correct torque

note changed position of line on nut relative to that on manifold
