## ACCIDENT

| <b>Aircraft Type and Registration:</b> | Zenair CH601UL, G-YOXI | |
| <b>Date &amp; Time (UTC):</b> | 25 August 2006 at 1503 hrs | |
| <b>Location:</b> | Near Bramley, South Yorkshire | |

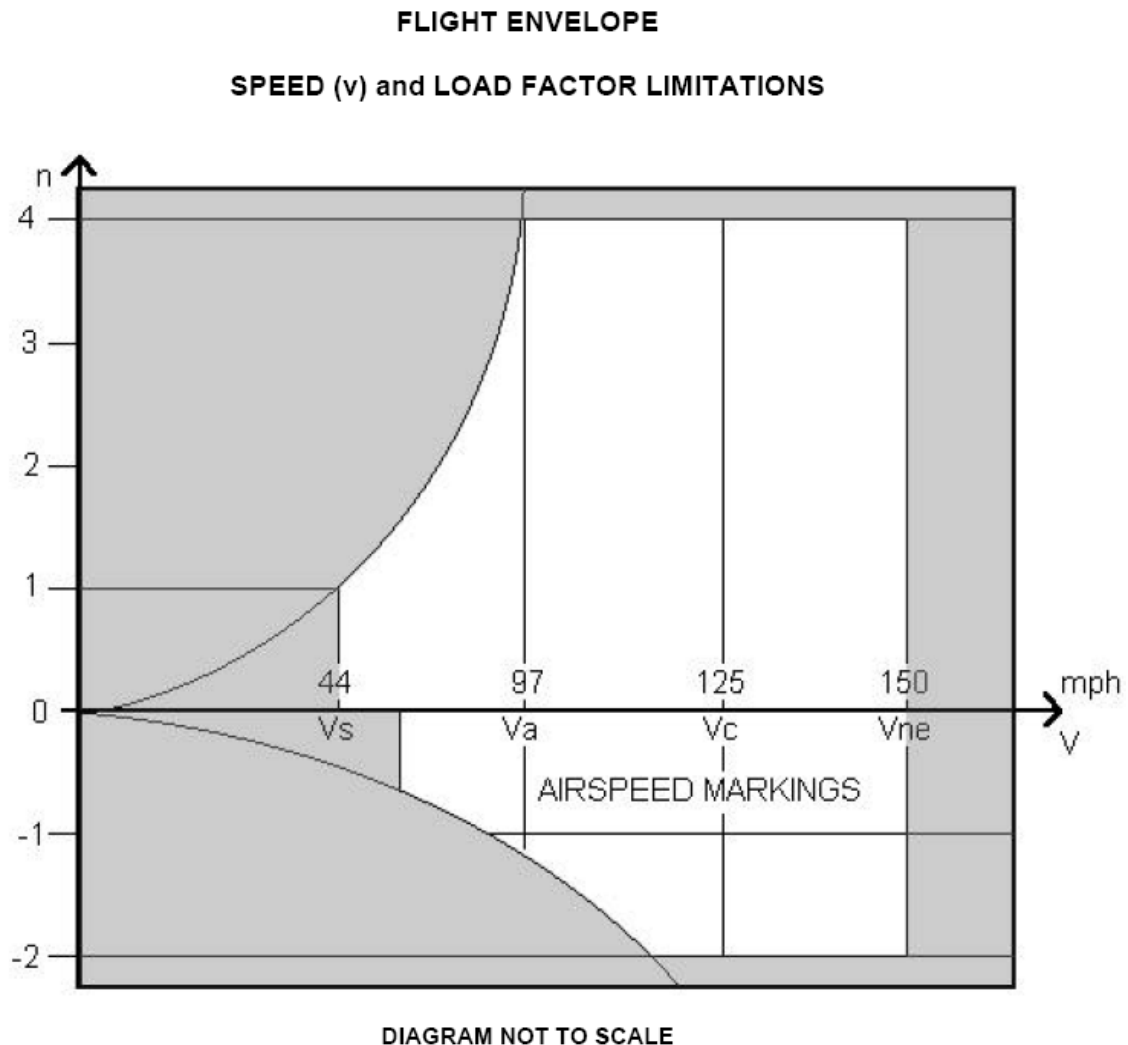
**Figure 1**

with two fuel tanks, one in each wing, and the fuel used was motor gasoline. The aircraft structural limitations were +4g and -2g. See Figure 1.

Load factor graph

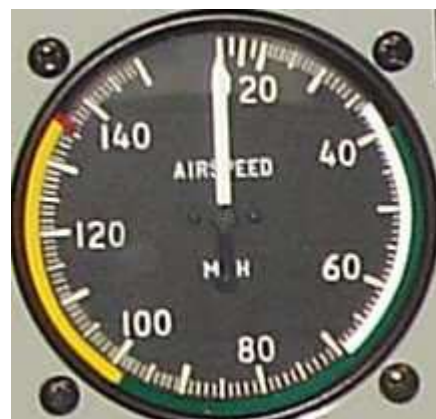
**Figure 2**

Figure 2 shows a picture of an Airspeed Indicator (ASI) similar to that fitted to G-YOXI. The instrument is marked with colour banded airspeed ranges indicating the safe operating ranges and operating limits. The upper limit of the green band shows the maximum cruising speed for normal operation ( $V_{NO}$ ), which in this case was the same as the manoeuvring speed ( $V_A$ ) of 97 mph (see Figure 1). The  $V_A$  is the maximum speed at which the flight controls can be fully deflected without

damage to the aircraft structure; it would not normally be indicated on an ASI. The yellow arc indicates the 'caution speed' range within which the aircraft should be operated only in smooth air. The red line is the never exceed speed ( $V_{NE}$ ) and on this example is marked at 135 mph; however, the  $V_{NE}$  for G-YOXI was 150 mph, although it could not be determined what  $V_{NE}$  was actually marked on its ASI.

have given an indication of the safe operating ranges but their meaning may not have been well understood by him. The aircraft had sufficient power to exceed 97 mph in level flight so it is possible that the aircraft had flown on previous occasions at a cruise speed within the amber caution range and thus above the manoeuvring speed. Any turbulence or sudden manoeuvre would then generate high stresses on the airframe. Moreover, the aircraft exhibited low stick forces when the elevators were used in flight. As a result it would be relatively easy to apply excessive loads, particularly at higher speeds. Much of the pilot's previous training experience was on a flex-wing aircraft and the higher forces involved in flying this type of aircraft may have led him to a false perception of the stick force that could safely be applied when manoeuvring G-YOXI.

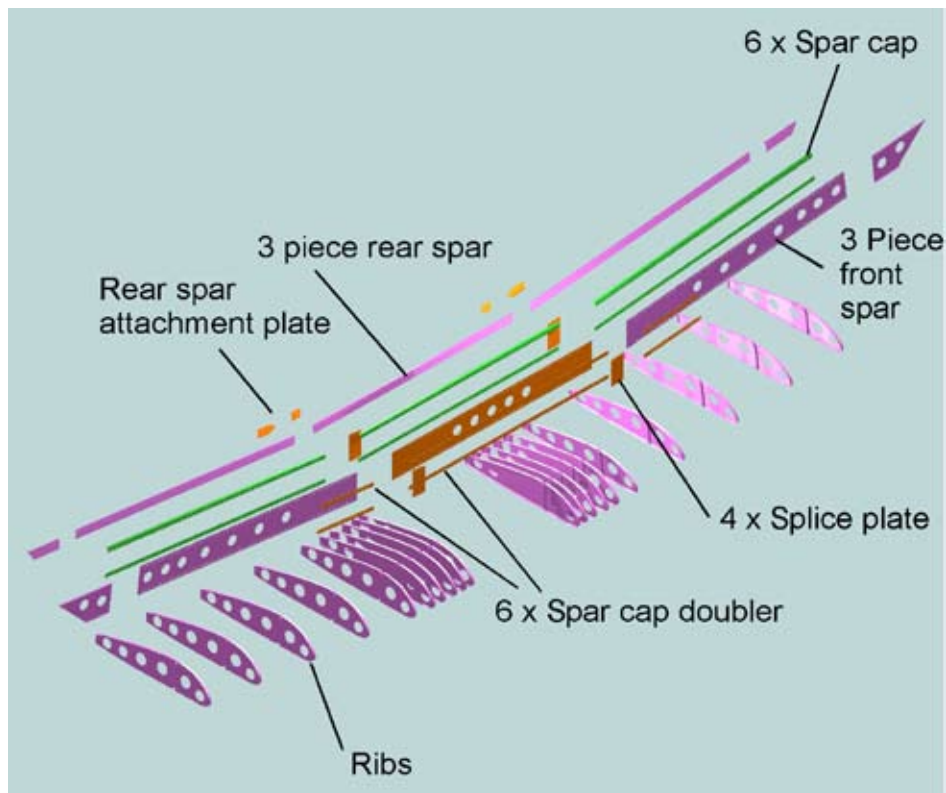
**Figure 3****Wing Structure****Airstrip**

The CH601UL wing is a stressed skin cantilever design with the majority of the loads being carried by the front spar. The spar consists of three sections, each with additional upper and lower L section spar caps. The left and right front spars are attached to the centre front spar using two splice plates. For additional strength toward the centre of the wing, upper and lower spar cap doubler strips are added to the front of the spar. Wing ribs form the wing shape between the front and rear spars and are covered with a stressed skin. The rear spar consists of three z sections. The left and right rear spar sections each have an attachment plate through which a bolt attaches them to the centre rear spar. The entire wing structure is made from 6061-T6 aluminium.

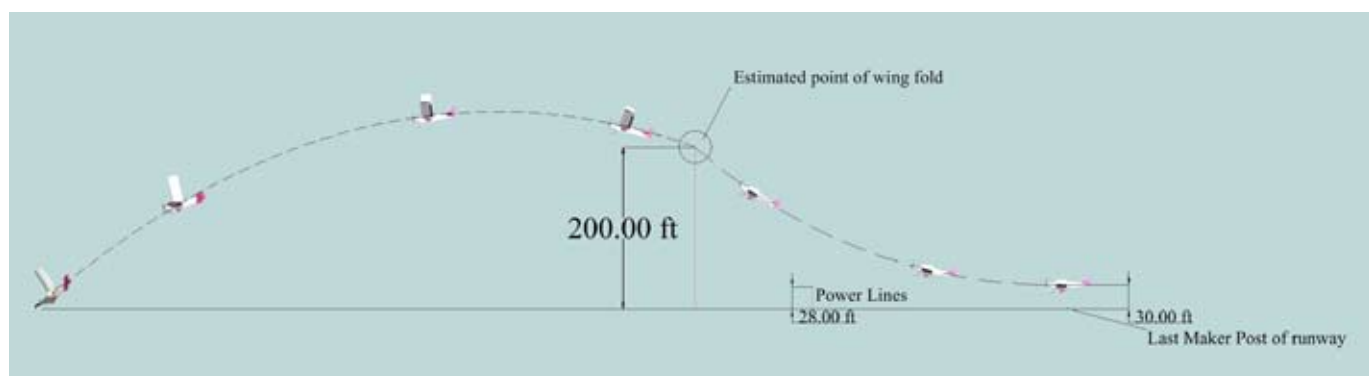
Figure 4

Based on the accident site ground marks and the position of the Perspex on the ground, a basic trajectory model was produced. This shows that the aircraft needed to have reached at least 200 ft above the ground before the wing folded. Extrapolating backwards, this meant that the aircraft must have cleared the electricity cables with a large margin to reach this height. See Figure 4.

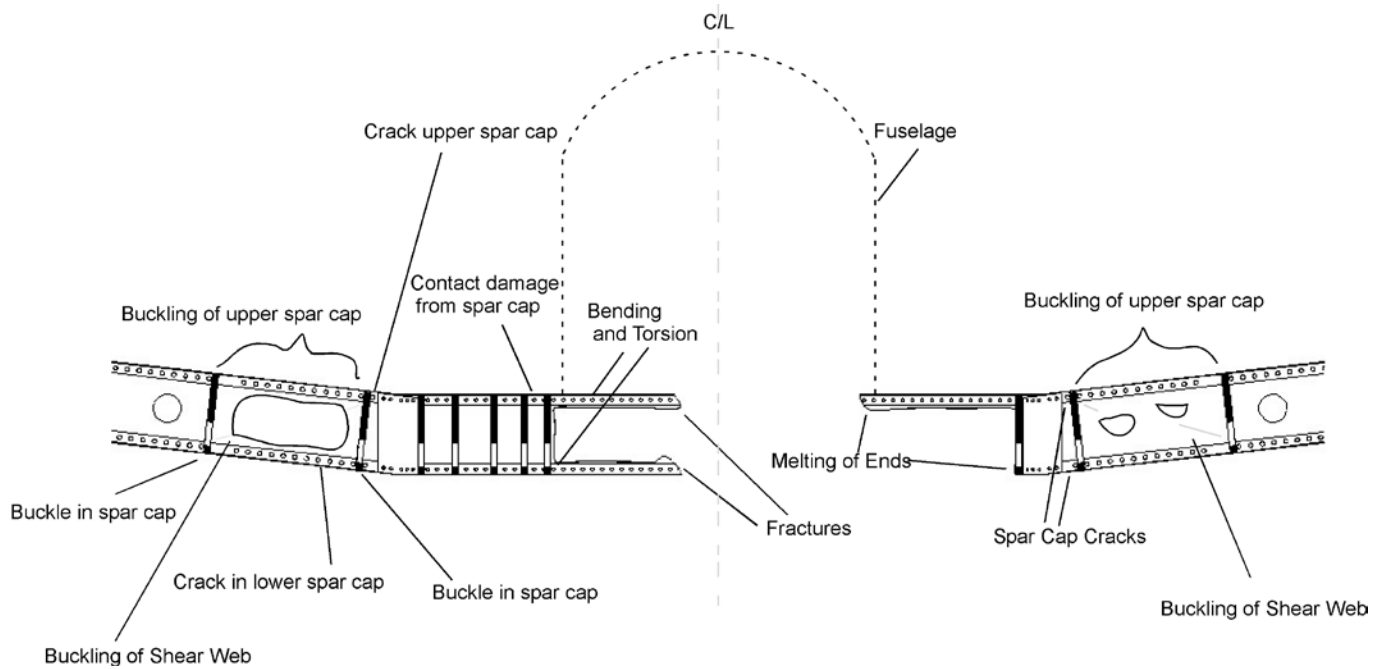
The wreckage was recovered from the site and taken to the AAIB for further detailed examination. Examination of the wing revealed extensive damage to the wing front spar. Unfortunately, the post-crash fire had melted much of the aluminium including a large section of wing and the area of possible initial failure. Despite this, the shear webs of both the left and right front spars revealed buckling indicative of over stress in upload. Similarly, buckling of the upper spar caps also confirmed a compressive stress indicative of an upload. The centre front spar had signs of torsion on the remains of the upper and lower spar caps, which were probably a result of the left wing and centre section inverting whilst the right wing remained upright. This also indicates that although the spar had failed, allowing the wing to fold, it had remained attached to a certain extent at impact. Figure 5 shows a summary of the damage found to the wing front spar.

examination. This confirmed that the wing spar shear web, spar caps and doublers on all three sections of the front spar were constructed of 6061 aluminium. Unfortunately, due to the post-crash fire, it was not possible to ascertain if the heat treatment applied to the material at build was to the T6 specification. Examination of the fractures on the upper and lower spar caps of the centre spar section was inconclusive due to the damage of the surfaces caused by the post-crash fire, although the upper spar cap did show some topography suggestive of an overload failure.

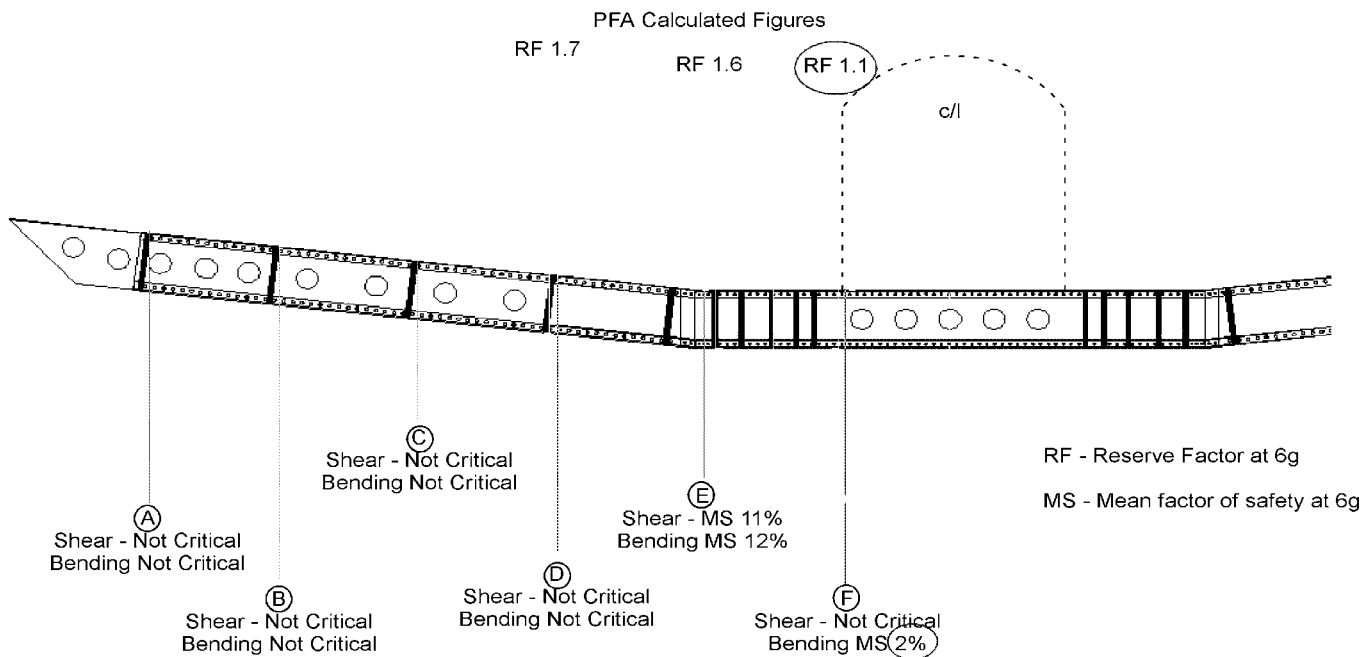
**Figure 6**

critical or declared a margin of safety as a percentage at the ultimate load and at a higher MAUW of 480 kg. The PFA calculations were similar but declared a reserve factor, but these were for the CH600 rather than the CH601. The sections and the respective conclusions are shown in Figure 6 and Table 1.

The figure and table below reveal that the weakest point of the wing front spar is at the point at which the wing enters the fuselage, a similar position to that

of the failure on G-YOXI. The aircraft manufacturer had conducted a destructive test to a similar wing on a CH600. The failure proved that the entire wing structure had a mean factor of safety of over 10% across the entire span.
