ACCIDENT

Aircraft Type and Registration:	Ultramagic N-250 balloon, G-BZJX	
No & Type of Engines:	None	
Year of Manufacture:	2000	
Date & Time (UTC):	21 July 2006 at 1815 hrs	
Location:	Henley on Thames, Oxfordshire	
Type of Flight:	Passenger Transport	
Persons on Board:	Crew - 1	Passengers - 10
Injuries:	Crew - None	Passengers - None
Nature of Damage:	No damage to G-BZJX. Damage to canopy of G-CBFY	
Commander's Licence:	Commercial Pilot's Licence (Balloons)	
Commander's Age:	58 years	
Commander's Flying Experience:	3,686 hours (of which 1,800 were on type) Last 90 days - 26 hours Last 28 days - 10 hours	
Information Source:	Aircraft Accident Report Form submitted by the pilot

Synopsis

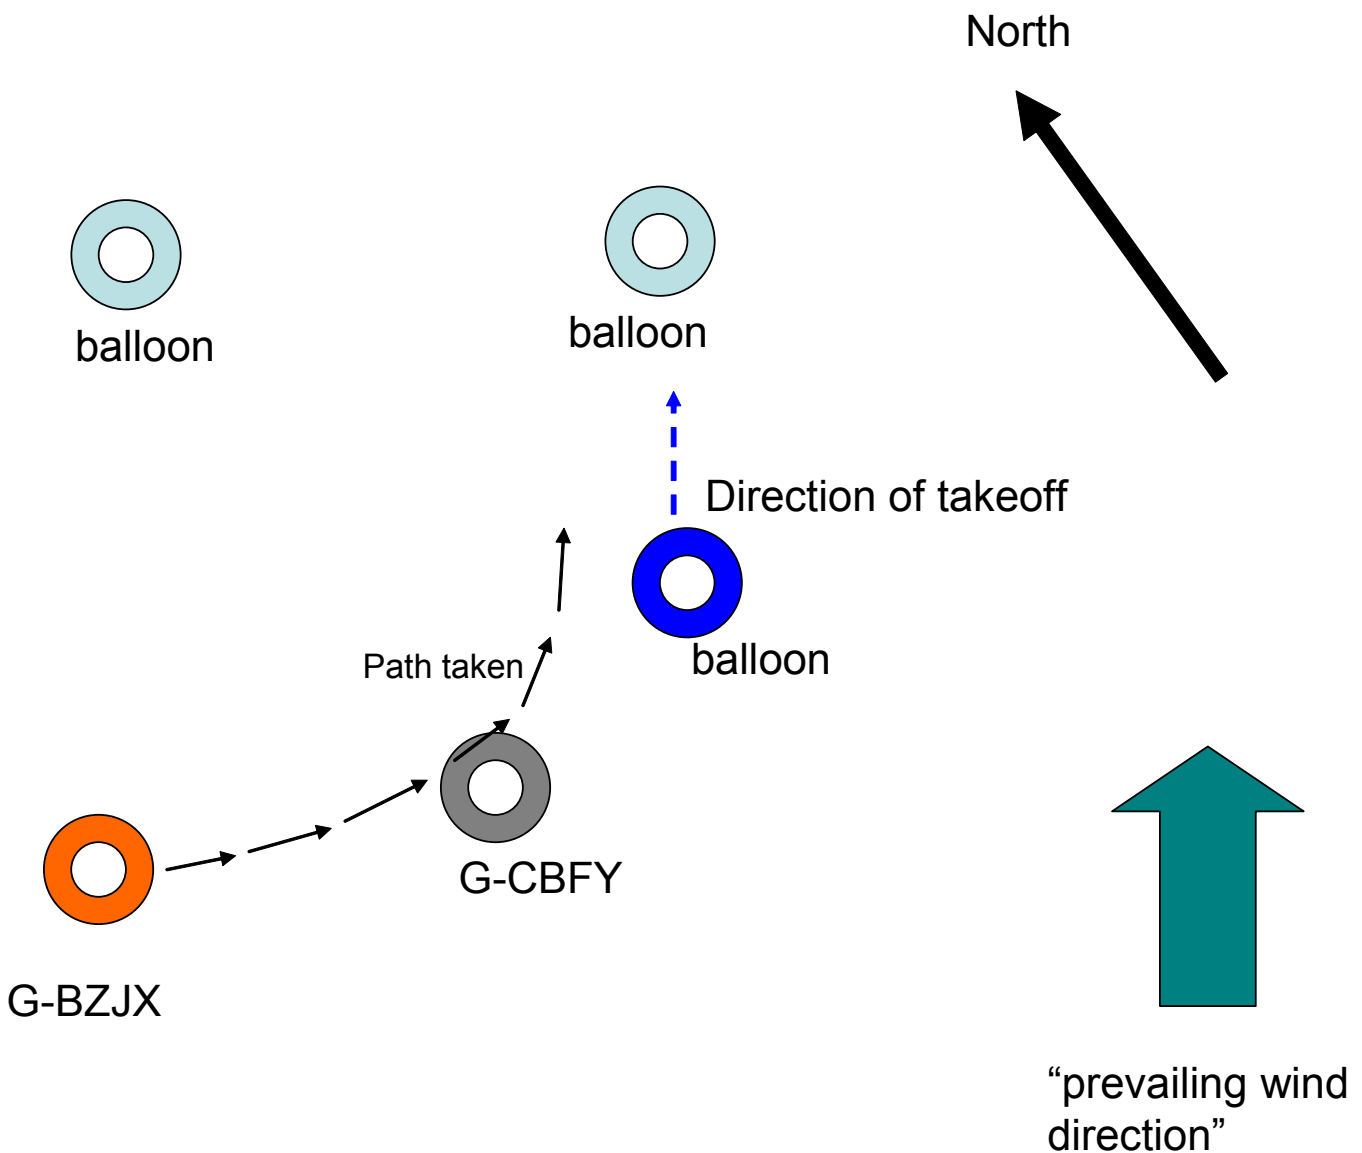
Figure 1

east of G-BZJX, ie some distance upwind of G-BZJX and not on the path that G-BZJX would be expected to take after takeoff, and this balloon took off in the expected direction of 020°. G-CBFY was situated midway between G-BZJX and the balloon that had taken off ie about 75 m away, slightly upwind and about 70° to the right of G-BZJX's expected path (see Figure 1).

The pilot of G-BZJX decided to take off. A gust of wind then blew G-BZJX towards G-CBFY and the pilot of G-BZJX promptly applied maximum heat in an attempt

to increase the rate of climb to avoid the stationary balloon. The basket of G-BZJX then brushed against, and tore, the canopy of G-CBFY before climbing clear. The initial contact of the basket was about 20 ft below the top of the canopy of G-CBFY.
