## Piper PA-38-112 Tomahawk, G-BMVM

| <b>AAIB Bulletin No: 12/2003</b> | <b>Ref: EW/C2003/06/08</b> | <b>Category: 1.3</b> |
| <b>Aircraft Type and Registration:</b> | Piper PA-38-112 Tomahawk, G-BMVM | |

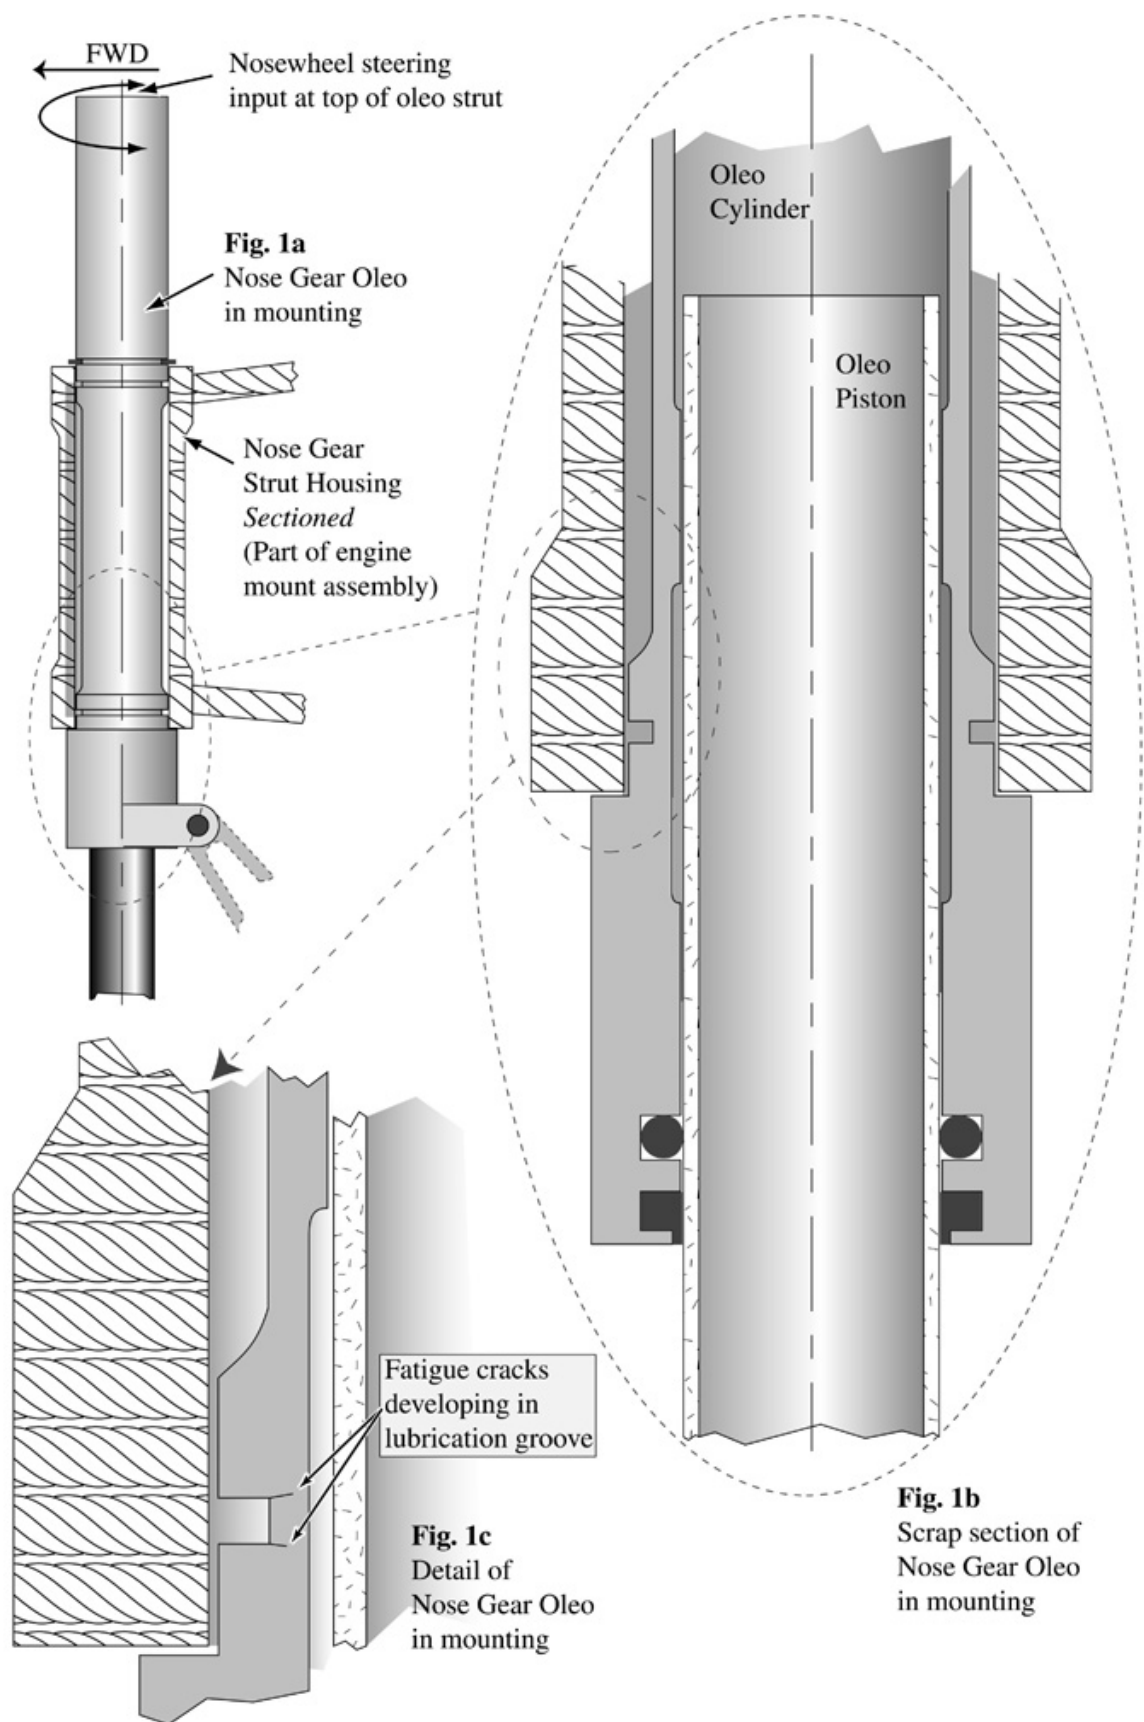
The lower section of the NLG was recovered from Runway 24. The cylinder had fractured at the position of a lubrication groove at its lower end which is located just above the lower support flange, Figure 1.

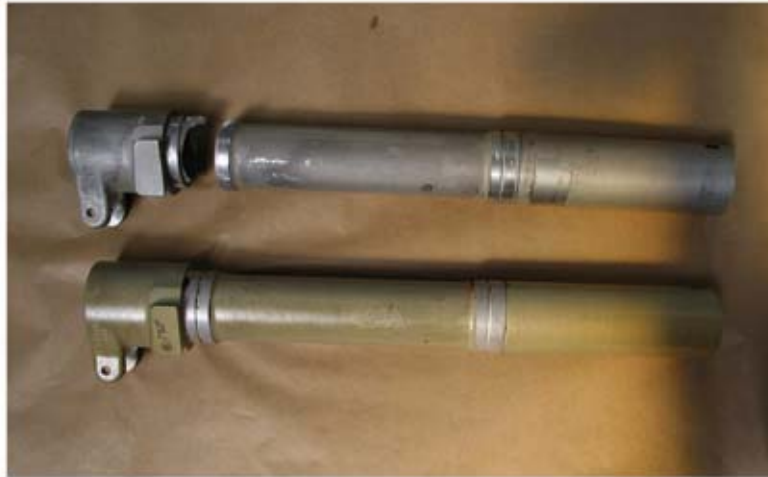
Failed NLG with New NLG

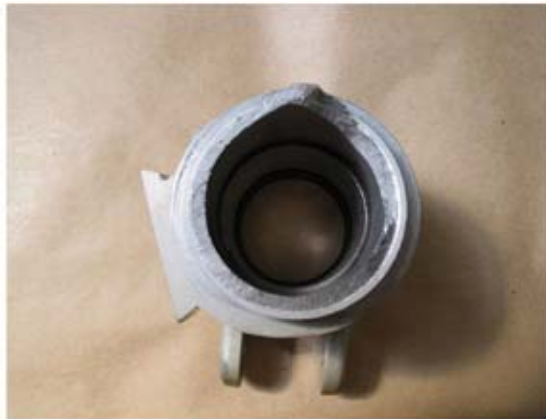
Failed NLG viewed from above

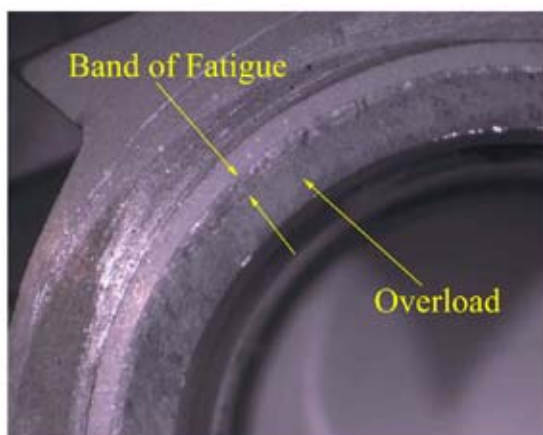
Figure 2 Failed NLG

The fracture surface exhibited a small area of fatigue cracking around its outer circumference, together with a larger area associated with overload failure, Figure 2. It was also evident that there had been other pre-existing fatigue cracks propagating around the groove. The NLG had been fitted to the aircraft since November 2000 and had completed 674 hours prior to the failure.

Fracture surface showing narrow fatigue failure and overload region

In order to prevent failure of the NLG on the Piper PA-38 Tomahawk, the aircraft manufacturer should change the requirement for conducting a dye penetrant inspection of the NLG cylinder lubrication groove, such that the interval between inspections takes into account those aircraft which experience high numbers of landings per hour, but particularly those aircraft used to conduct basic flight training, and to communicate that such an inspection exists through appropriate service information documentation.

The CAA should consider making the requirement to carry out a dye penetrant inspection of the Piper PA-34 Tomahawk NLG cylinder lubrication groove, in accordance with the manufacturer's documentation, mandatory.
