SERIOUS INCIDENT

Aircraft Type and Registration:	Eurocopter EC155B1, OY-HJJ	
No & Type of Engines:	2 Turbomeca Arriel 2C2 turbine engines	
Year of Manufacture:	2003 (Serial No: 6662)	
Date & Time (UTC):	6 November 2013 at 2023 hrs	
Location:	Clipper Gas platform, North Sea	
Type of Flight:	Commercial Air Transport (Passenger)	
Persons on Board:	Crew - 2	Passengers - 8
Injuries:	Crew - None	Passengers - None
Nature of Damage:	None	
Commander's Licence:	Airline Transport Pilot's Licence	
Commander's Age:	41 years	
Commander's Flying Experience:	2,240 hours (of which 1,160 were on type) Last 90 days - 120 hours Last 28 days - 44 hours	
Information Source:	AAIB Field Investigation

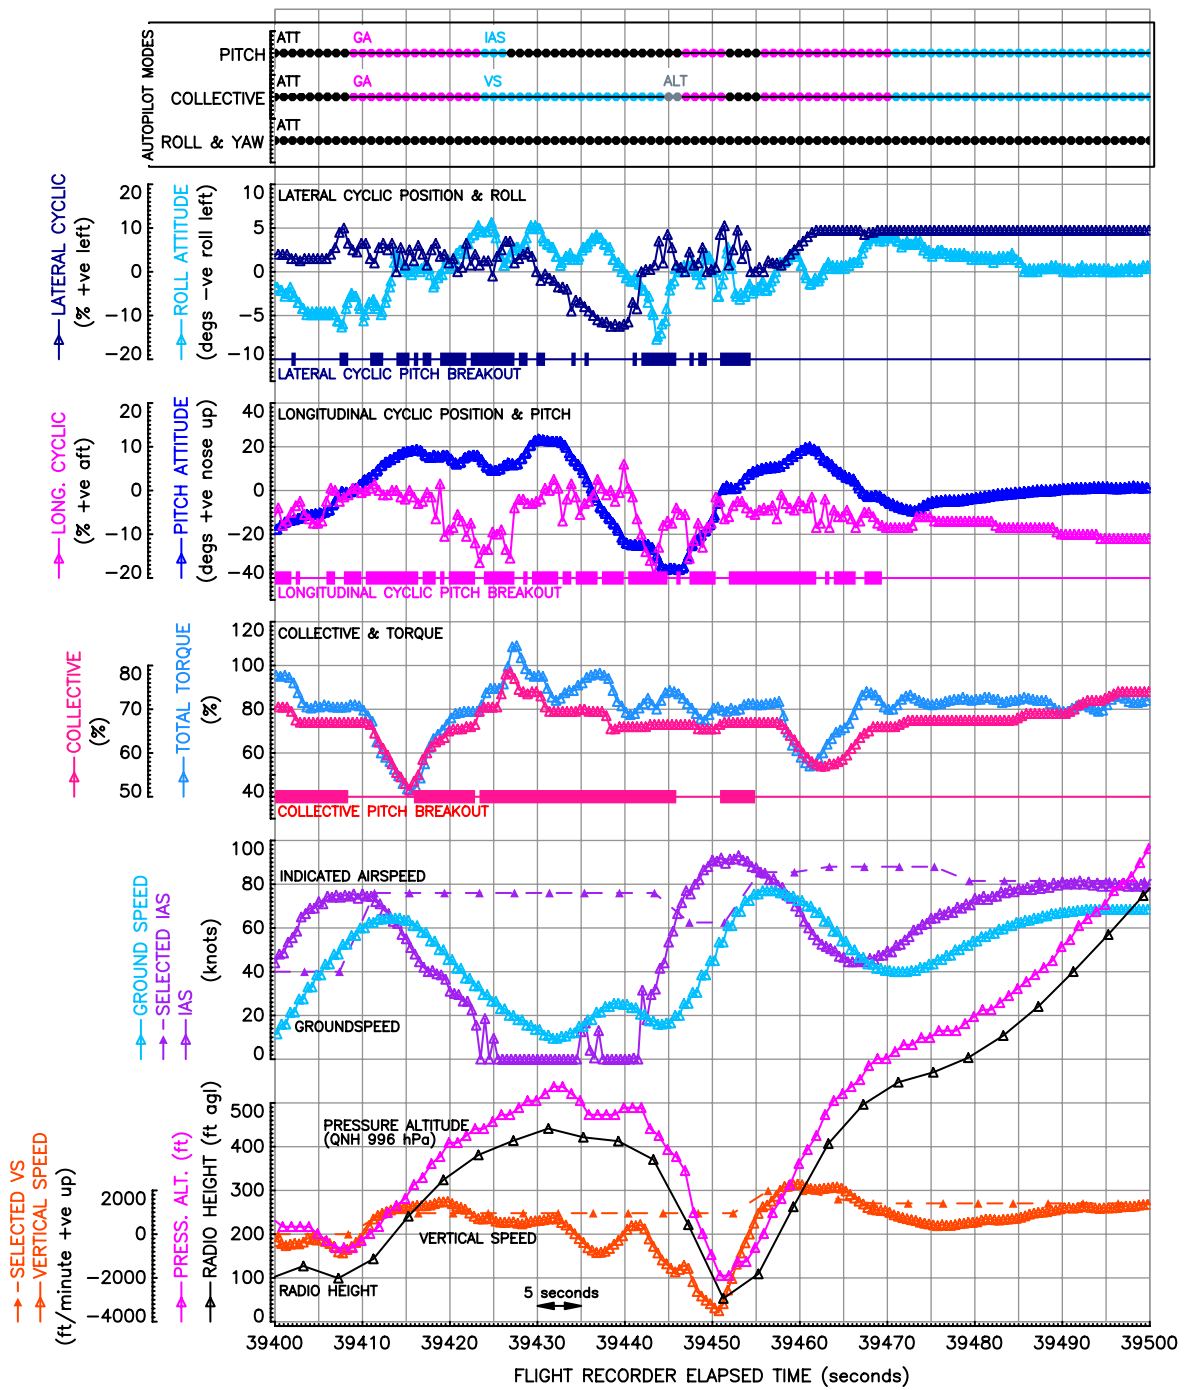
Figure 3

Recorded flight data showed the transition commencing with a progressive forward movement of the cyclic control and a corresponding decrease in pitch attitude from the hover attitude of 2 to 3° nose-up to 18° nose-down (Figure 3 - time 39400 seconds). The cyclic then moved back to just forward of neutral and nose-down pitch started to reduce. As the helicopter accelerated and power was reduced to maximum continuous (not shown), the pitch attitude was still significantly below 10° nose-down. The helicopter's flight path changed from level flight to a descent. At about 70 kt, as the helicopter pitched up through 10° nose-down, the cyclic control moved further back to about the neutral position and the rate at which the helicopter was pitching up increased, although it continued to descend with a maximum rate of 860 ft/min for two or three more seconds before a climb was established. At this point, as the pitch attitude passed 0°, and at 76 kt airspeed, autopilot GA mode was engaged (time 39409).

About two seconds after mode engagement, with vertical speed increasing towards (and eventually exceeding) the target of 1,000 ft/min, the collective and engine torque began to reduce under the control of the autopilot collective channel as it tried to limit the vertical speed to 1,000 ft/min. Vertical speed reached a maximum of 1,500 ft/min.

The cyclic control remained at about neutral as the pitch continued to increase. Although the autopilot GA mode remained engaged, force 'breakout' sensors on the cyclic control detected continued pilot manual control inputs, primarily in pitch but also in roll, which continued until the point of eventual recovery. The helicopter continued to pitch up and climb, reaching 18° nose-up pitch at about 240 ft radio height³ and with speed reducing through about 45 kt. At this point, total engine torque, which had reduced to below 50% (time 39415), started to increase again, reaching about 80% over 6 seconds.

With increasing forward cyclic inputs, the pitch attitude then decreased over the next 8 seconds (although with oscillations) to reach 10° nose-up, by which time the helicopter had climbed to 400 ft radio height with airspeed reducing to below 20 kt. The collective lever was raised, to give about 88% torque. About two seconds later, there was a noticeable forward movement of the cyclic and the collective was further raised (believed to be the inputs made by the co-pilot). Engine torque increased briefly to 109%, representing the point at which the over-torque occurred. Radio height at this point was about 410 ft.

Salient recorded flight data for the incident to OY-HJJ

With data indicating zero airspeed⁴, the cyclic control then moved significantly aft again, initially to just forward of the neutral position, and pitch attitude started to increase again (time 39426). This was coincident with operation of the cyclic trim release button (not shown), which allowed the pilot to disengage the trim actuators temporarily on the cyclic control, allowing it to be repositioned to a new datum without the artificial load applied (the commander remembered repositioning the cyclic rearwards, although he thought this occurred earlier in the sequence, in response to his initial perception that the helicopter was not responding correctly to GA mode engagement). The helicopter reached 25° nose-up pitch over the next 3 seconds (time 39430). It remained at this value for a further 3 seconds, with the helicopter at 460 ft radio height and indicating zero airspeed, before a noticeable forward cyclic input was made. The helicopter then pitched nose-down and started to descend.

The helicopter reached 24° nose-down pitch in about 7 seconds. After a brief pause at this value, the helicopter responded to increasing forward cyclic input by pitching down further, to 36° nose-down. This was accompanied by a rise in airspeed and descent rate calculated from the pressure altitude as 2,900 ft/min at a height of about 100 ft. After about a second, the helicopter pitched up again, reaching zero pitch angle just before it reached the lowest recorded radio height of 53 ft.

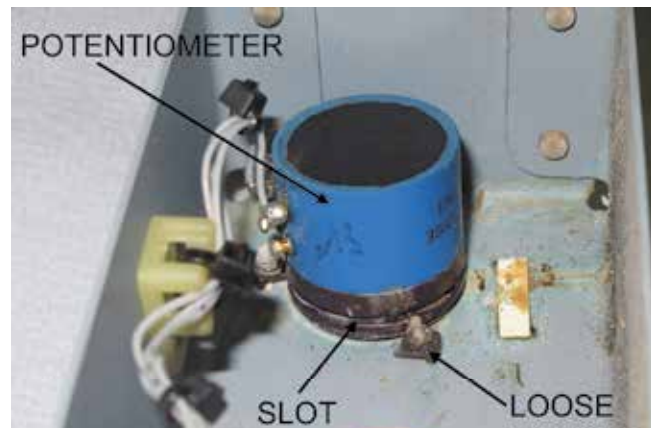
Figure 5

Examination of the collective control system revealed that the potentiometer inside the CLPD had become loose. When the collective was moved the body of the potentiometer moved slightly. The CLPD was removed which revealed that one of the three tongues which secured the potentiometer to the casing had become loose (Figures 4 and 5). This tongue should have engaged into the slot at the base of the potentiometer, but it had become loose and rotated out, enabling the body of the potentiometer to rotate slightly during collective movement. The other two tongues were still securely engaged in the slot.

Close-up of potentiometer inside CLPD
