ACCIDENT

Aircraft Type and Registration:	Grob G115, G-BOPT	
No & Type of Engines:	1 Lycoming O-235-H2C piston engine	
Category:	1.3	
Year of Manufacture:	1988	
Date & Time (UTC):	19 June 2005 at 11:10 hrs	
Location:	Barton Airfield, Manchester	
Type of Flight:	Training	
Persons on Board:	Crew - 1	Passengers - None
Injuries:	Crew - None	Passengers - N/A
Nature of Damage:	Significant damage to landing gear and propeller	
Commander's Licence:	Student pilot	
Commander's Age:	35 years	
Commander's Flying Experience:	59 hours (of which 53 were on type) Last 90 days - 15 hours Last 28 days - 5 hours	
Information Source:	Aircraft Accident Report Form submitted by the pilot

Synopsis

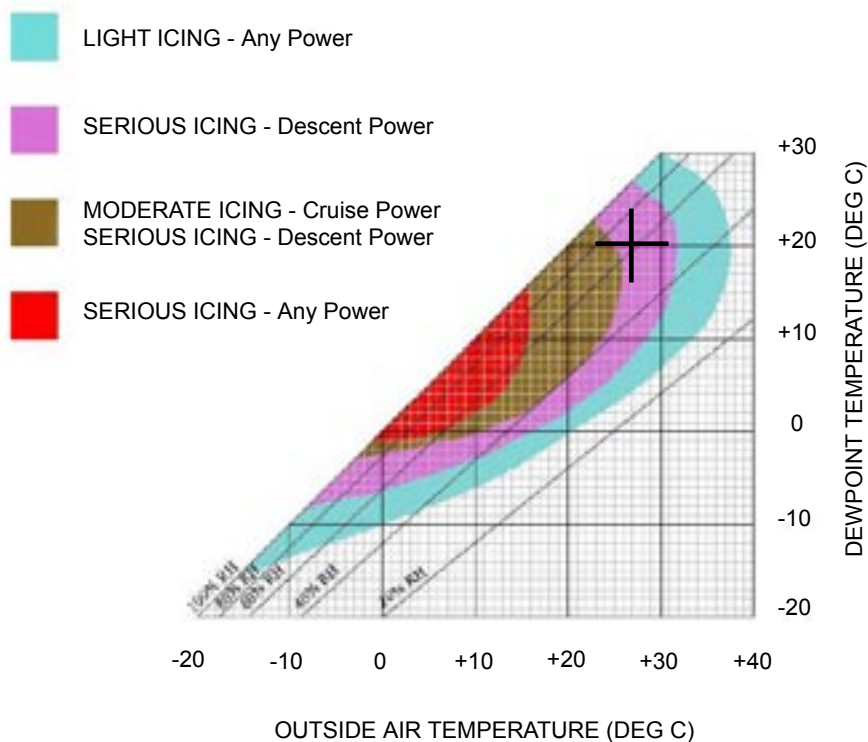
Figure 1

At the time of writing this report no fault has been found with the engine. The temperature and dew point recorded would have put the aircraft at risk from carburettor icing (Figure 1). The student had been flying circuits and had been using carburettor heat for only a limited period during each circuit. Thus there had potentially been sufficient time for ice to form when the carburettor heat was set to cold and insufficient time for it to clear when the carburettor heat was set to hot.
