ACCIDENT

Aircraft Type and Registration:	Piper PA-34-200T Seneca II, G-JDBC	
No & Type of Engines:	2 Continental Motors Corp LTSIO-360-E piston engines	
Year of Manufacture:	1975	
Date & Time (UTC):	30 June 2008 at 1458 hrs	
Location:	Runway 23L, Manchester International Airport, Greater Manchester	
Type of Flight:	Training	
Persons on Board:	Crew - 3	Passengers - None
Injuries:	Crew - None	Passengers - N/A
Nature of Damage:	Failed left main landing gear attachments, damage to left flap, aileron, propeller and pitot head and horizontal stabiliser tip	
Commander's Licence:	Commercial Pilot's Licence	
Commander's Age:	47 years	
Commander's Flying Experience:	1,975 hours (of which 302 were on type) Last 90 days - 28 hours Last 28 days - 4 hours	
Information Source:	Aircraft Accident Report Form submitted by the pilot and metallurgical examination of landing gear trunnion fitting

Synopsis

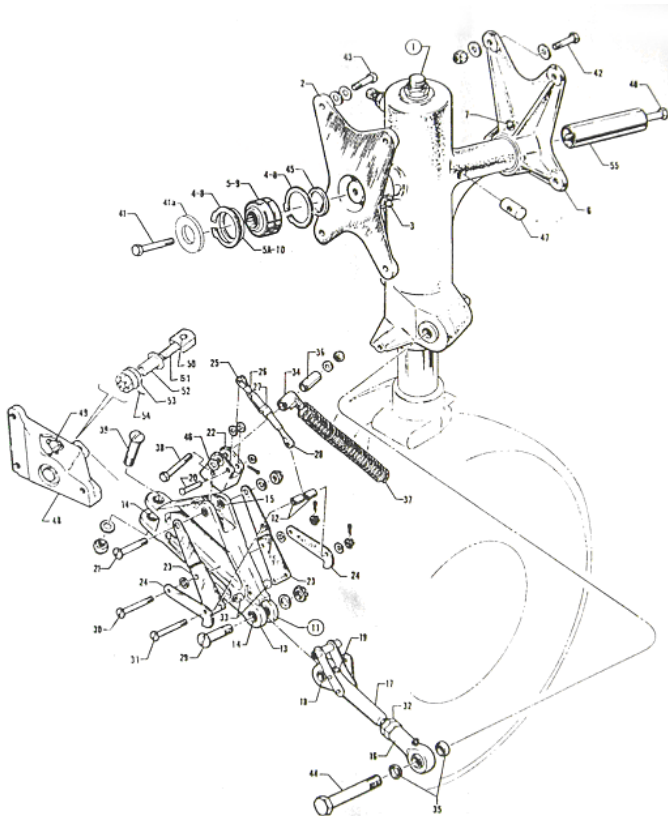
The aircraft was recovered to the maintenance organisation's hangar, where an inspection revealed that the left landing gear forward trunnion fitting had broken into several pieces. Parts of the component were missing, although one piece was later recovered from the runway at Tatenhill. Figure 1 shows an illustration from the Illustrated Parts Catalogue, which shows details of the installation.

Drawing illustrating installation of the main landing gear trunnion fittings

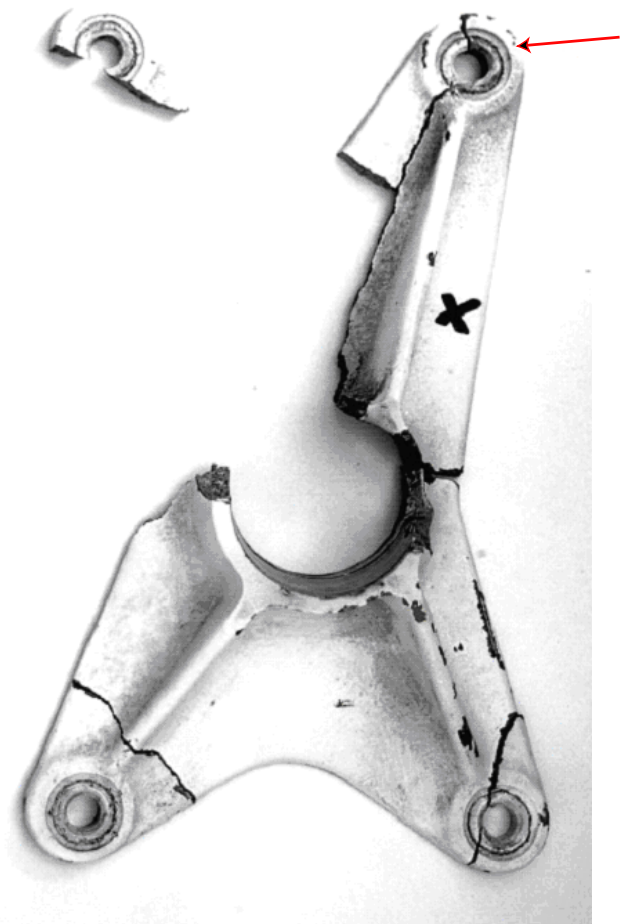
Figure 2

both engines were shut down and the propellers feathered. Subsequent examination of the aircraft showed that the left landing gear forward trunnion fitting had broken into several pieces, thus releasing the leg from its location. Metallurgical examination indicated that the fitting had failed from a combination of loose attachment bolts and fretting damage.

The fragments from the trunnion fitting were removed from the aircraft, Figure 2, and subjected to a metallurgical examination.

Recovered trunnion pieces. Fragment marked 'X' was found at Tatenhill. Note damage around bolt hole (arrowed)

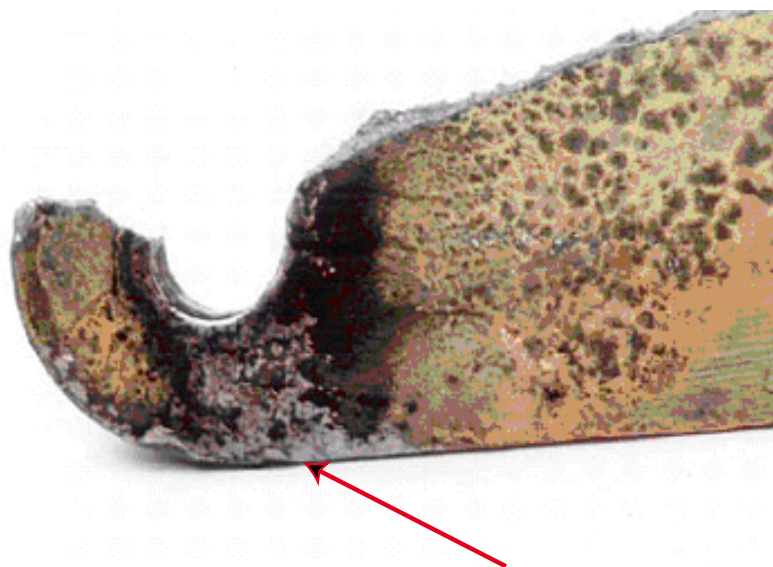
Figure 3

There was evidence, in the form of polished areas on the rear face of the trunnion fitting, of fretting, ie, small amplitude relative movement between the fitting and the wing spar surface to which it was bolted, Figure 3. Fretting had also occurred between the attachment bolts, the bolt holes, and the washers under the bolt heads. Some of the fracture faces around the bolt holes bore evidence of very low cycle, high peak stress fatigue cracking. It is considered that this occurred during the later stages of the failure sequence, after the fretting damage. It was not possible to establish a timescale

Fretting damage area on reverse side of fragment X (arrowed)

The metallurgical examination of the failed trunnion fitting determined that fretting had occurred, leading to a low cycle fatigue process in the material adjacent to the bolt holes. This culminated in the complete failure of the component, much as predicted in SB 956. In the absence of any additional evidence, it is likely that the fretting occurred due to the bolt torques slackening off in service.
