**ACCIDENT**

<b>Aircraft Type and Registration:</b>	De Havilland Canada DHC-6 300 Twin Otter, C-FAKB	
<b>No &amp; Type of Engines:</b>	2 Pratt & Whitney PT6A-27 turboprop engines	
<b>Year of Manufacture:</b>	1969 (serial number 273)	
<b>Date &amp; Time (UTC):</b>	24 February 2010 at 0057 hrs	
<b>Location:</b>	London Gatwick Airport	
<b>Type of Flight:</b>	Ferry flight	
<b>Persons on Board:</b>	Crew - 2	Passengers - None
<b>Injuries:</b>	Crew - None	Passengers - N/A
<b>Nature of Damage:</b>	Electrical fire in cabin	
<b>Commander's Licence:</b>	Air Transport Pilot's Licence	
<b>Commander's Age:</b>	38 years	
<b>Commander's Flying Experience:</b>	10,018 hours (of which 8,560 hours were on type) Last 90 days - 95 hours Last 28 days - 23 hours	
<b>Information Source:</b>	AAIB Field Investigation

**Synopsis**

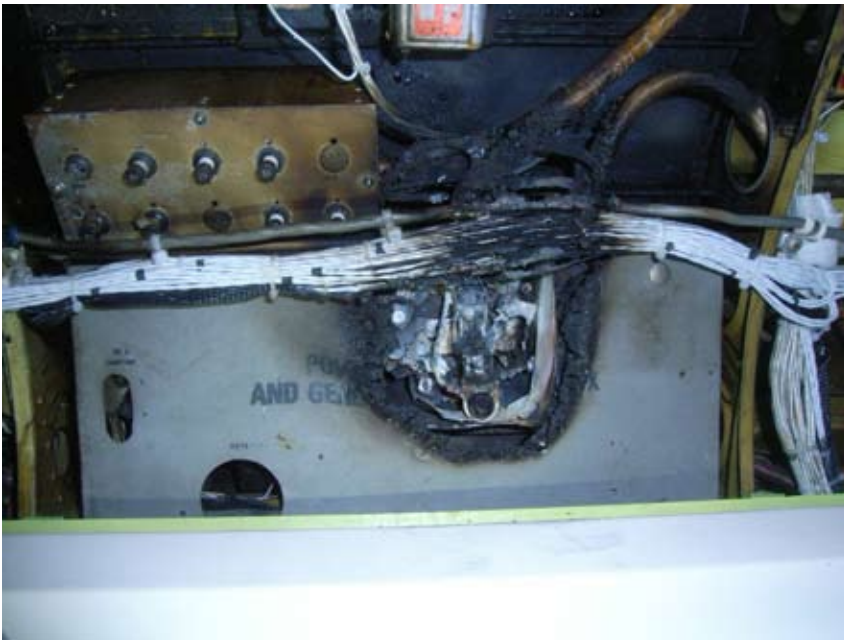
**Figure 3**

Examination of the aircraft revealed that there had been an electrical fire, which had almost consumed the left RCR, Figure 3. The fire had burnt through the cover of the power distribution and generator control box and, whilst the heat had caused the trim in the cabin to blister,

Damage to power distribution box and generator control box

the trim remained intact and there was no evidence of any smoke damage in the cabin. The trail of the combustion products shows that the smoke remained trapped between the fuselage and cabin trim and was drawn out of the cabin vent mounted in the roof of the aircraft. The heat had also damaged the wiring for the entertainment system and the aerial for a redundant ADF system; there was no other damage to any of the aircraft wiring. Although the adjacent structure and components were covered with combustion products there was no evidence of heat damage outside of the power distribution and generator control box, except to the adjacent cabin trim, .

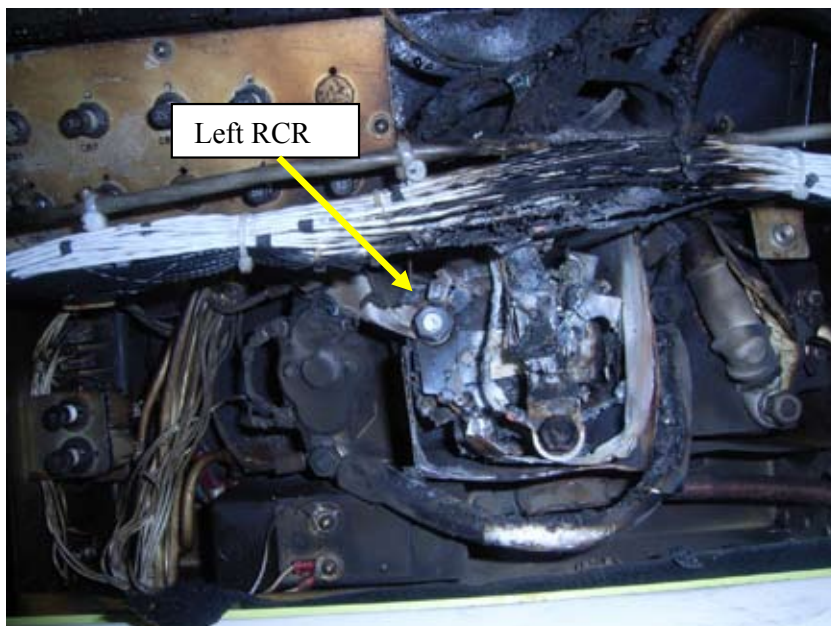
The damage indicates that the left RCR was the source of the fire and the temperature was sufficiently high to destroy the majority of the cover and the container in which the components for the RCR are located, Figure 4.

One of the two contact faces in the main relay (R3) had welded closed and the face on the second contact

had light pitting. This pitting was similar to that seen on the faces of the main contact in the right RCR which had been removed at Calgary. While the data plate had been destroyed, the components in the left RCR, and the design of the main contacts (R3), were found to be identical to the components in the right RCR that had been replaced at Calgary; the right RCR had a data plate identifying it as an A-700A relay. The documentation for the left RCR also identified it as an A-700A relay rated at 300 amps.

**Figure 4**  
Damage to left RCR

The damage to the aircraft indicates that the electrical fire started in the left RCR and the fire, and associated heat damage, did not spread outside the power distribution and generator control box.

The first indication to the crew was the ‘two brief flickers’ on the left GENERATOR caution caption. It is likely that this was caused by the rapid opening and closing of the main contacts (R3) in the left RCR. With the left generator on-line, it is likely that this action would have resulted in arcing between the moving and fixed contact plates, which may have been sufficient to weld one of the two contacts in the closed position. When the crew checked the DC load meter they noticed that on the left system the needle was fully deflected to the left, and on the right system was partially deflected to the right. This indicates that while the right generator was providing power to the right DC bus, current of at least 400 amps was flowing into the left starter/generator. It is this current flow which most probably caused, and sustained, the electrical fire.

It is recommended that Transport Canada takes appropriate action to ensure that only approved Reverse Current Relays are fitted to De Havilland DHC-6 aircraft.

It is recommended that Transport Canada require the replacement of existing Reverse Current Relays (part number A-700AP and A-700AAP) fitted to De Havilland DHC-6 aircraft with relays of a higher current rating and improved design of the electrical contacts.
