ACCIDENT

Aircraft Type and Registration:	Bell 206B Jet Ranger III, G-BXLI	
No & Type of Engines:	1 Allison 250-C20J turboshaft engine	
Category:	2.3	
Year of Manufacture:	1989	
Date & Time (UTC):	22 January 2005 at 1242 hrs	
Location:	Priors Park Wood, 5 nm south of Taunton, Somerset	
Type of Flight:	Private	
Persons on Board:	Crew - 1	Passengers - 3
Injuries:	Crew - 1 (Fatal)	Passengers - 3 (Fatal)
Nature of Damage:	Aircraft destroyed	
Commander's Licence:	Private Pilot's Licence	
Commander's Age:	54 years	
Commander's Flying Experience:	330 hours (of which 220 were on type) Last 90 days - 10 hours Last 28 days - 4 hours	
Information Source:	AAIB Field Investigation

Synopsis

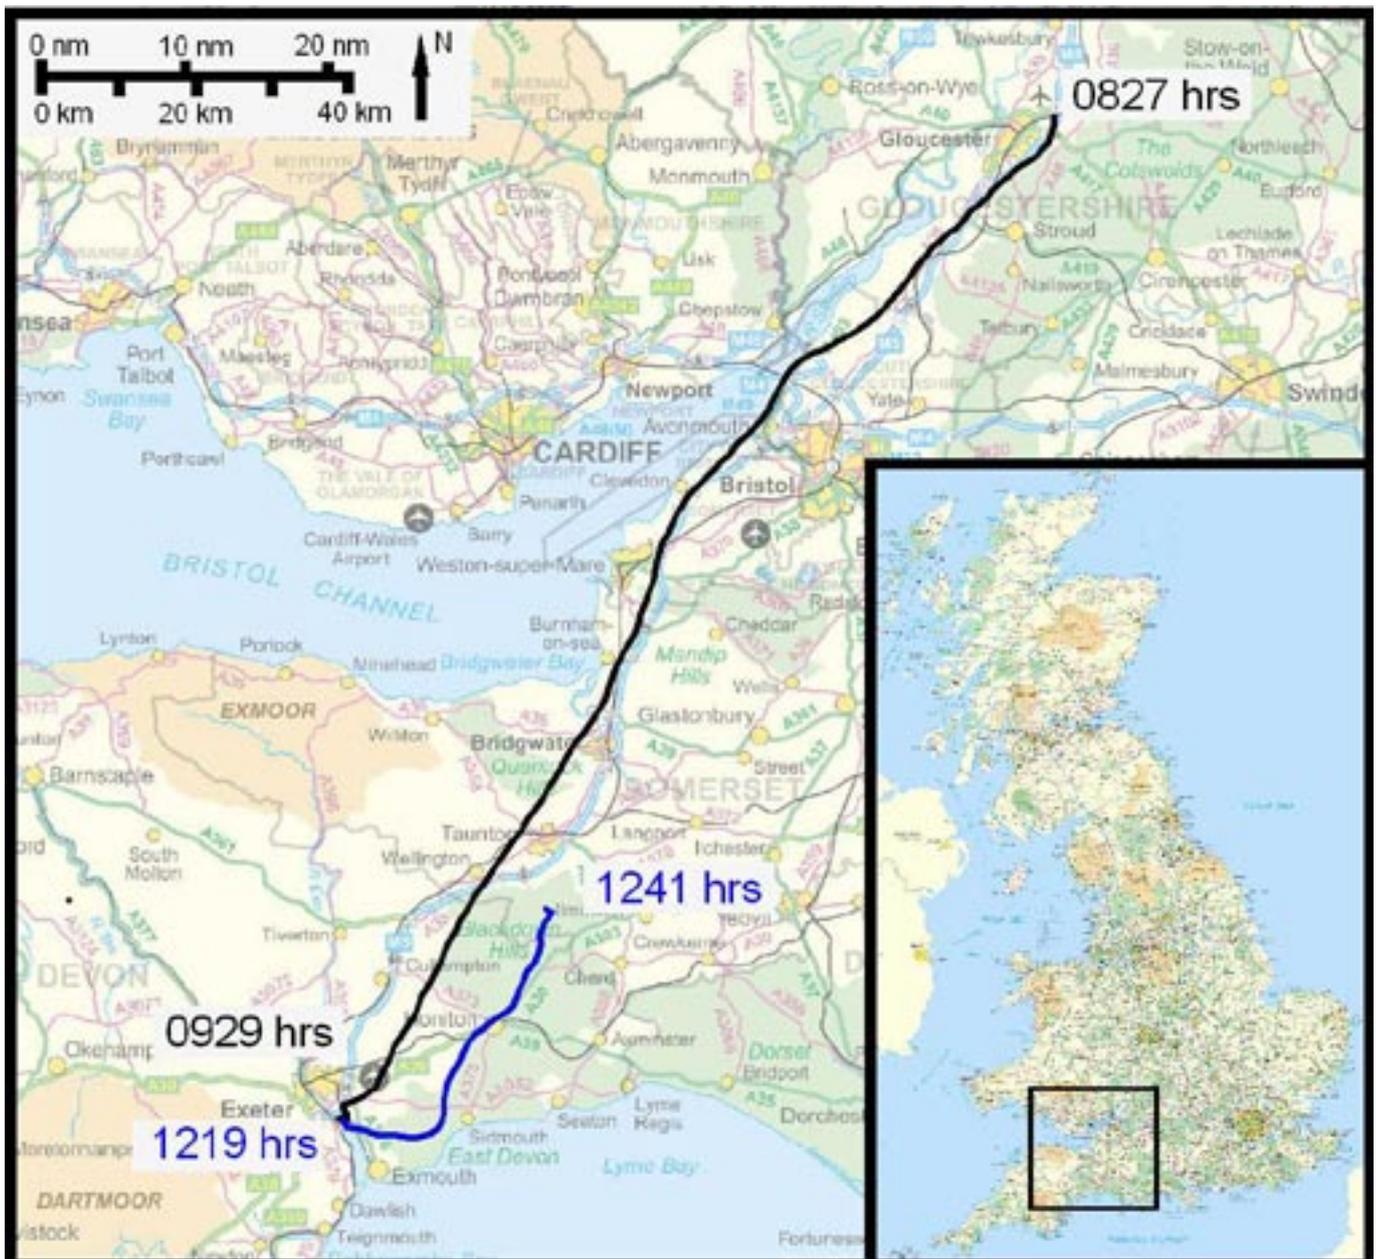
Figure 1 shows the two GPS tracks recorded on the day of the accident. The first flight of the day departed from Gloucester airport, and the first track point was recorded at 0827 hrs with the helicopter in the air. The flight ended at 0929 hrs at Topsham, south east of Exeter. The second flight, during which the accident occurred, departed Topsham at 1219 hrs. The last flight log point recorded was at 1241:29 hrs just south of Priors Park Wood, approximately 5 nm south of Taunton.

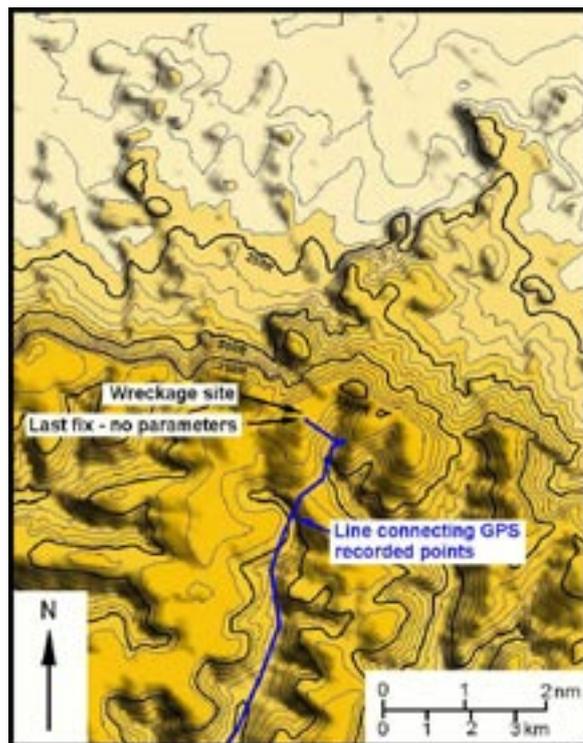
Figure 3

with the Blackdown Hills, Figure 3, and this was the last ridge of hills on track before the terrain fell away towards Taunton and the M5 motorway. A minute or so before the flight log terminated, in the vicinity of Moor, Westhay and Walland Farms, the aircraft slowed appreciably, dropped in altitude and significantly changed its heading. The low sample rate of the GPS did not afford more detailed description of the manoeuvring at the end of the flight.

End section of the accident flight in relation to terrain height

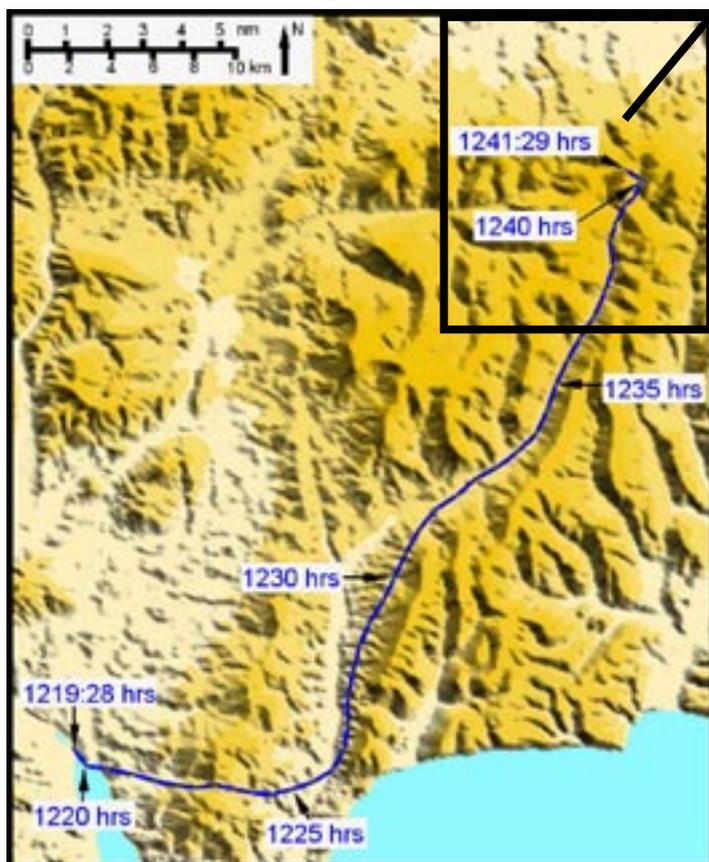
Figure 2 shows the flight path of the accident flight overlaid on a map of the terrain. During this flight, the aircraft initially tracked east and crossed a ridge. The helicopter then flew north-east, following a valley floor at approximately 400 ft agl with an average ground speed of approximately 80 kt. The valley floor elevation increased as the flight progressed. The flight terminated at a location where the valley floor effectively merged

Accident flight track overlaid on a terrain map

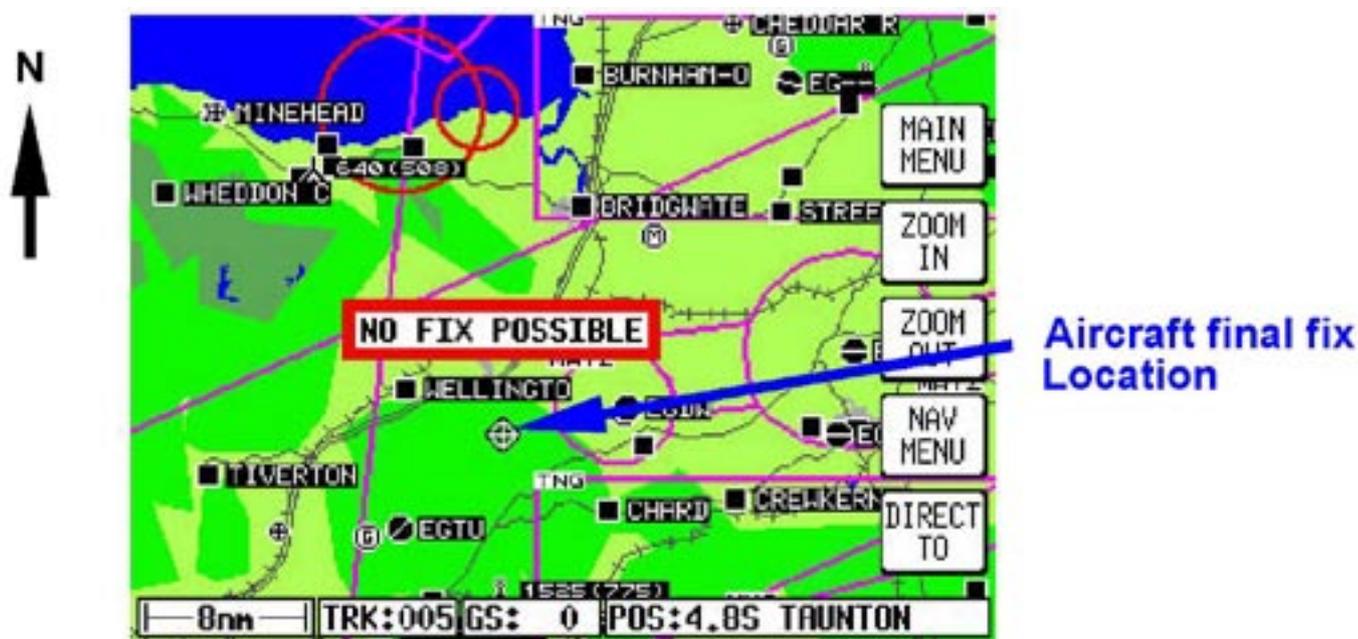
Figure 4

Screen shot of G-BXLI's final GPS fix.

The last photograph taken on the flight, by the passenger who was sat in the left rear seat, shows the GPS display situated on the top of the instrument panel. In contrast with other photographs taken by the same camera on that day’s flights, there was no visible countryside in this picture beyond the windscreen, just a general greyness, suggesting that the helicopter was flying either in cloud or in very poor visibility. In such conditions, the GPS display may well have assumed a greater significance than normal, to the pilot, as an aid to navigation.
