AAIB Bulletin No: 12/95

Ref: EW/G95/09/01

Aircraft Type and Registration: Pierre Robin HR100/200B Royale, G-AZKN

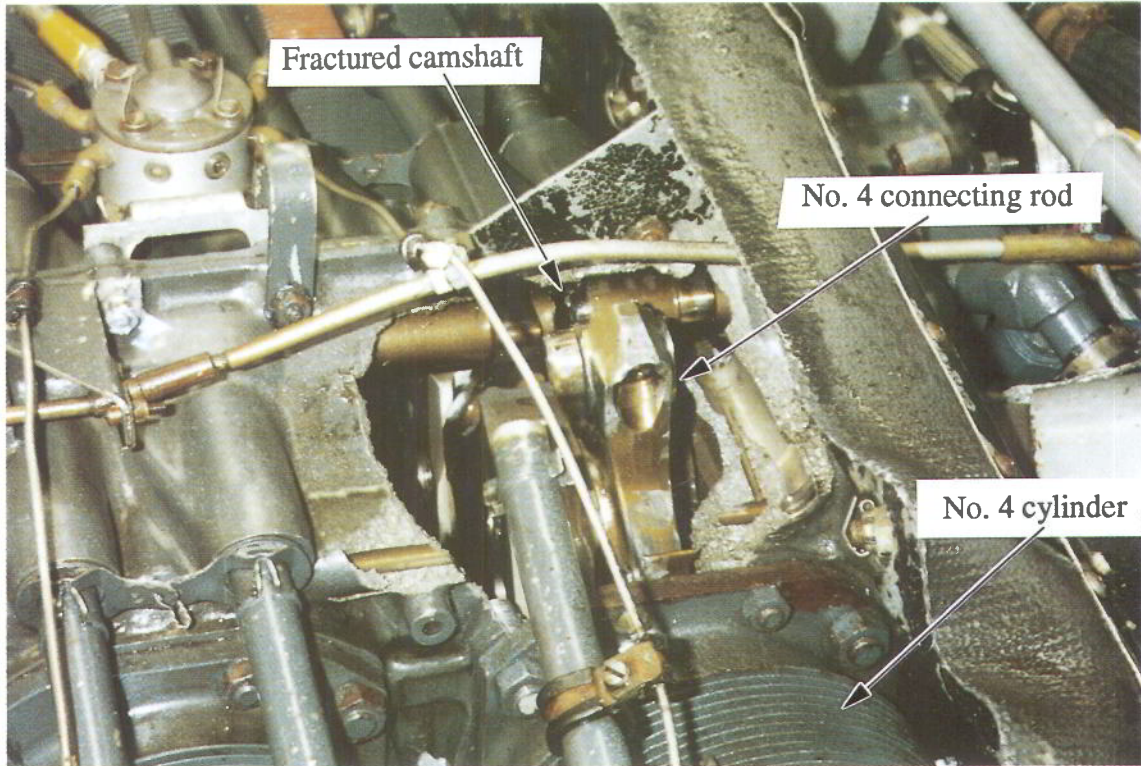
Inspection of the aircraft after the accident showed that the sudden engine stoppage had been due to the No 4 connecting rod becoming detached from its end cap (Figure 1). The big-end of the connecting rod had thus been freed from its crankshaft journal and had fractured the camshaft, immediately stopping the engine and knocking out a substantial portion of the upper crankcase.

Figure 1 - Big-end failure at No. 4 cylinder, G-AZKN, 1/9/95

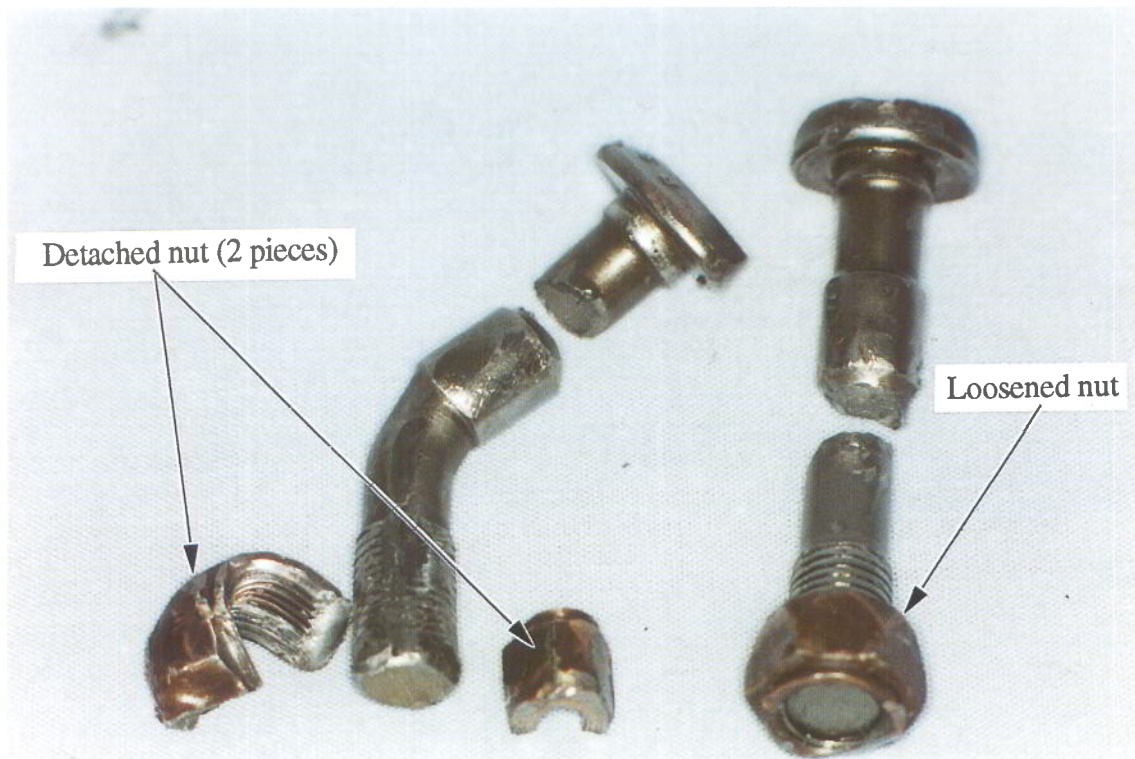
Metallurgical examination of the bolts from the No 4 big-end showed that the failures of these bolts had resulted from the unscrewing of the nuts from their threads. The big-end failure in the No 4 connecting rod appeared, therefore, to be consistent with the initial loosening of one of the big-end nuts, followed by the progressive unscrewing of both of the nuts

Figure 2 - Big-end bolts and retaining nuts, No. 4 connecting rod, G-AZKN, 1/9/95
