ACCIDENT

Aircraft Type and Registration:	Spezio DAL-1, G-NOBI	
No & Type of Engines:	1 Continental Motors C125-2 piston engine	
Year of Manufacture:	1970	
Date & Time (UTC):	21 April 2007 at 1300 hrs	
Location:	Nayland Airfield, Essex	
Type of Flight:	Private	
Persons on Board:	Crew - 1	Passengers - None
Injuries:	Crew - 1 (Serious)	Passengers - N/A
Nature of Damage:	Damage to landing gear, lower fuselage and both wing leading edges	
Commander's Licence:	Private Pilot's Licence	
Commander's Age:	52 years	
Commander's Flying Experience:	400 hours Last 90 days - Not known Last 28 days - 1 hour	
Information Source:	Aircraft Accident Report Form submitted by the pilot and AAIB enquiries

Synopsis

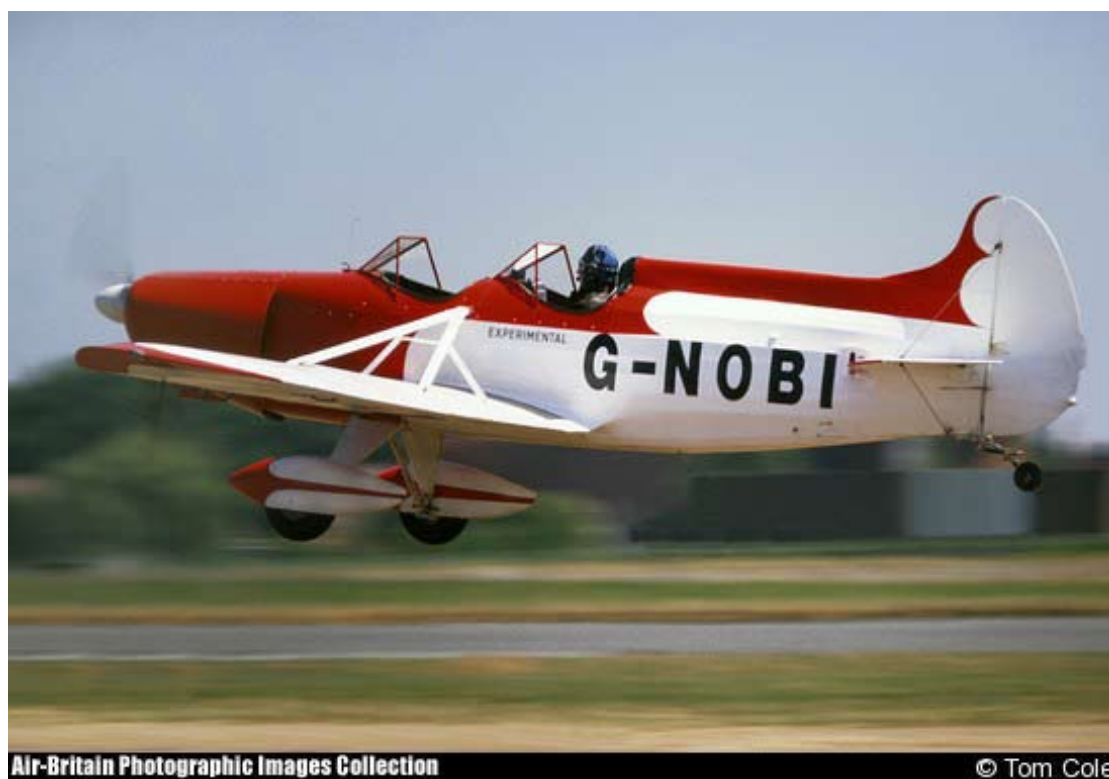
Figure 1

The Spezio DAL-1 is a single-engined, home-built aircraft and G-NOBI was fitted with a Continental C125-2 engine. It is a two-seat, low-wing monoplane with two cockpits arranged in tandem and with a tail-wheel landing gear, see Figure 1. As a result of the tandem cockpit layout it is sometime referred to as the 'Spezio Tuholer'. The aircraft has conventional primary flying controls but does not have flaps. Flight controls were fitted in both cockpits although the fuel management controls were only fitted to the rear cockpit.

Photograph of G-NOBI
(reproduced with permission of Tom Cole)

Whilst the pilot had experience of several tail-wheel types, his lack of experience on this type would appear to be a factor in the heavy subsequent landing. The long nose ahead of the rear cockpit might also have been a contributing factor.
