**ACCIDENT**

<b>Aircraft Type and Registration:</b>	Jodel D117A, G-ASXY	
<b>No &amp; Type of Engines:</b>	1 Continental Motors Corp C90-14F piston engine	
<b>Year of Manufacture:</b>	1958	
<b>Date &amp; Time (UTC):</b>	13 March 2011 at 1331 hrs	
<b>Location:</b>	Grovesend, near Swansea	
<b>Type of Flight:</b>	Private	
<b>Persons on Board:</b>	Crew - 2	Passengers - None
<b>Injuries:</b>	Crew - 1 (Fatal) 1 (Serious)	Passengers - N/A
<b>Nature of Damage:</b>	Aircraft damaged beyond economic repair	
<b>Commander's Licence:</b>	Private Pilot's Licence	
<b>Commander's Age:</b>	73 years	
<b>Commander's Flying Experience:</b>	1,138 hours (of which 687 were on type) Last 90 days - 3 hours Last 28 days - 1 hour	
<b>Information Source:</b>	AAIB Field Investigation

**Synopsis**

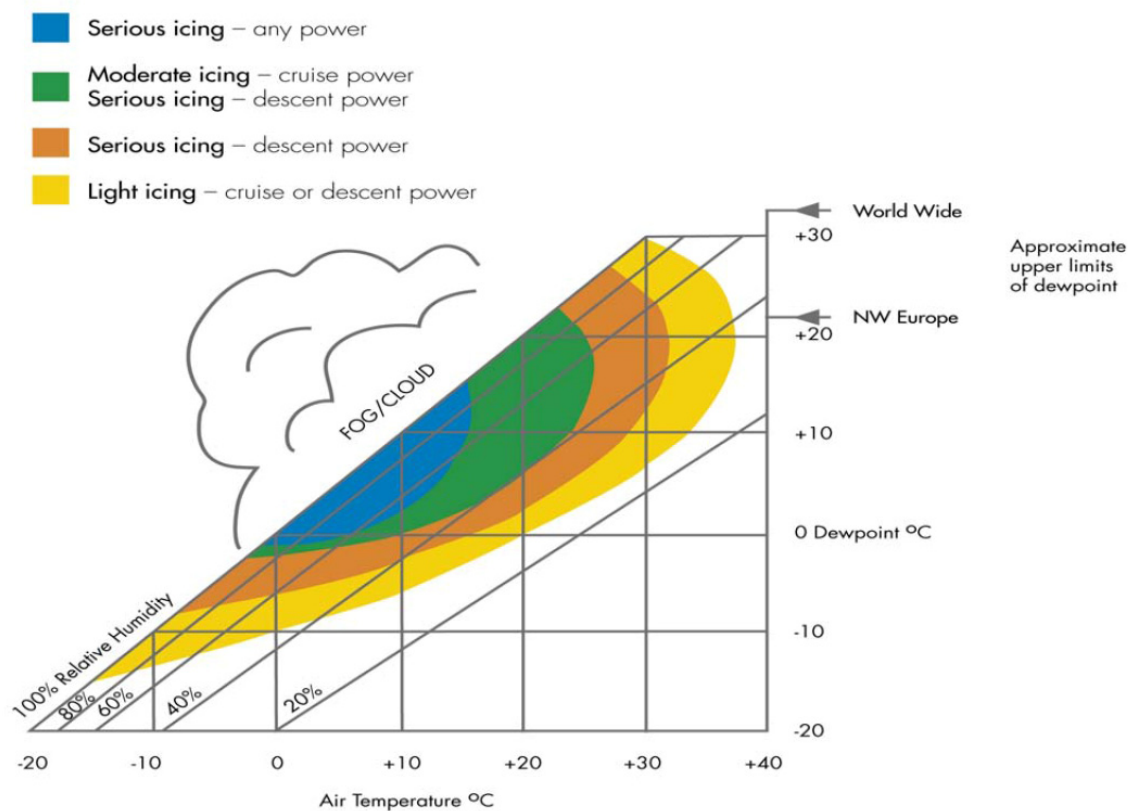
The temperature and dew point at Cardiff at the time of takeoff were +8°C and +2°C, respectively. The temperature at the cruising altitude of 2,500 ft was +1°C and the dew point was -7°C. The Cardiff temperature and dew point were such that moderate carburettor icing may have occurred at cruise power or serious icing could have developed at descent (idle) power. The cruising altitude temperature and dew point were such that there was a likelihood of light carburettor icing at cruise or descent power. Figure 1 is the Carburettor Icing chart published in the CAA's General Aviation Safety Sense Leaflet 14 – *Piston Engine Icing*.

Carburettor icing chart

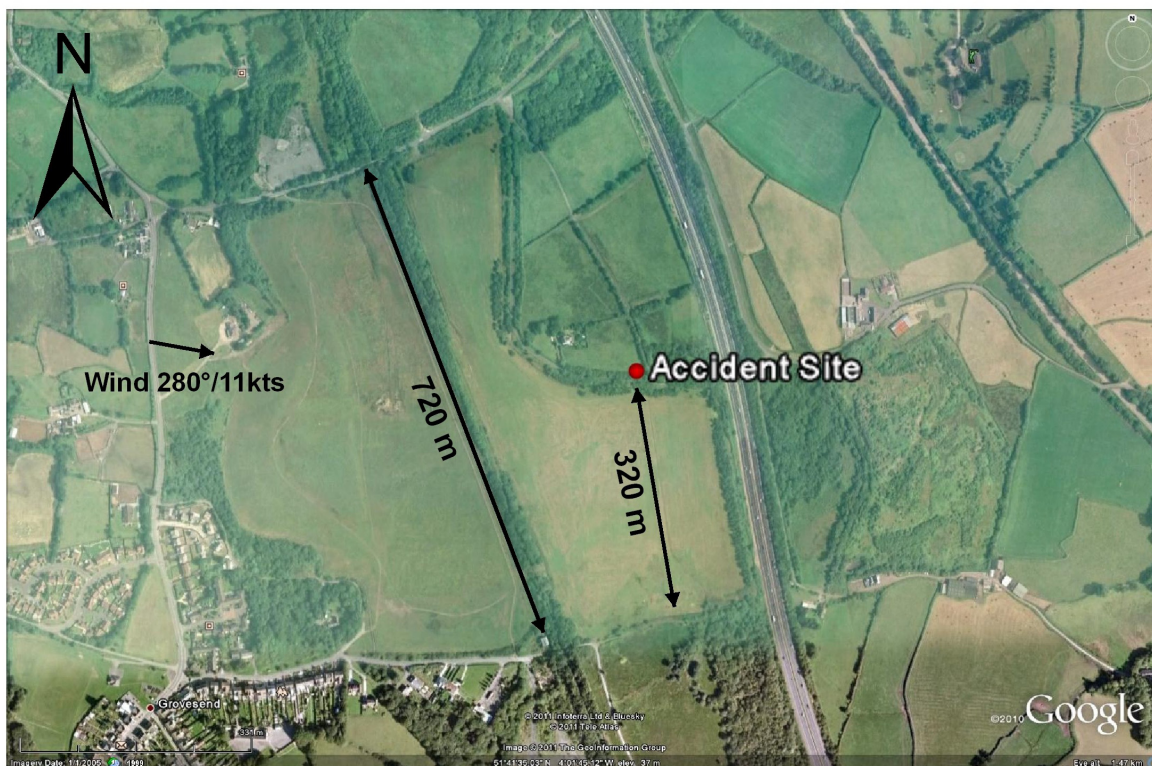
The fields selected by both pilots were of level pasture with short grass. They appear to have been the largest in the locality. The field chosen by the commander was approximately 320 m in length, with its long axis orientated 350°/170°M. The adjacent field suggested by the co-pilot was approximately 720 m in length and orientated 340°/160°M. These axes were 60-70° off the estimated surface wind. Figure 2 shows an aerial view of the selected fields.

Fields adjacent to the accident site

The long axis of the selected field was about 70° off the wind. This is likely to have reduced the headwind component from 11 kt to about 4 kt. As practice forced landings are generally flown into wind, being off the wind would have reduced the aircraft's angle of descent.

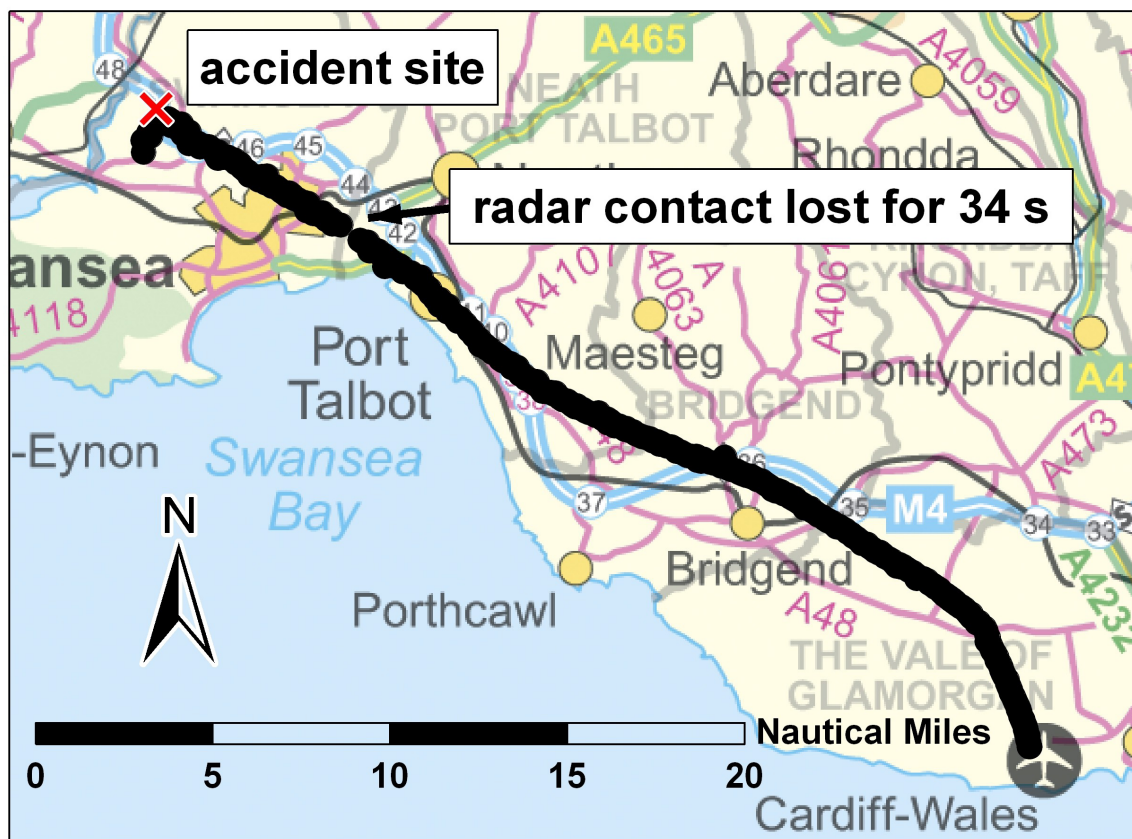
Figure 3 shows the accident track from 1320:49 hrs, north of Cardiff Airport, to 1329:50 hrs, approximately 1 nm south of the accident site. Between 1323:43 hrs and 1324:19 hrs radar contact was lost. This loss of contact was probably due to the aircraft's altitude reducing briefly to a level that placed it out of line of sight of the radar head.

Shortly before the radar contact was briefly lost the track becomes jittery in nature, suggesting that the radar tracker software was having difficulty in tracking the aircraft at this range and altitude. Also, due to the jittering and other software issues, the software's calculation of the aircraft's groundspeed was unreliable.
