ACCIDENT

Glider Type and Registration:	Glaser Dirks DG600 Glider, BGA 3445 (Tail No 656)	
No & Type of Engines:	None	
Year of Manufacture:	1988	
Date & Time (UTC):	18 September 2005 at 1230 hrs	
Location:	Ridgewell Airfield near Great Yeldham, Essex	
Type of Flight:	Private	
Persons on Board:	Crew - 1	Passengers - None
Injuries:	Crew - 1 (Fatal)	Passengers - N/A
Nature of Damage:	Glider destroyed	
Commander's Licence:	FAI Gold C Certificate (August 1981) and 3 Diamonds completed July 1985	
Commanders Age:	74 years	
Commander's Flying Experience:	4,186 hours (estimated 2,000 on type)	
Information Source:	AAIB Field Investigation with BGA assistance

Synopsis

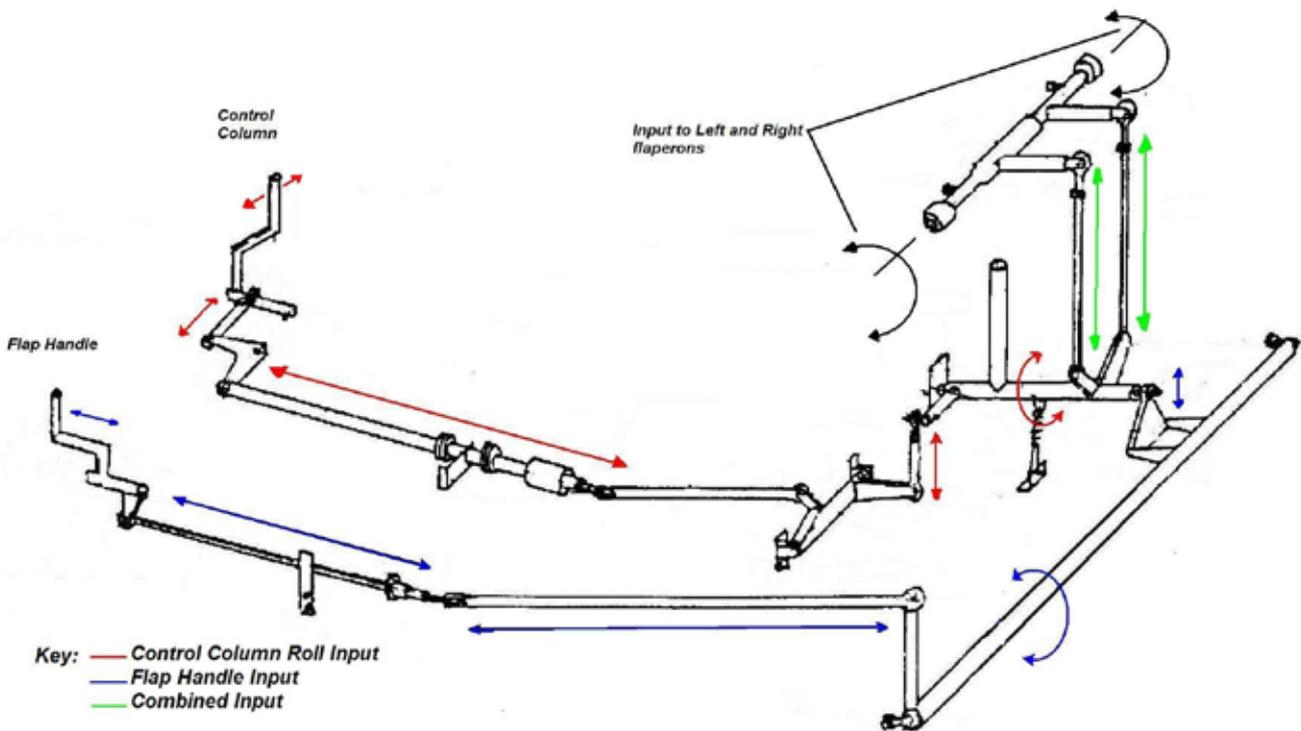
Figure 1
DG600 Flaperon control circuit
(Modification of manufacturers drawing)

The continuity of the primary control circuits from the cockpit to the wing joint and tail was verified; no evidence of restriction, jamming or pre-impact damage was identified in the flap, spoiler or elevator circuits. However, a connecting turnbuckle which transmitted aileron inputs into the 'mixer' unit had failed. Analysis of the fracture surface showed the characteristics of a single overload failure with no evidence of fatigue or pre-existing defect.

The 'self connecting' mechanisms on the 'mixer' unit and the wings were examined and no evidence of incorrect connection or a mechanical disconnect in flight was identified. The wing control surfaces were operated through their full range of movement from the wing root connection points and no binding or jamming of either the flaperons or the spoilers was identified. The position of the flap lever prior to impact could not be determined.

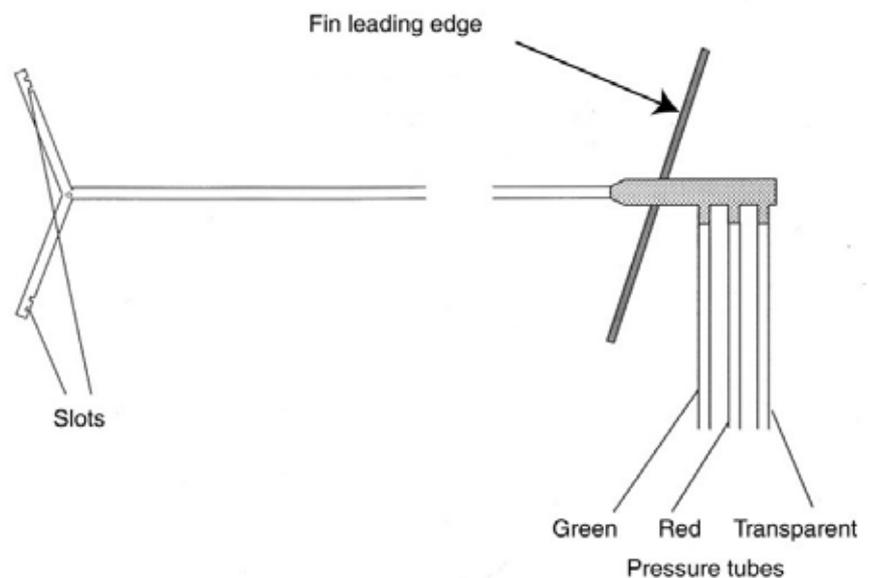
Figure 2

BGA 3445 was fitted with a ‘total energy’ probe. The red and green tubes were blanked with tape, leaving the clear tube open to provide the ‘total energy’ pressure. The probe consisted of a 60 cm long pipe with a ‘Y’ shaped end piece as illustrated in Figure 2.

Two slots were cut in the aft face of each side of the ‘Y’ shaped end piece allowing the ‘total energy’ pressure to be transmitted through the probe.

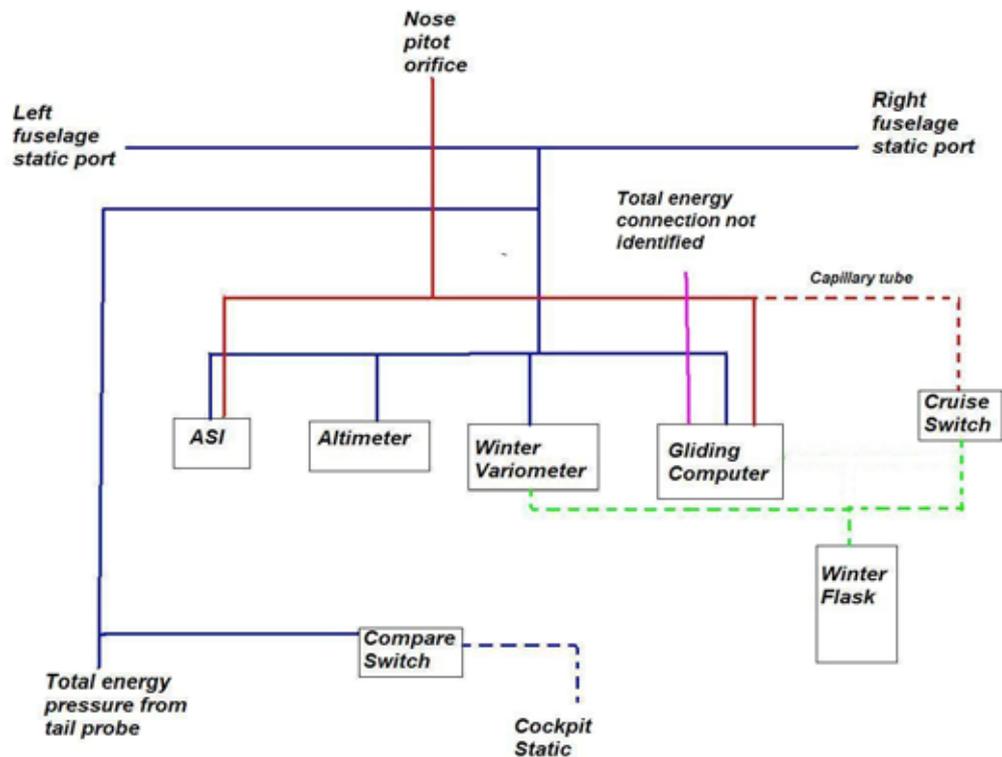
Figure 3

A reconstruction of the pitot static system showed that the gliding computer, flask variometer and the primary flight instruments were connected to the same pitot and static sources, including a static pressure input from the tail mounted total energy probe, see Figure 3.

During the reconstruction it was not possible to identify a connection to the separate total energy input of the gliding

computer. However, it was found that the computer fitted to this glider was capable of being programmed to generate an equivalent total energy signal using pitot and static pressure inputs. Therefore, it is possible that there was no total energy input to the gliding computer.

The ASI was serviceable and probably accurate immediately before the accident. Although the 'total energy' probe was connected to the primary flight instrument static system, it is considered very unlikely to have introduced errors in airspeed indication during the winch launch.

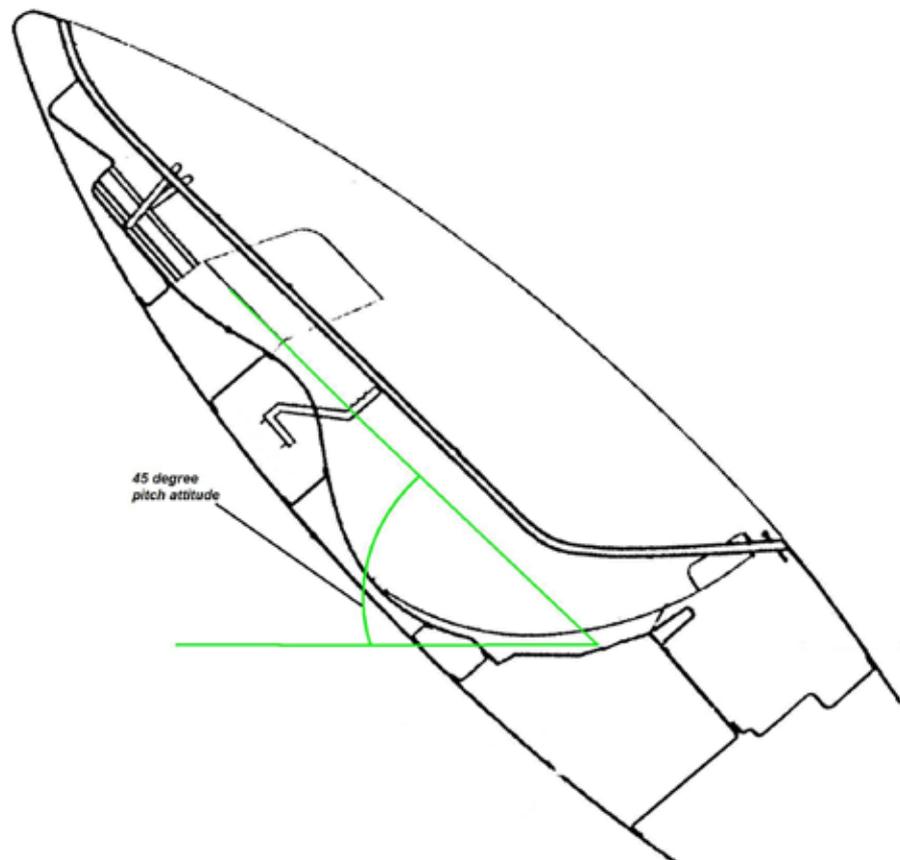
Figure 5

The seating position in the DG600 is semi-reclined, (see Figure 5), with a smoothly curved backrest. Typical fuselage pitch attitudes during a winch launch are between 35° and 45°; this results in the pilot's torso effectively lying flat on the seat back with his hips and legs raised.

In this position the mass of the pilot's hips and legs would exert a force on the pilot's torso which would tend push the pilot 'up' the seat back. Acceleration of the glider in the initial stages of the launch can also contribute to this effect. Any tendency for the pilot to move in this direction would normally be restrained by the harness shoulder straps.

If the pilot was unrestrained by the shoulder straps during the flight, it is possible that during the launch his body slipped 'up' the seat. The cockpit of the DG600 does not offer any obvious hand holds, with the exception of glider control levers. It is possible, therefore, that the pilot inadvertently pulled back further on the control column before finding a suitable hand-hold for his free hand. This would result in an increase in pitch, an increasing in the load on the winch and a decrease in the glider's airspeed, bringing it closer to its stalling speed. It may also have decreased the pilot's ability to lower the nose sufficiently rapidly to prevent the glider stalling and entering the spin.
