## ACCIDENT

<b>Glider Type and Registration:</b>	Glaser Dirks DG600 Glider, BGA 3445 (Tail No 656)	
<b>No &amp; Type of Engines:</b>	None	
<b>Year of Manufacture:</b>	1988	
<b>Date &amp; Time (UTC):</b>	18 September 2005 at 1230 hrs	
<b>Location:</b>	Ridgewell Airfield near Great Yeldham, Essex	
<b>Type of Flight:</b>	Private	
<b>Persons on Board:</b>	Crew - 1	Passengers - None
<b>Injuries:</b>	Crew - 1 (Fatal)	Passengers - N/A
<b>Nature of Damage:</b>	Glider destroyed	
<b>Commander's Licence:</b>	FAI Gold C Certificate (August 1981) and 3 Diamonds completed July 1985	
<b>Commanders Age:</b>	74 years	
<b>Commander's Flying Experience:</b>	4,186 hours (estimated 2,000 on type)	
<b>Information Source:</b>	AAIB Field Investigation with BGA assistance

## Synopsis

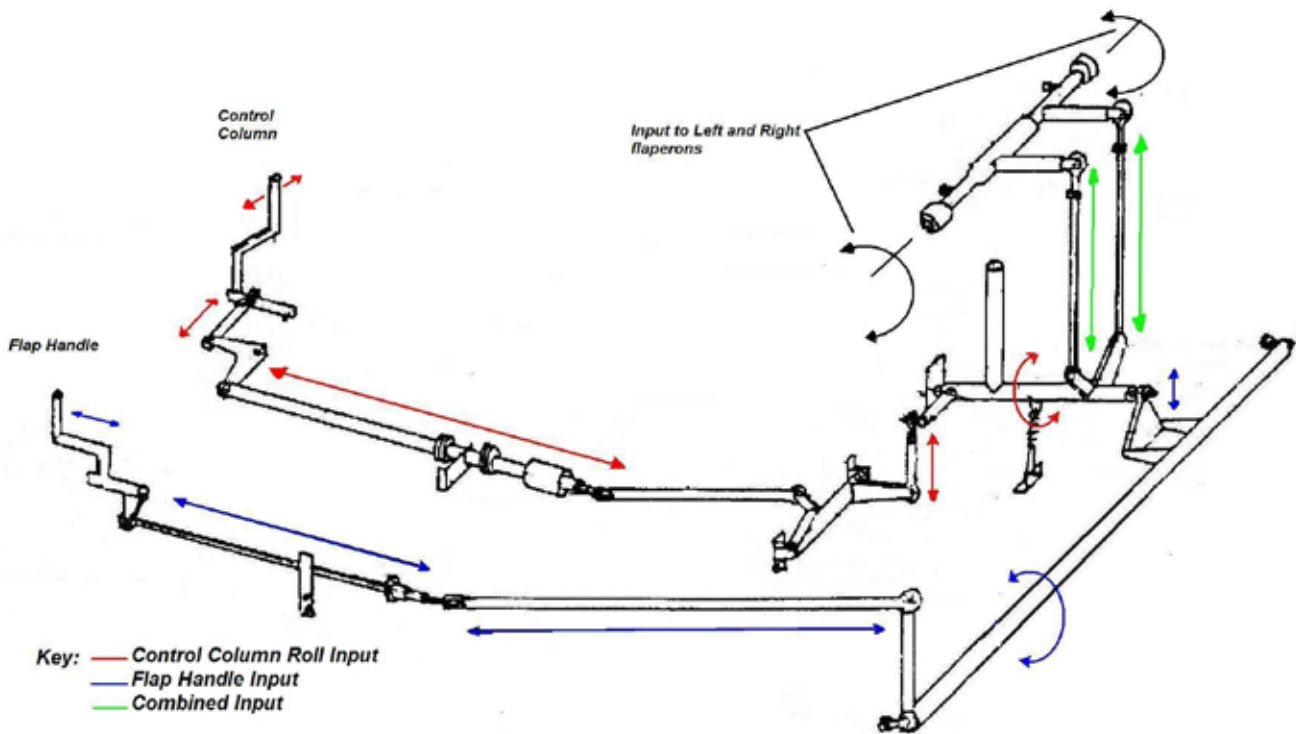
**Figure 1**  
DG600 Flaperon control circuit  
(Modification of manufacturers drawing)

The continuity of the primary control circuits from the cockpit to the wing joint and tail was verified; no evidence of restriction, jamming or pre-impact damage was identified in the flap, spoiler or elevator circuits. However, a connecting turnbuckle which transmitted aileron inputs into the 'mixer' unit had failed. Analysis of the fracture surface showed the characteristics of a single overload failure with no evidence of fatigue or pre-existing defect.

The 'self connecting' mechanisms on the 'mixer' unit and the wings were examined and no evidence of incorrect connection or a mechanical disconnect in flight was identified. The wing control surfaces were operated through their full range of movement from the wing root connection points and no binding or jamming of either the flaperons or the spoilers was identified. The position of the flap lever prior to impact could not be determined.

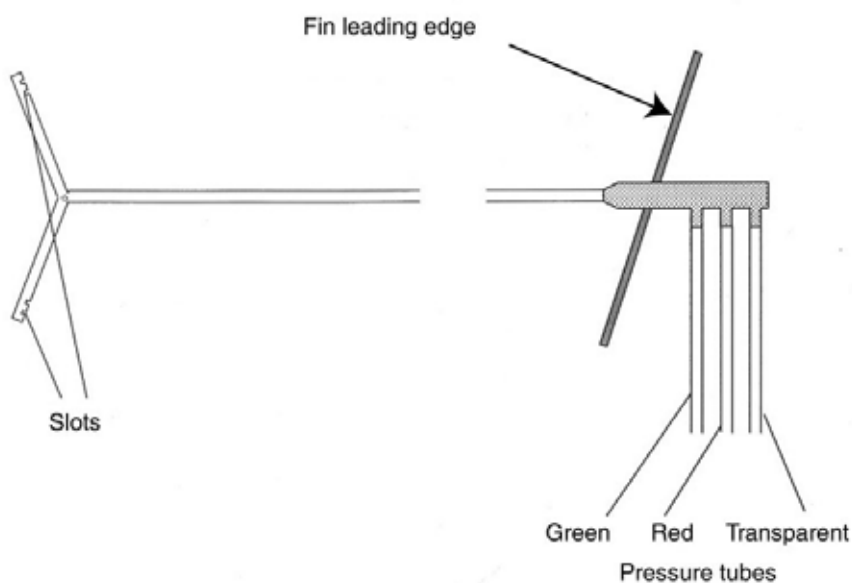
**Figure 2**

BGA 3445 was fitted with a ‘total energy’ probe. The red and green tubes were blanked with tape, leaving the clear tube open to provide the ‘total energy’ pressure. The probe consisted of a 60 cm long pipe with a ‘Y’ shaped end piece as illustrated in Figure 2.

Two slots were cut in the aft face of each side of the ‘Y’ shaped end piece allowing the ‘total energy’ pressure to be transmitted through the probe.

The ASI was serviceable and probably accurate immediately before the accident. Although the 'total energy' probe was connected to the primary flight instrument static system, it is considered very unlikely to have introduced errors in airspeed indication during the winch launch.

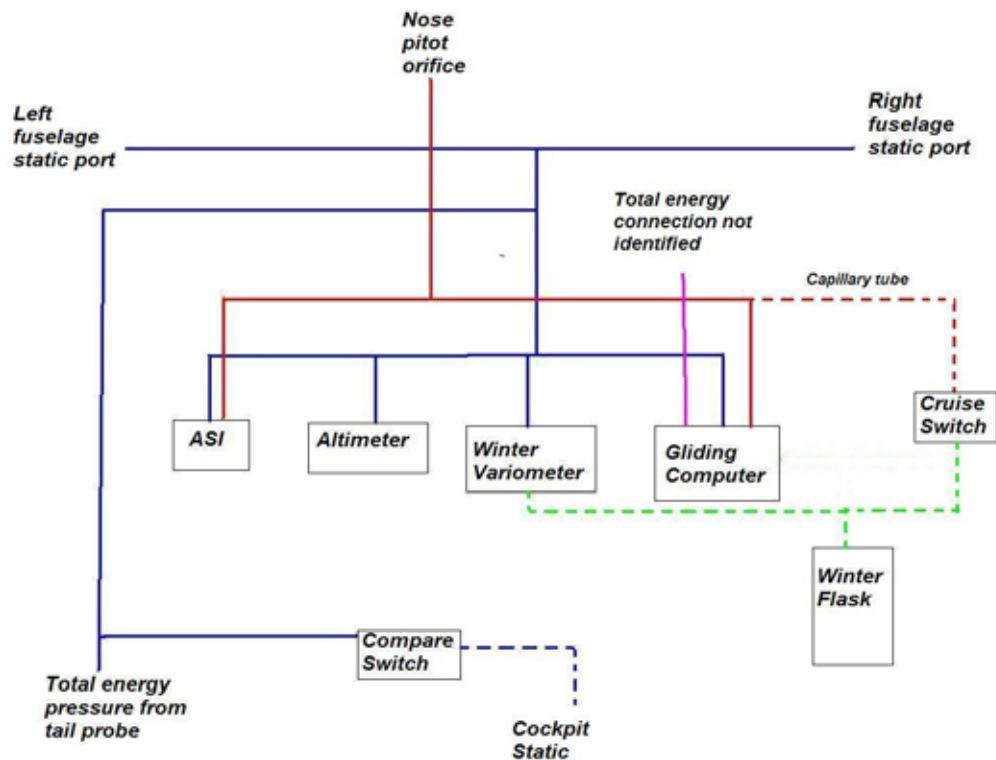
**Figure 3**

A reconstruction of the pitot static system showed that the gliding computer, flask variometer and the primary flight instruments were connected to the same pitot and static sources, including a static pressure input from the tail mounted total energy probe, see Figure 3.

During the reconstruction it was not possible to identify a connection to the separate total energy input of the gliding

computer. However, it was found that the computer fitted to this glider was capable of being programmed to generate an equivalent total energy signal using pitot and static pressure inputs. Therefore, it is possible that there was no total energy input to the gliding computer.

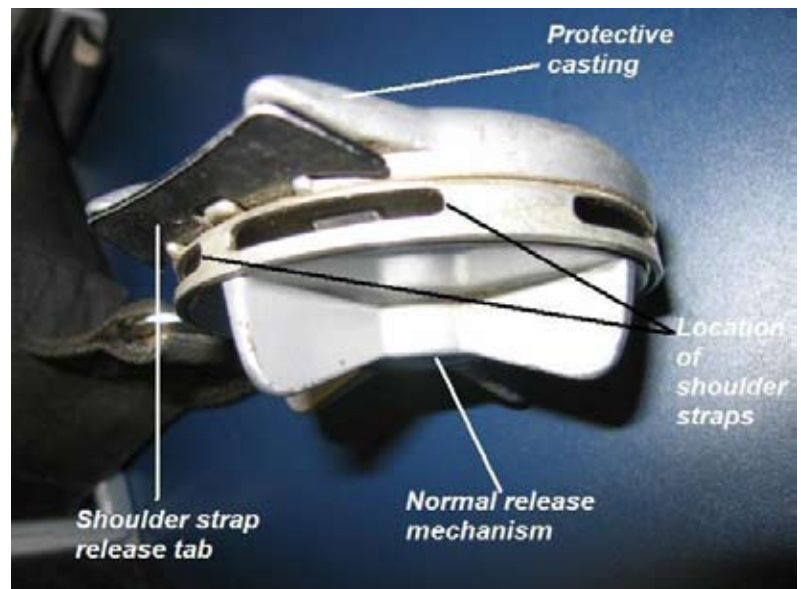
**Figure 4**

The glider was fitted with a four-point nylon harness consisting of two shoulder straps and two lap straps. The harness buckle was attached to the right lap strap. The shoulder and left lap straps were released from the buckle by turning the release mechanism on the front of the buckle through 45° in either a clockwise or anticlockwise direction. The buckle was also fitted with a shoulder strap release tab behind the shoulder strap slots (see Figure 4),

Pushing the tab forward would release both shoulder straps but leave the lap straps secure. The tab requires a force of 19.6 Newtons to operate it and is protected from inadvertent operation by two projections on the rear of the buckle casing. During the impact, the seat

structure failed but the harness attachments remained intact. The straps were free from tears or damage; the buckle was also free from damage and functioned normally. Evidence of soil was found on both the inner and outer faces of the right shoulder strap but not on the other straps. Both lap straps showed some degree of 'hardening' of the webbing where it passed through the adjustment points. This is typical of the nylon material subjected to a high load. The shoulder straps did not exhibit this 'hardening'.

Examination of the seat harness shows that the shoulder straps were not subject to the same magnitude of loading as the lap straps. The position of the shoulder straps in the wreckage and the soil contamination of the right shoulder strap suggests that they were not secured when the glider hit the ground. There are two likely explanations for this apparent insecurity: either the shoulder straps had not been fastened properly or the dynamics of the ground impact released them very early during the impact sequence.

The BGA remind all glider pilots of the importance of ensuring that glider harnesses correctly fit the user of the glider and that that harness is fully secured before flight.

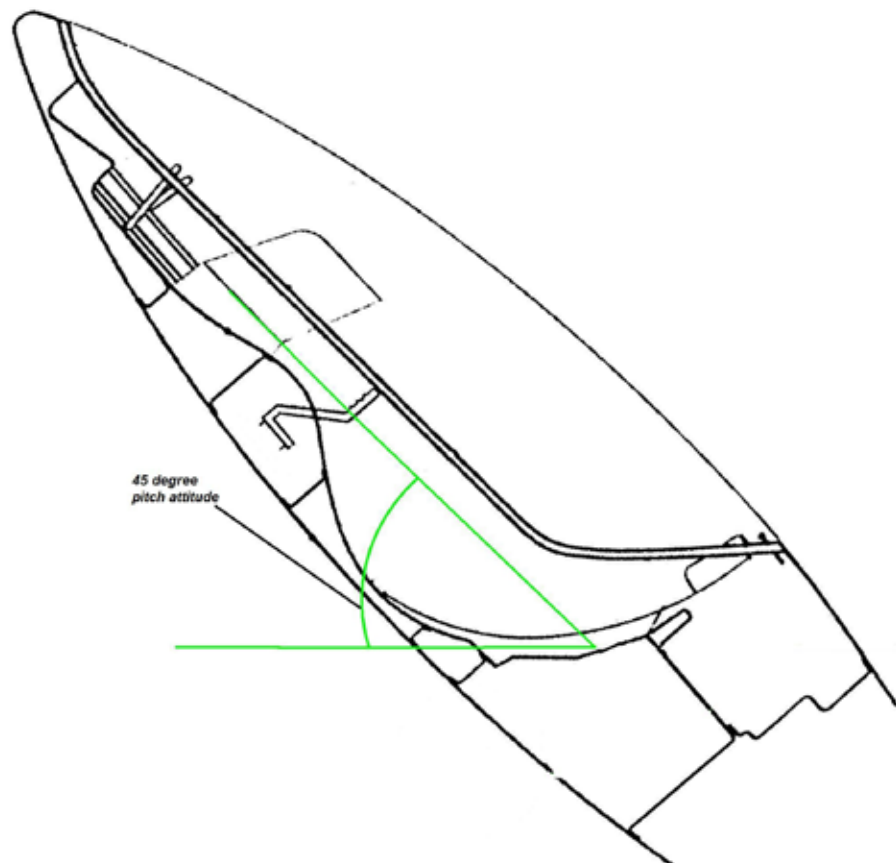
**Figure 5**

The seating position in the DG600 is semi-reclined, (see Figure 5), with a smoothly curved backrest. Typical fuselage pitch attitudes during a winch launch are between 35° and 45°; this results in the pilot's torso effectively lying flat on the seat back with his hips and legs raised.

In this position the mass of the pilot's hips and legs would exert a force on the pilot's torso which would tend push the pilot 'up' the seat back. Acceleration of the glider in the initial stages of the launch can also contribute to this effect. Any tendency for the pilot to move in this direction would normally be restrained by the harness shoulder straps.

If the pilot was unrestrained by the shoulder straps during the flight, it is possible that during the launch his body slipped 'up' the seat. The cockpit of the DG600 does not offer any obvious hand holds, with the exception of glider control levers. It is possible, therefore, that the pilot inadvertently pulled back further on the control column before finding a suitable hand-hold for his free hand. This would result in an increase in pitch, an increasing in the load on the winch and a decrease in the glider's airspeed, bringing it closer to its stalling speed. It may also have decreased the pilot's ability to lower the nose sufficiently rapidly to prevent the glider stalling and entering the spin.
