ACCIDENT

Aircraft Type and Registration:	Boeing 737-8AS, EI-DLR
No & Type of Engines:	2 CFM56-7B turbofan engines
Year of Manufacture:	2006
Date & Time (UTC):	13 November 2008 at 1920 hrs
Location:	Stand D 61, London Stansted Airport, Essex
Type of Flight:	Commercial Air Transport (Passenger)
Persons on Board:	Crew - 4 Passengers - 164
Injuries:	Crew - None Passengers - None
Nature of Damage:	No 1 engine cowling damaged, tow bar attachment broken
Commander's Licence:	Airline Transport Pilot's Licence
Commander's Age:	53 years
Commander's Flying Experience:	14,000 hours (of which 2,500 were on type) Last 90 days - 270 hours Last 28 days - 23 hours
Information Source:	AAIB Field Investigation

Synopsis

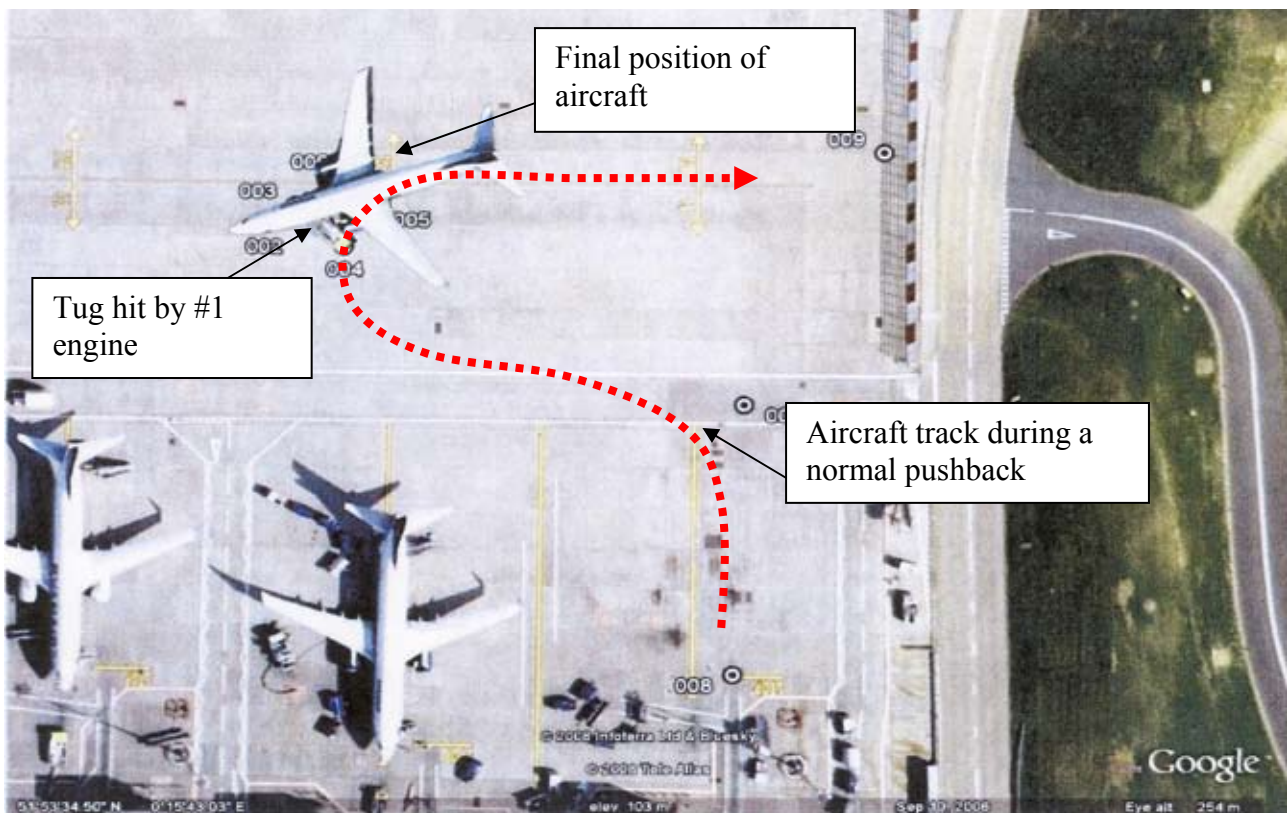
The pushback from stand D61L requires a ‘dogleg’ manoeuvre to be carried out, see Figure 1. As the tug was starting to straighten the aircraft onto the taxiway centreline, the headset operator called the commander and said ‘CLEAR TO START NUMBER TWO’. The commander

Figure 1
‘Dogleg’ pushback manoeuvre from Stand D 61 at London Stansted Airport

Plotting of the ground markers identified that, in its final position, the aircraft was pointing approximately 30° to the left of the taxiway centreline, Figure 1. Although the pushback procedure used on this stand is known as a 'dogleg' pushback, the aircraft actually transcribes a path closer in shape to a letter 'S'. In order to achieve this, the tug faces almost at right angles to the centreline of the aircraft prior to the manoeuvre being completed, Figure 4. Given the angle of the towbar relative to the aircraft as a consequence of this manoeuvre, the tug would have been able to exert relatively little resistive force to the forward movement of the aircraft. The aircraft's nosewheels would also have been pushed to a high angle of turn at this point so, as the aircraft moved forward, the tyres skidded rather than rolled, leaving the ground marks observed. The tug driver vacated his cab, given its increasing proximity to the aircraft's operating engine, leaving the tug in the path of the oncoming aircraft. The left engine then contacted the side of the tug, rotating it and pushing it sideways. At this point, the pilot applied the brakes and stopped the aircraft.

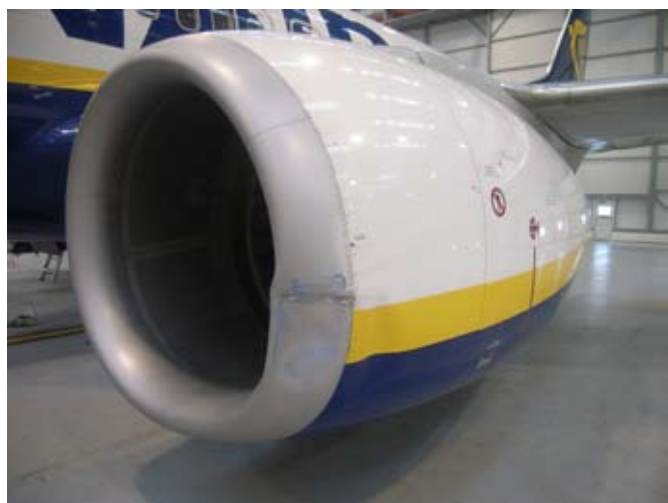
A large dent and a crease along the outside edge of the cowl, at the four o'clock position looking aft, was present on the aircraft's No1 engine nose cowl, together with an open crack along the circumference of the nose cowl leading edge where the cowl had distorted. Paint had been removed along the line of the crease and blue paint from the tug had transferred onto the cowling across the whole depth of the dent, Figure 3. The left nosewheel tyre tread exhibited a large cut and missing sections of tread. The towbar attachment bar on the front of the nose landing gear had been distorted.

Figure 3
Cowling damage

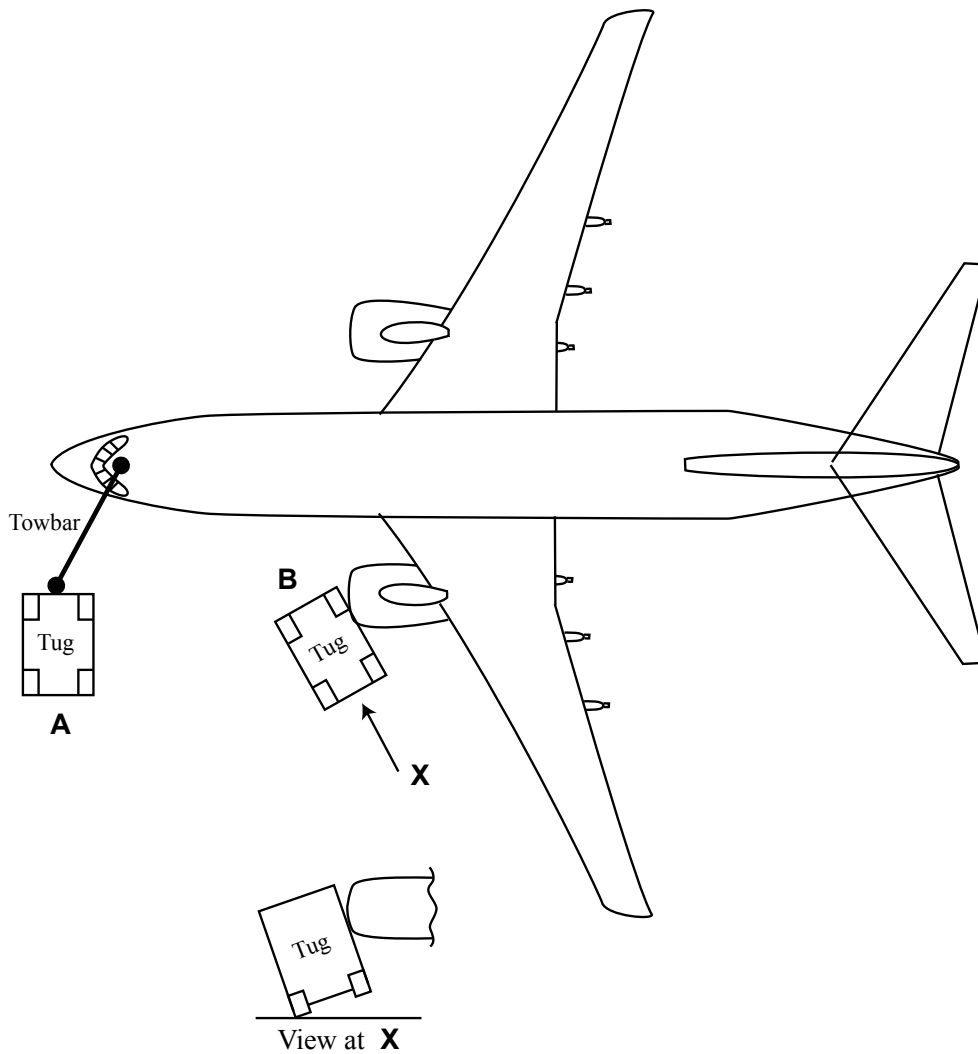
- A** Approximate position of tug relative to the aircraft when the aircraft began to move forward
- B** Position of tug relative to the aircraft when the aircraft came to rest

Diagram showing the approximate relative positions of tug and aircraft

the aircraft began to move forward the resistive force applied by the tug was acting almost perpendicular to the aircraft thrust line and quickly resulted in an overload of the towbar attachment. This removed any ability of the tug to prevent further forward movement of the aircraft. Although the tug in use was relatively lightweight and the taxiway conditions were wet, these were not considered to be significant contributory factors in this case.

Since this event, the operator has added the following information to their Part-A - Operations Manual, Section 8.2.6.4.2:

*'Flight Crew shall **not** attempt to crossbleed start until:*

- *Pushback is complete, **and***
- *The park brake is set, **and***
- *The tug is disconnected, **and***
- *ATC clearance is obtained.'*
