INCIDENT

Aircraft Type and Registration:	Avro 146-RJ100, G-CFAH
No & Type of Engines:	4 Lycoming LF507-1H turbofan engines
Year of Manufacture:	2001
Date & Time (UTC):	29 March 2005 at 1819 hrs
Location:	London (City) Airport
Type of Flight:	Public Transport (Passenger)
Persons on Board:	Crew - 5 Passengers - 104
Injuries:	Crew - None Passengers - None
Nature of Damage:	Tail scrape protection strip damaged
Commander's Licence:	Airline Transport Pilot's Licence
Commander's Age:	34 years
Commander's Flying Experience:	5,725 hours (of which 2,549 were on type) Last 90 days - 167 hours Last 28 days - 66 hours
Information Source:	AAIB Field Investigation

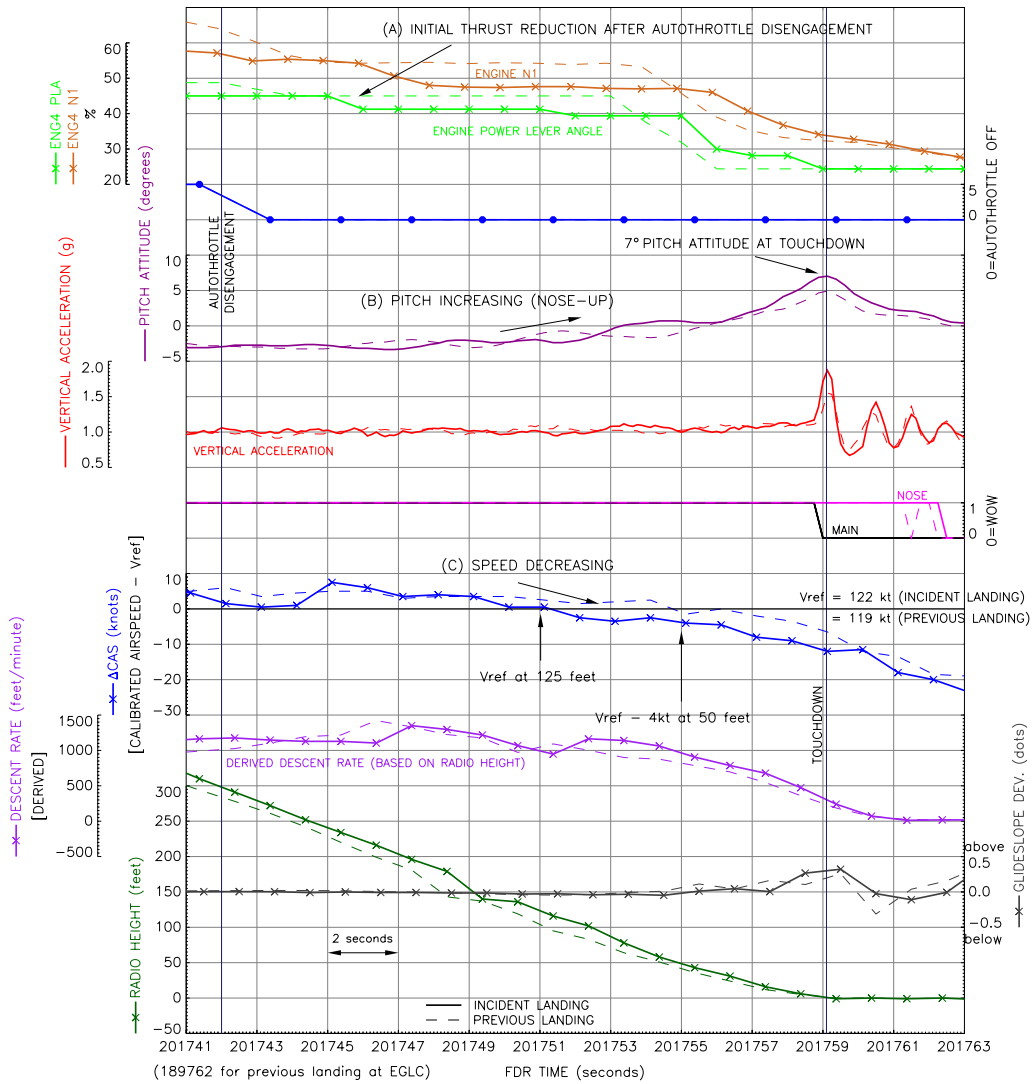
Figure 1
 Salient FDR Parameters
 (Incident to G-CFAH on 29 March 2005)

A time-history of the relevant parameters during the incident is shown in Figure 1 as a solid line. For comparison, data is also presented in Figure 1 for a normal landing carried out earlier that day by the same crew at London City Airport in G-CFAH (time-aligned for main-wheel touchdown), this is depicted as a dashed line.

Three seconds after the disengagement of the autothrottle, the power levers for all four engines were retarded slightly, reducing N1 to 48% two seconds later (Point A of Figure 1). As the aircraft descended, its pitch began to increase (Point B of Figure 1) and the airspeed began to decrease (Point C of Figure 1) while maintaining the 5.5° glideslope. At 125 ft, with the airspeed at V_{ref} , the power levers were further retarded causing a slight reduction in

N1. At 50 ft, when the power levers were retarded for the flare, the airspeed had decreased to $V_{ref} - 4$ kt and the descent rate was about 1,060 ft/min (compared with V_{ref} and about 880 ft/min for the previous landing³).

increased to just above 0° , where it remained for three seconds before increasing steadily until touchdown. At touchdown the pitch attitude was 7° , the airspeed was $V_{ref} - 11$ kt and the descent rate was 480 ft/min (compared with 5° , $V_{ref} - 6$ kt and 360 ft/min respectively for the previous landing).
