No: 7/88

Ref: EW/G88/02/09

Aircraft Type and Registration: Piper PA 28-140, G-AXTH

Location: Compton Abbas Airfield, Wiltshire

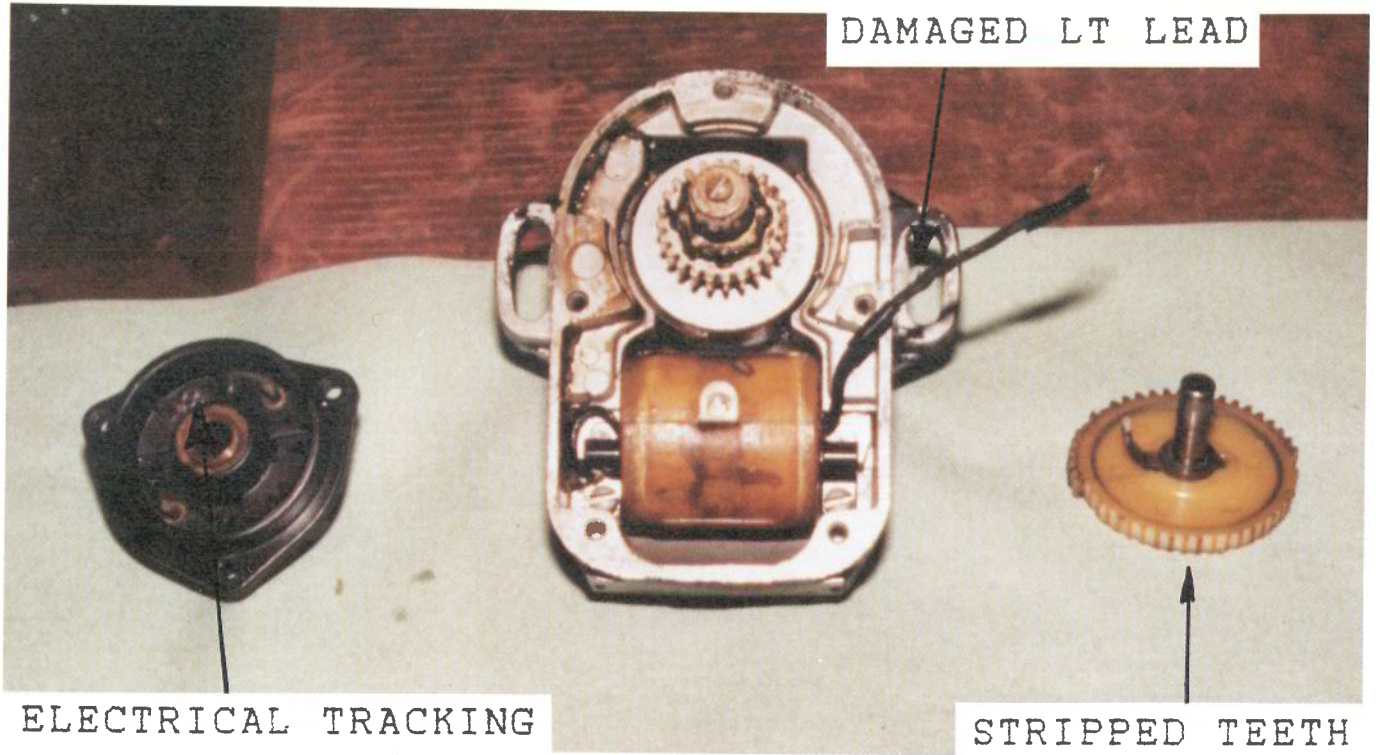
The aircraft was dismantled and transported to the AAIB engineering facility at Farnborough for further examination. The engine, whilst still mounted in the airframe, was test-run. It was found to run very roughly and would not achieve full power. When the magnetos were checked during the engine run, it was noted that the right-hand magneto produced an excessive rpm-drop and that the engine backfired. Strip examination at an authorised overhaul agency found that the teeth of the nylon distributor gear had been "stripped" over half of the gear circumference, and that there was heavy electrical tracking and arcing within the HT cap. It was also noted that the LT lead from the contact breaker to the coil was badly damaged, to the extent that it could have given intermittent electrical continuity. There was no obvious reason for the teeth to have stripped from the gear, although it was suggested by the agency that engine backfiring could have caused this type of damage.

DAMAGED LT LEAD

ELECTRICAL TRACKING

STRIPPED TEETH
