No: 2/92

Ref: EW/C91/11/1

Aircraft Type and Registration: 1. Airbus A310-221, HB-IPA
2. Boeing 757-236, G-BMRI

Location: Stand E36, Terminal 2, London Heathrow Airport

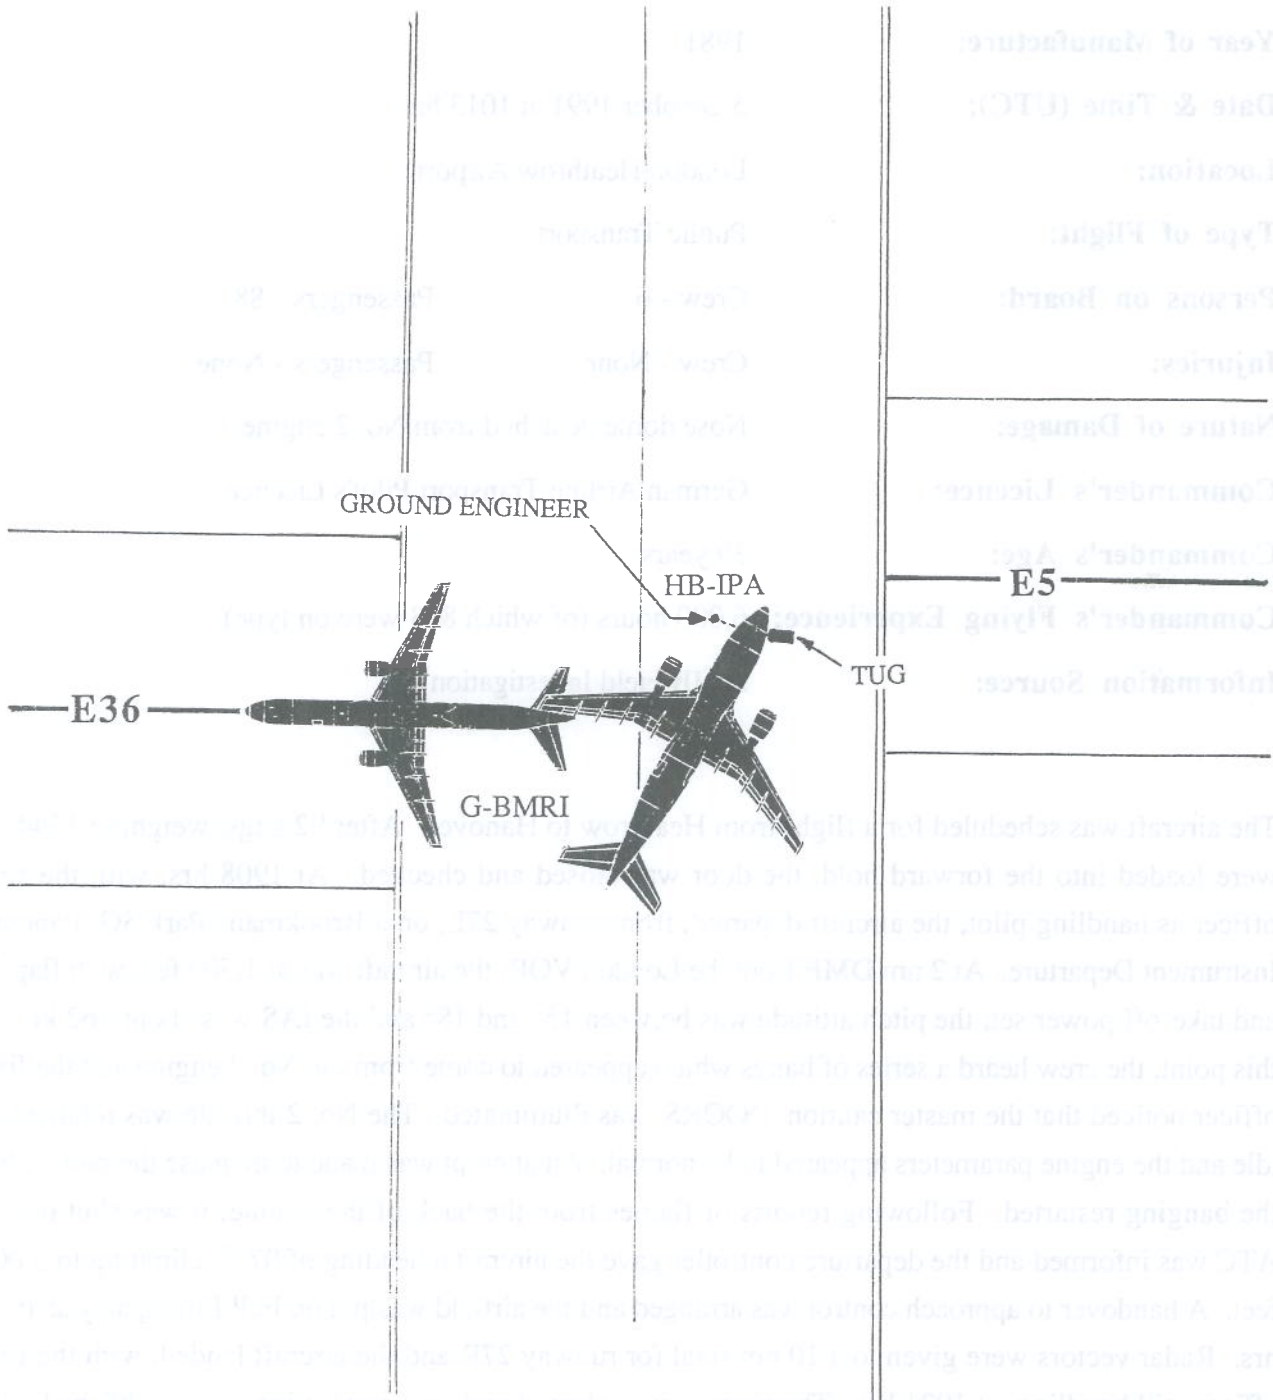
From subsequent measurements at the scene, the tail of the Boeing 757 was found to be protruding approximately twenty one metres into the taxiway beyond the end boundary marking of the E36 stand (See diagram). The overall length of the Boeing 757 to the rear of the fuselage is 46.9 metres.
