## ACCIDENT

| <b>Aircraft Type and Registration:</b> | Airwave Sport 3-L paraglider, no registration required | |
| <b>Date &amp; Time (UTC):</b> | 7 September 2006 at about 1830 hrs | |
| <b>Location:</b> | White Rocks, near Portrush, County Antrim | |

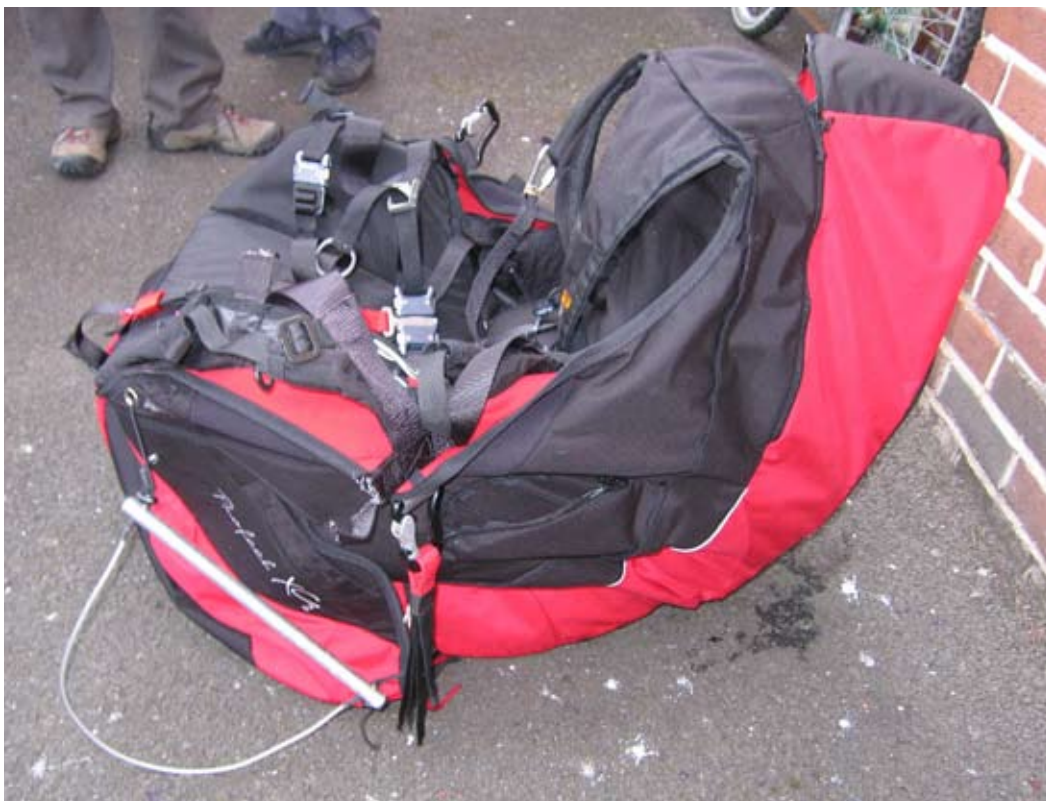
**Figure 1**

The Profeel XC2 harness, (Figure 1), was fitted with shoulder, lap and leg straps to secure the pilot. The shoulder straps were attached to the lap straps and both the lap and leg straps were fastened using quick release latches, which could be released by simultaneously pressing two tabs on the latch. A reserve parachute was carried in a pocket on the lower right side of the harness and an additional pocket was provided on the rear of the harness to allow stowage of personal items. The harness incorporated a 'Bumpair 17' back protection system, which was designed to provide cushioning in the event of a hard landing. The 'Bumpair 17' consists of a 40-litre multi-cell shaped foam 'cushion' extending from the pilots shoulders around the base of the harness and under the pilot's thighs, reaching its maximum thickness at the base of the spine and under the pilot's thighs. The foam is designed to release air and compress at a controlled rate, to minimise shock loading of the spine and legs.

Profeel XC2 harness

The harness showed no defects which would have contributed to the accident, or which would have prevented the pilot releasing himself from the harness whilst in the water.

The harness lap and leg straps would have made swimming difficult and would have hampered the pilot's attempts to climb onto the submerged rocks. The buoyancy from the Bumpair air bag in the harness would also have tended to push the pilot's head underwater, this being compounded by the pilot's lack of a life jacket. These facts, together with the sea state presented by the spring tide and prevailing weather, resulted in a set of circumstances that significantly increased the likelihood of drowning.
