Enstrom F-28A, G-BWOV

AAIB Bulletin No: 7/2001 **Ref:** EW/G2000/11/01 **Category:** 2.3

Incident

Aircraft Type and Registration: Enstrom F-28A, G-BWOV

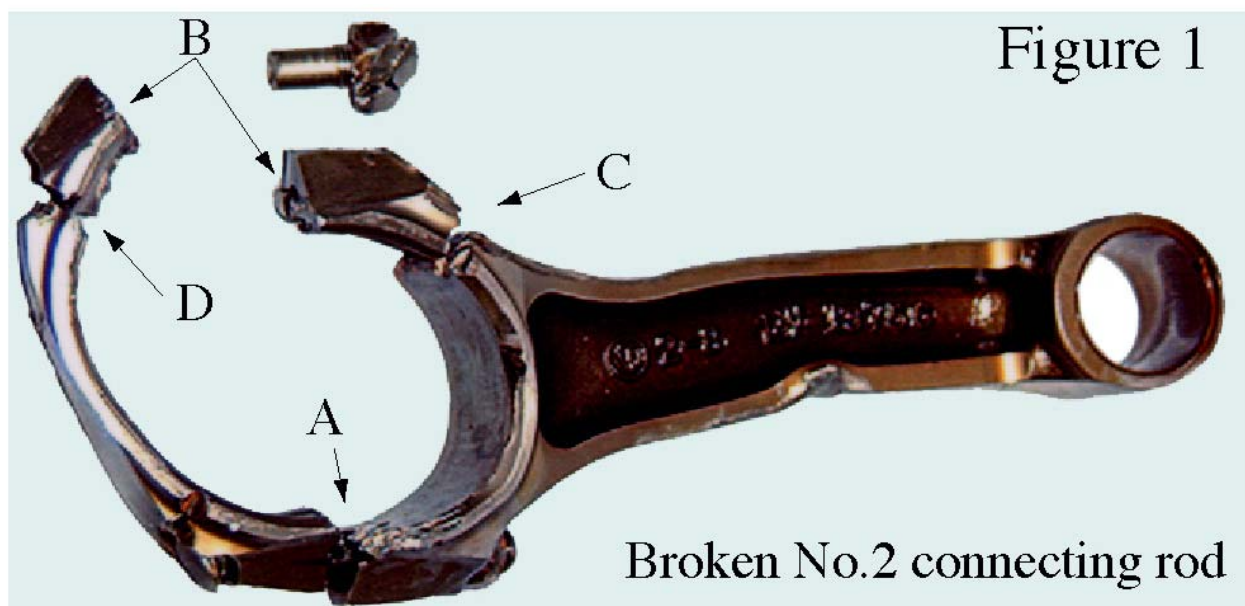
Examination of the No 2 connecting rod big end (see illustration) revealed that both cap bolts had failed close to the mating faces and that both the rod (at C) and the cap (at D) had broken through their sections on the same side of the bearing. Both halves of the cap bolt from the unbroken side of the rod (A) were recovered, but only the bolt tail and nut from the other side (B) were found.

Metallurgical examination of the No 2 big end components revealed the presence of high cycle fatigue in the failure across the section of the cap at 'D'. As a result of subsequent damage to the failure surfaces in the area where the fatigue had originated, it was not possible to establish whether or not there had been any significant pre-existing damage or defects in the area of the fatigue origin.

The failures across the section of the rod at 'C', and that of the bolt 'B', were both the result of high strain, low cycle, fatigue. The failure of the bolt at 'A' was the result of bending overload. The observed failures were consistent with the primary failure having been a tensile fatigue failure of the cap. As a result of this cap failure, the remainder of the cap attached by the bolt at 'B' had acted as a 'hook' and had applied large cyclic bending loads to the connecting rod at 'C' and large cyclic tensile loads to the bolt at 'B', inducing consequential failure of both.

The failure of a connecting rod big end cap was extremely unusual. The failed parts were sent to the manufacturer, together with the known engine service history. During their inspection, the manufacturer detected evidence of 'galling' on the big-end cap in the vicinity of the fatigue failure. Galling in bearing housings is normally associated with movement of the bearing shells within the housing and is known to generate surface defects which can be conducive to fatigue initiation. It does not occur under normal operating conditions, but is a common result of engine overspeeding. The overhaulers who performed the last overspeed check were fully aware that galling of big-end housings was unacceptable and that connecting rod assemblies with galling damage must be scrapped.

The investigation found the presence of galling damage to the failed big-end cap which was consistent with the type of damage most frequently associated with engine overspeeding. This finding suggested that this engine, after it had been subjected to the previous full overspeed check inspection and rectification, may have suffered at least one unreported overspeed event which had caused the galling found present on the big end cap. This galling could have initiated the fatigue failure of the cap.

This incident highlighted the importance of having a full overspeed inspection performed following engine overspeeds of more than 10%.
