No: 6/89

Ref: EW/G88/05/13

Aircraft Type and Registration: Cessna 401, G-OADS

Location: Leeds-Bradford Airport

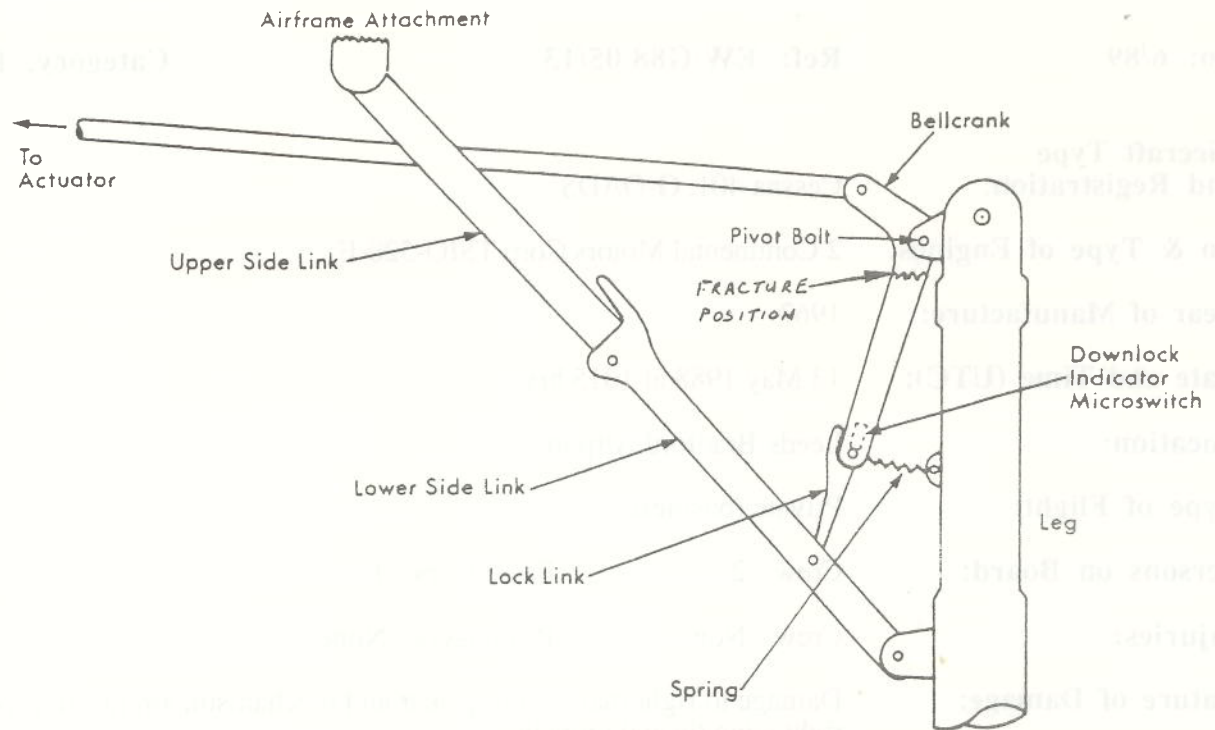
Main Landing Gear Schematic

Examination of the right main landing gear carried out after some dismantling had taken place indicated that a failure had occurred in the bellcrank of the main-gear retraction linkage which also forms part of the geometric downlock. The fracture was a bending overload failure, the direction of loading being the same as that normally occurring during the final stages of gear extension. It was also the same direction as the loading to be expected if the leg had retracted whilst carrying the weight of the aircraft with the side links not in the geometrically locked position.

It was noted that the position of the fracture permitted the lower part of the bellcrank and the attached lock link to move under the influence of spring pressure to a position where the downlock micro-switch would operate, almost regardless of the leg position. There was evidence to suggest that a number of the pivot bearings associated with extension and retraction of the leg had received inadequate lubrication. Failures of this type of bellcrank component on Cessna 340 and 420 aircraft were reported in AIB Bulletins 5/85 and 7/85 respectively. Both occurred under generally similar circumstances to that of G-OADS, although the position of the fractures on those bellcranks were different from that in G-OADS. A further somewhat similar failure was reported in Bulletin 3/81.
