No: 11/86

Aircraft type and registration: HS 748 Series 2A-245 G-BFLL

Nature of damage: Loss of section of right elevator outboard of outer hinge

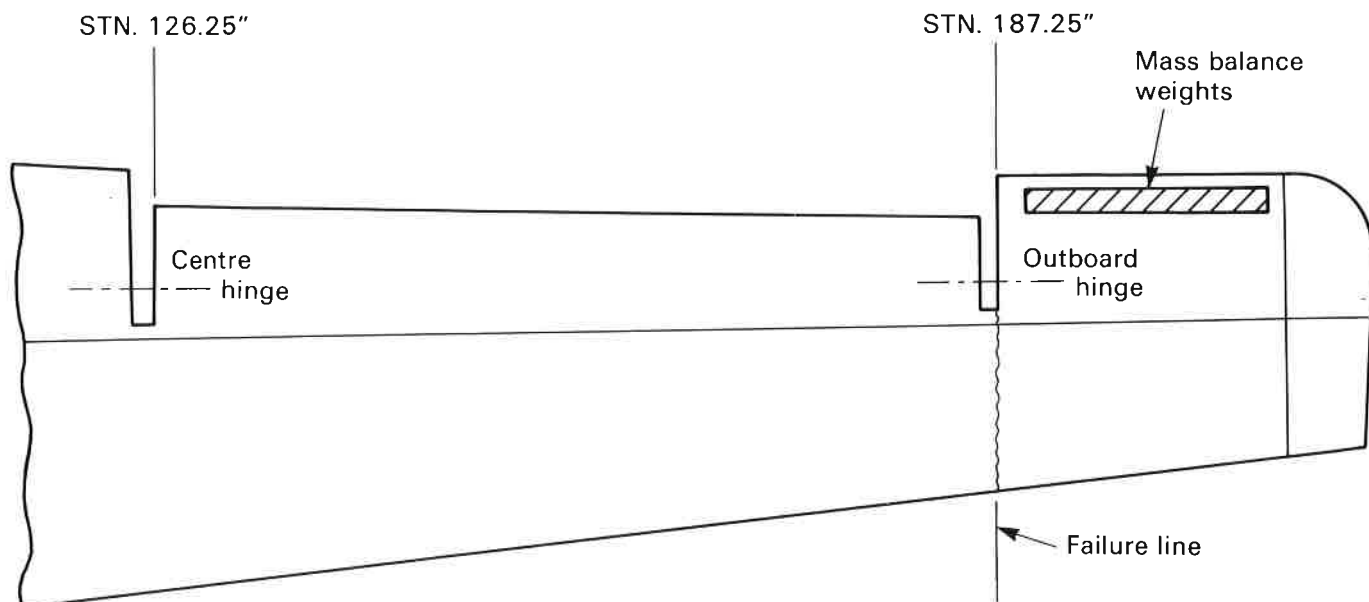
FIGURE 1

A detailed inspection and strip examination of the failed elevator revealed that a chordwise failure had occurred at station 187" and that the fracture of the upper and lower areas of the aileron spar, nesting angles, and finger plates were all associated with high cycle fatigue.

Configuration of outboard section of elevator

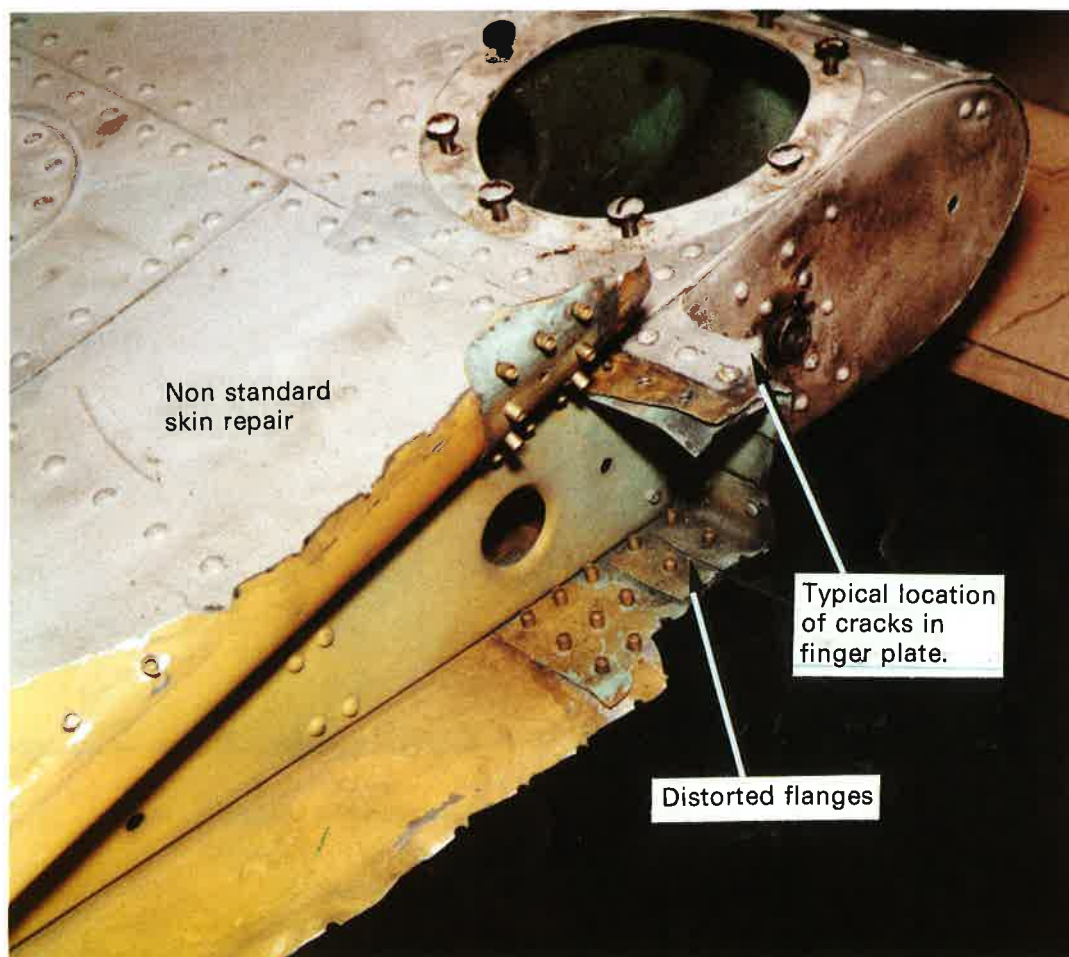
Bruising and fretting damage had occurred over relatively large areas of the fracture surfaces and local structure, indicating that the crack had been developing for some time. It quickly became apparent that the failure had occurred in the region of a poor quality repair that did not conform to the manufacturer's repair manual. Over-long blind or "pop" type rivets had been used to secure a skin insert and three rivets used to secure the inboard hinge rib (and its respective trailing edge rib) to the spar were missing. However, it was evident that at some time these rivets had been installed and a portion of one blind rivet which was recovered from this area showed evidence of fatigue. In addition, the hinge rib had been assembled onto the spar on a relatively thick bed of sealant which had not extruded from the joint as the rivets were installed, indicating an imprecise fit of these components after the repair.

Once the individual parts of the elevator adjacent to the failure were separated it became apparent that the horizontal flanges, both of the spar and nesting angles, were slightly rippled over a distance of several inches in from the failure. These ripples could not be readily explained as resulting from the elevator tip detachment and were strongly suggestive of a compression instability effect.

Elevator failure section details-G-BFLL

The structural repair manual for the aircraft is being reviewed by the manufacturer with reference to the adequacy of flying control surfaces repair instructions. In addition the secondary problem is being dealt with by the issue of service bulletins, one mandatory, relating to increased frequency of inspections and improvements which take into account the in-service experience of the aircraft type.

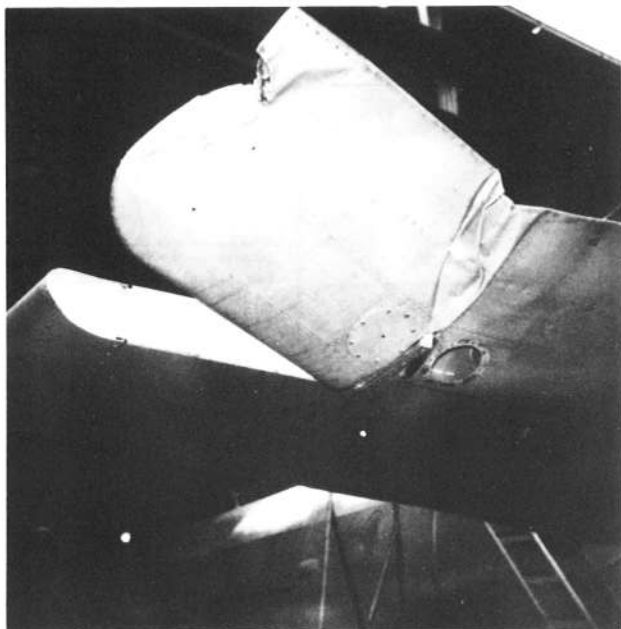
As part of a subsequent fleet inspection an elevator from a similar model HS748, TJ-CCV, was discovered which had suffered damage believed to be similar to that which occurred on G-BFLL. A photograph of the damage is shown as Figure 2. On examination, similar rippling was present on the upper and lower spar flanges over a similar distance, with a small crack present in the top surface spar nesting angle, close to the failure section position on G-BFLL. The manufacturer considered it probable that in both cases, after the spars were distorted, they were straightened and re-used leaving residual deformation of the flanges. Both these spars were identified as being of original manufacture.

Damage to TJ CCV

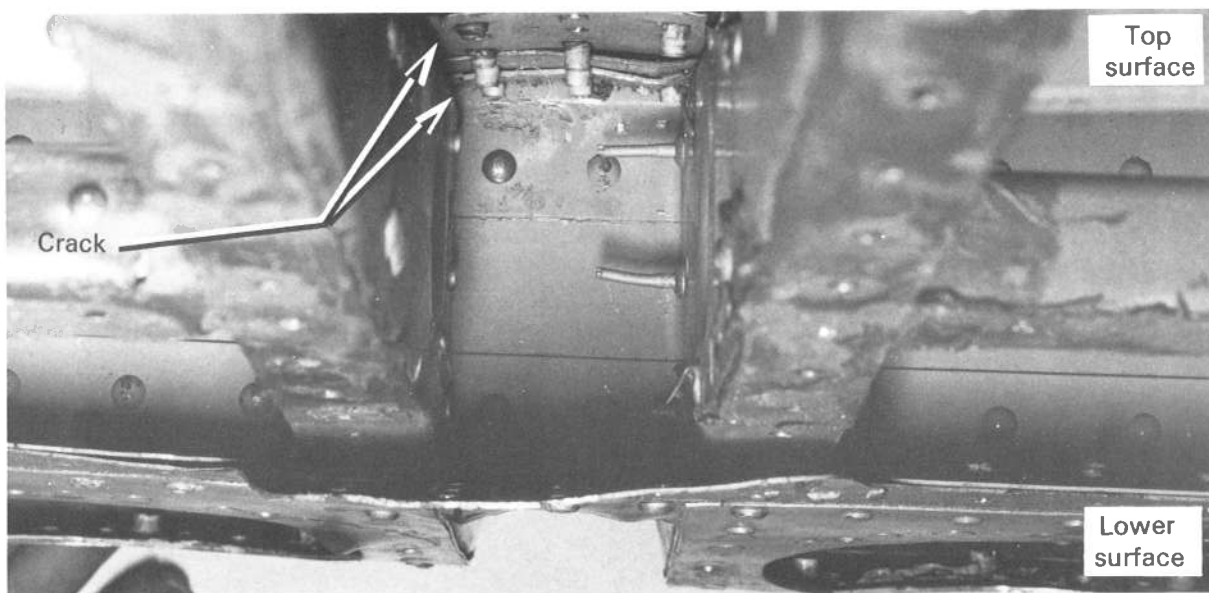
It was recorded that TJ-CCV had accomplished 3,700 hours and 4,600 landings since the repair.

View of O/B hinge cut out of left elevator from TJ-CCV showing distortion of flanges and crack in nesting angle 3700 hours after repair.
