ACCIDENT

| Aircraft Type and Registration: | i) Pierre Robin HR200/120B, G-BYLH ii) Pierre Robin HR200/120B, G-BXGW |
| Date & Time (UTC): | 27 August 2006 at 0835 hrs |
| Location: | Leeds (Bradford) Airport, Yorkshire |

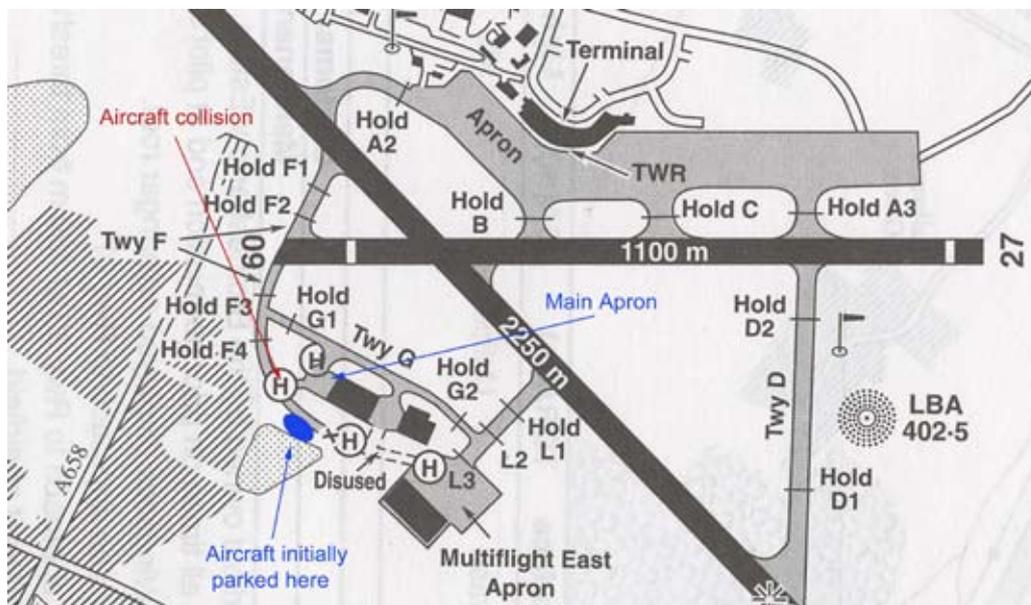
Figure 1

The aircraft commanders involved in this collision were both scheduled to carry out training details with their respective students and were employed by the same company. They were parked adjacent to each other on the south-western side of Taxiway 'F' (see Figure 1). After the engine had been started, G-BYLH was taxied

to the western mouth of the main apron where engine power checks were completed with the aircraft pointing north-west. Meanwhile G-BXGW had been started and the crew carried out power checks on Taxiway 'F' before ATC instructed them to taxi to the 'L1' hold for Runway 32 via Taxiways 'G' and 'L'. Due to limitations on available space, the operating company parks some of its aircraft on the western side of Taxiway 'F' and it was necessary for G-BXGW to be taxied to the right of the taxiway centreline in order to avoid these parked aircraft. This was the situation as G-BXGW passed the mouth of

the main apron where G-BYLH was positioned. As they passed, the right wing tip of G-BXGW collided with the left wing of G-BYLH which was protruding slightly into the taxiway. Both aircraft were shut down and the crew, who were uninjured, vacated through the normal exits.

As a result of this incident, aircraft operating on the south side of the airfield now complete their power checks at the appropriate runway holding point rather than on or adjacent to the taxiway in the start up area.
