No: 10/88

Ref: EW/G88/07/12

Aircraft Type and Registration: Rockwell Commander 114A, G-NATT

Nature of Damage: Damage to right undercarriage components and right wing

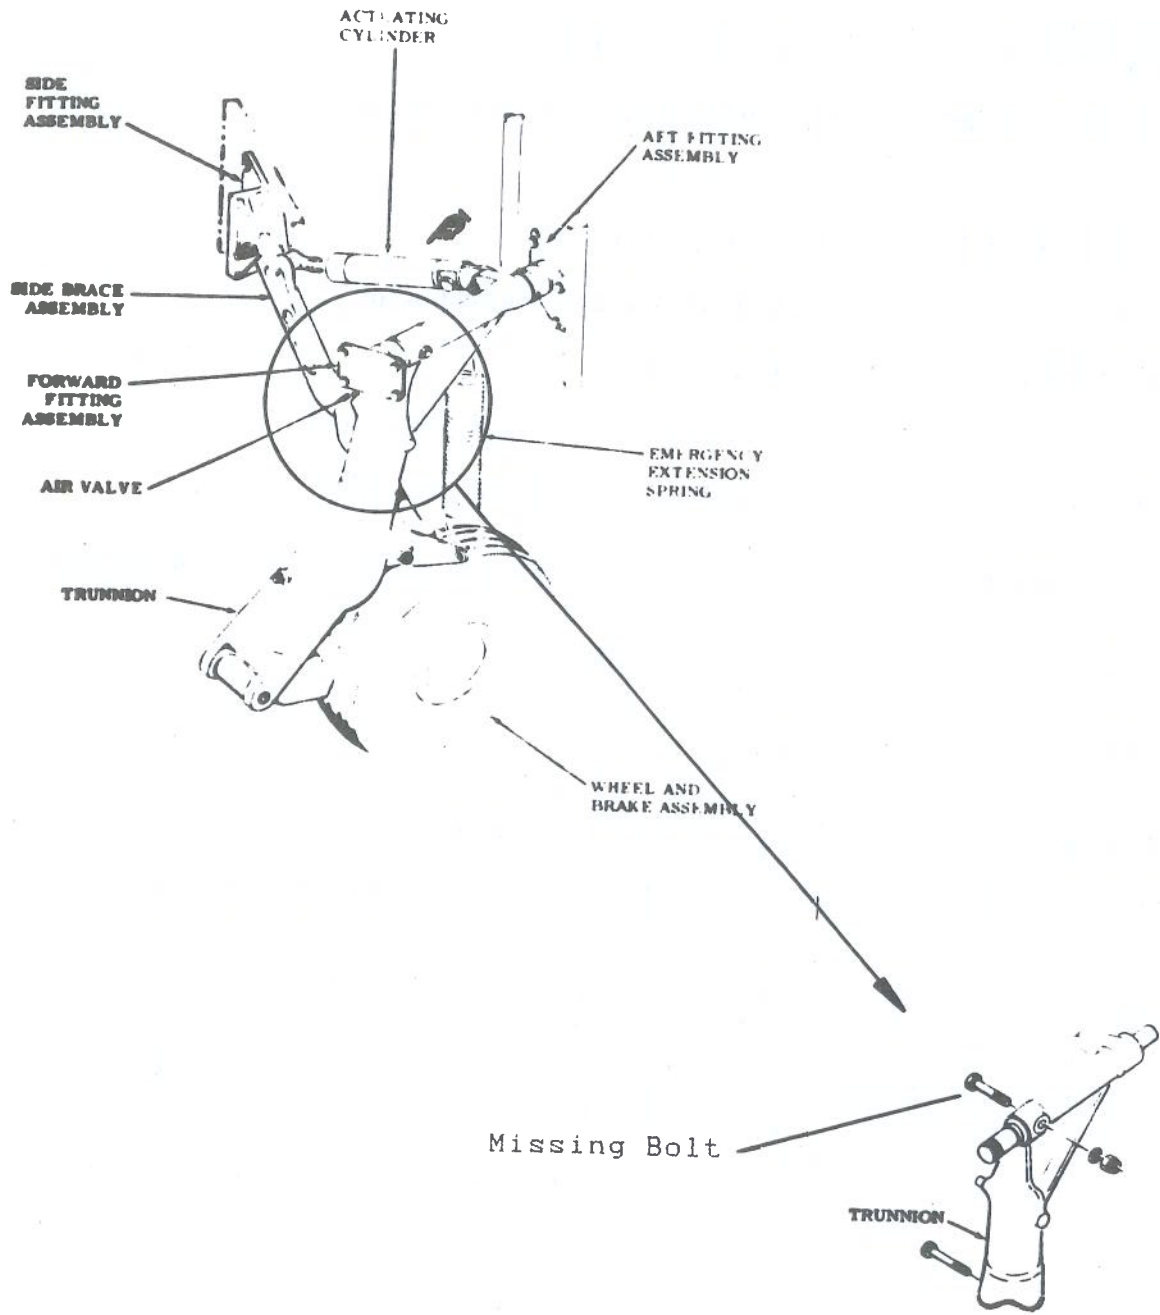
MAIN UNDERCARRIAGE DETAILS - ROCKWELL COMMANDER 114A

The aircraft was recovered by local maintenance personnel, who took the opportunity to examine the collapsed landing gear. With reference to Figure 1, it was quickly determined that the main pivot shaft at the top of the leg had moved forward, allowing the rear end to disengage from its aft fitting assembly. It was apparent that a bolt was missing from the forward end of this shaft. This bolt is intended to retain the front spigot in the shaft. It was therefore possible for this front spigot to move within the shaft.
