Boeing 737-436, G-DOCH

AAIB Bulletin No: 6/2004	Ref: EW/C2002/11/02	Category: 1.1
INCIDENT		
Aircraft Type and Registration:	Boeing 737-436, G-DOCH	
No & Type of Engines:	2 CFM56-3C1 turbofan engines	
Year of Manufacture:	1991	
Date & Time (UTC):	8 November 2002 at 1458 hrs	
Location:	Near Clacton, Essex	
Persons on Board:	Crew - 6	Passengers - 68
Injuries:	Crew - None	Passengers - None
Nature of Damage:	Damage and shorting within electrical wiring loom in cabin ceiling and associated failure of water supply hose	
Commander's Licence:	Airline Transport Pilot's Licence	
Commander's Age:	35 years	
Commander's Flying Experience:	4,400 hours (of which 4,150 were on type)	
	Last 90 days - 144 hours	
	Last 28 days - 52 hours	
Information Source:	AAIB Field Investigation

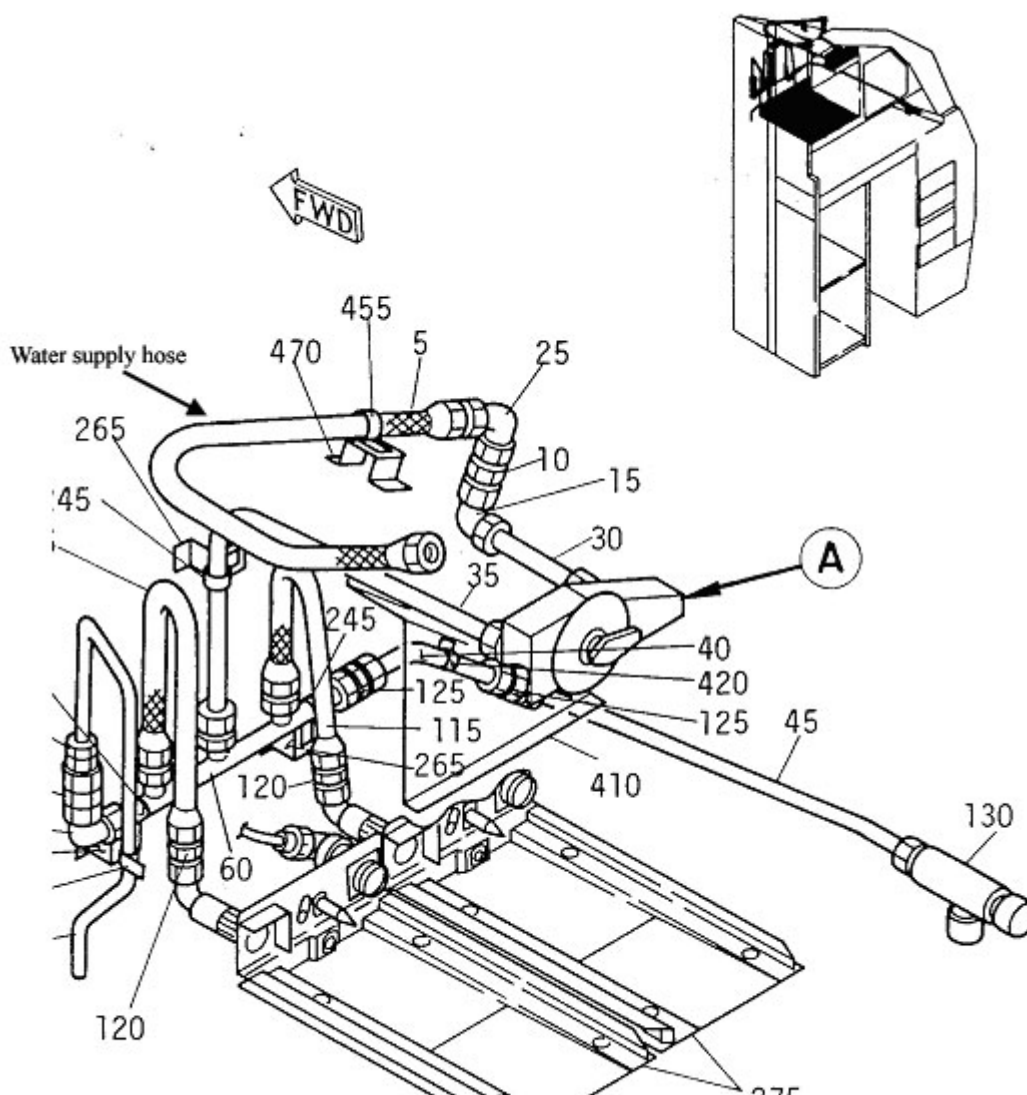
Figure 3: Illustration from galley Component Maintenance Manual

The water supply hose was removed from the aircraft for examination. The galley, Figure 3, was designed and manufactured by the JAMCO manufacturing company in Japan as buyer-furnished equipment (BFE), specified by the customer but fitted, in this case, at the time of the aircraft's manufacture.

Figure 3 Illustration from galley Component Maintenance Manual
