ACCIDENT

Aircraft Type and Registration:	Van's RV-9A, G-CCZT	
No & Type of Engines:	1 Lycoming O-320-E2A piston engine	
Year of Manufacture:	2004	
Date & Time (UTC):	16 April 2006 at 1525 hrs	
Location:	Bicester Airfield, Oxfordshire	
Type of Flight:	Private	
Persons on Board:	Crew - 1	Passengers - 1
Injuries:	Crew - None	Passengers - None
Nature of Damage:	Damage to the nose landing gear, propeller and the engine area	
Commander's Licence:	Private Pilot's Licence	
Commander's Age:	62 years	
Commander's Flying Experience:	137 hours (of which 45 were on type) Last 90 days - 1 hour Last 28 days - 1 hour	
Information Source:	AAIB field investigation

Synopsis

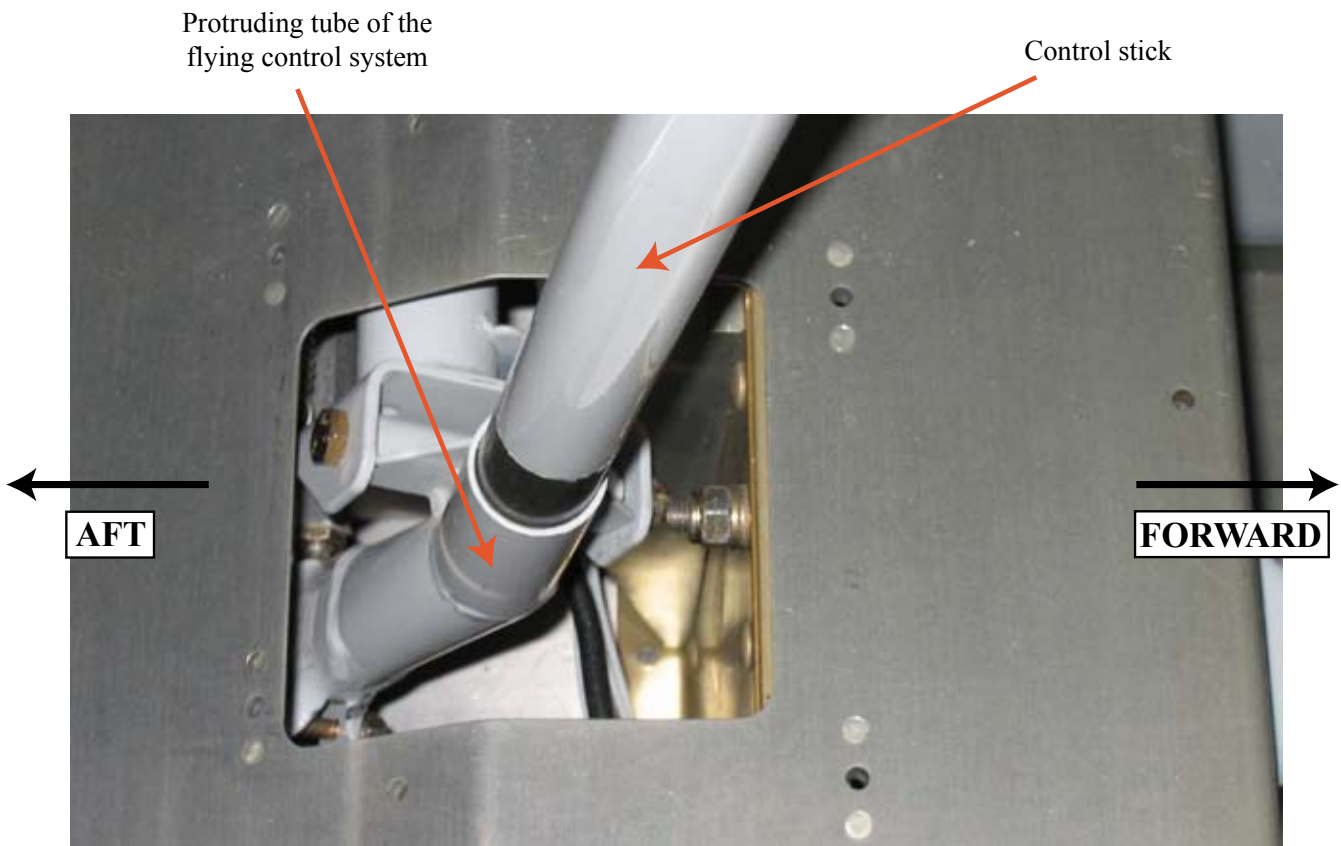
Figure 1

Whilst initiating the landing flare the dual cockpit control stick became disconnected from the flying control system and the aircraft pitched nose down. It impacted the grass runway damaging the nose landing gear, propeller and engine mountings and cowling.

The right-hand control stick, also known as the dual control stick, was attached to the flying control system by the lower section of the tubular stick sliding into the inside of a tube (protruding upwards from the forward seat

area) connected to the flying control system (Figure 1). The control stick was held into the protruding tube by the friction associated with the ‘push fit’ between the two tubes. There was no positive secure connection, such as, for example, a bolt between the control stick and the tube of the flying control system.

The aircraft manufacturer’s drawings did not specify any positive secure connection between the dual control stick and the aircraft’s flying control system.

19 May 2006 requiring a nut and bolt to be installed at the junction of the dual control stick and the aircraft’s flying control system on all Van’s RV-9/9A aircraft. During the PFA’s research they found that the Van’s RV-7/7A aircraft had a similar arrangement for the attachment of the dual control stick as that of the RV-9/9A. On 19 May 2006 the PFA issued mandatory airworthiness information MOD/323/001 requiring a nut and bolt to be installed at the junction of the dual control stick and the aircraft’s flying control system on all Van’s RV-7/7A aircraft.

It is recommended to Van's Aircraft, the producer of the drawings and aircraft kits, that they modify their drawings for the RV-7, -7A, -9 and -9A models to introduce a positive attachment of the dual cockpit control stick to the aircraft's flying control system.

It is recommended to Van's Aircraft, the producer of the drawings and aircraft kits, that they issue a Service Bulletin recommending to all owners of RV-7, -7A, -9 and -9A aircraft that they positively attach the dual control stick to the aircraft's flying control system.
