Slingsby Sport Vega Glider T65D, BGA 2758

AAIB Bulletin No: 7/2004	Ref: EW/C2002/06/05	Category: 3
Aircraft Type and Registration:	Slingsby Sport Vega Glider T65D, BGA 2758	
Year first registered	1981	
Date & Time (UTC):	23 June 2002 at 1248 hrs	
Location:	Wormingford Airfield, Colchester	
Type of Flight:	Private	
Persons on Board:	Crew - 1	Passengers - None
Injuries:	Crew - Serious	Passengers - N/A
Nature of Damage:	Glider destroyed	
Commander's Licence:	BGA Gold C, Diamond Height and Goal badges	
Commander's Age:	22 years	
Commander's Flying Experience:	415 hours	
Information Source:	BGA accident report and further AAIB investigation of restraint issues

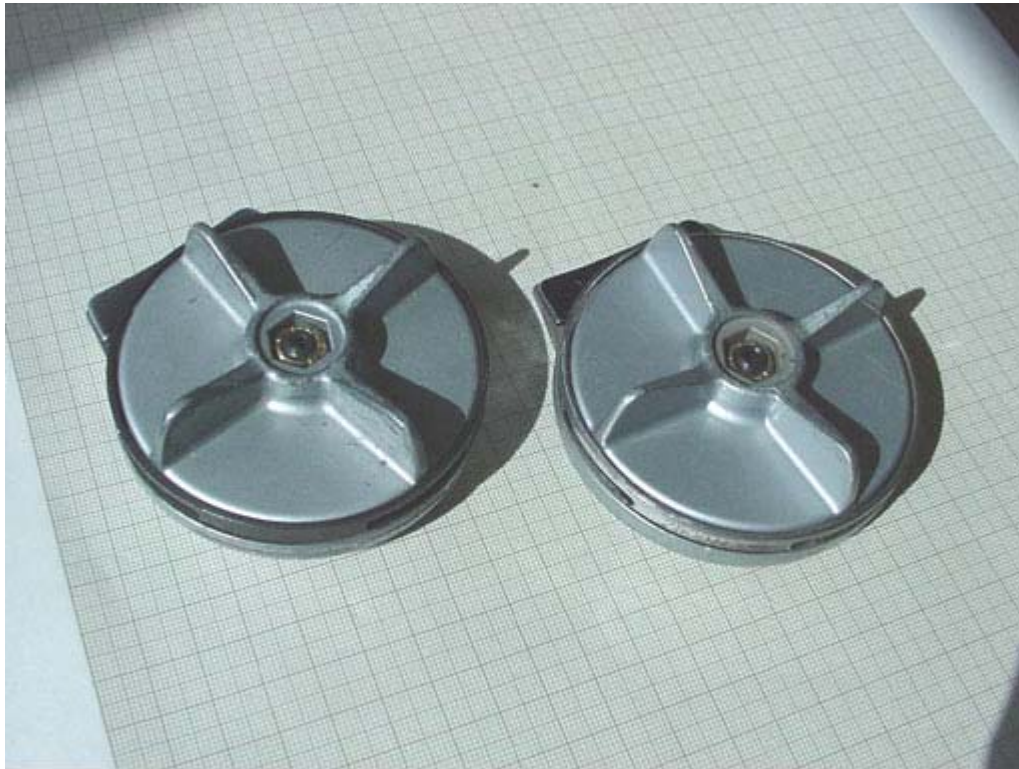
The rotary buckle is an all-metal device consisting of a housing with five slotted sockets to accommodate end fittings for two shoulder restraints, two lap belts and one crotch strap. Release of the end fittings is accomplished by rotating the four-vaned handle (see Figure 1) in either direction. The release mechanism for the crotch strap or either of the lap belts can be inactivated so that, with rotation of the handle, the buckle will remain attached to one item of webbing. The two shoulder restraints can also be released separately by pushing forward on the tab located between the shoulder fittings.

Figure 1 - Failed buckle and example buckle

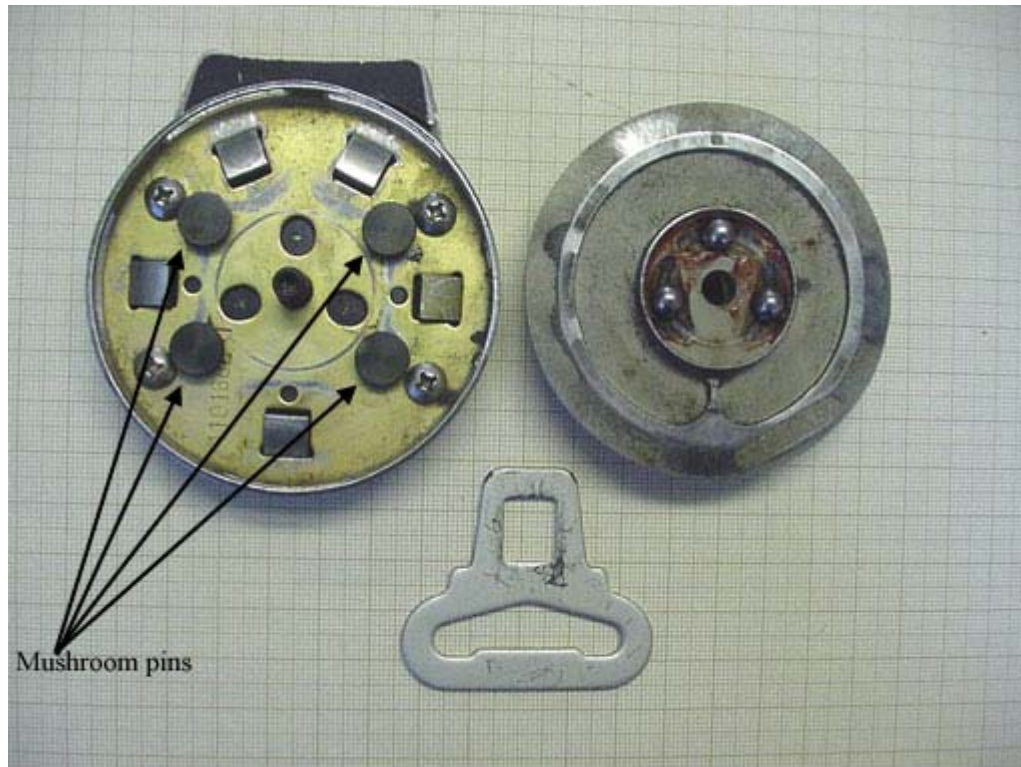
The rotary buckle is a simple fabricated device in which each belt plug-in fitting is restrained by a restraining dog (retracted by rotation of the four-vane handle), and a combination of the 'mushroom' pins shown in Figure 2 (an example with the pins in place).

Figure 2 - Example buckle with one harness fitting

It was noted that the shoulder restraint fittings only have one locating mushroom pin (Figure 2) but are held in place because of the restriction on their movement by the smaller spacing between the restraining dog and the head of the mushroom pin. Under load, the geometry of the harness would make the shoulder fittings more likely to maintain their 'flat' attitude to the buckle, whereas the lap fittings would be liable to tilt away from the body plate because of the direction of the applied force. It is this tilting that would tend to pry the mushroom pins from the body plate and, together with the increased freedom of movement, would allow the fitting to ride over the restraining dog if the mushroom pin became detached.

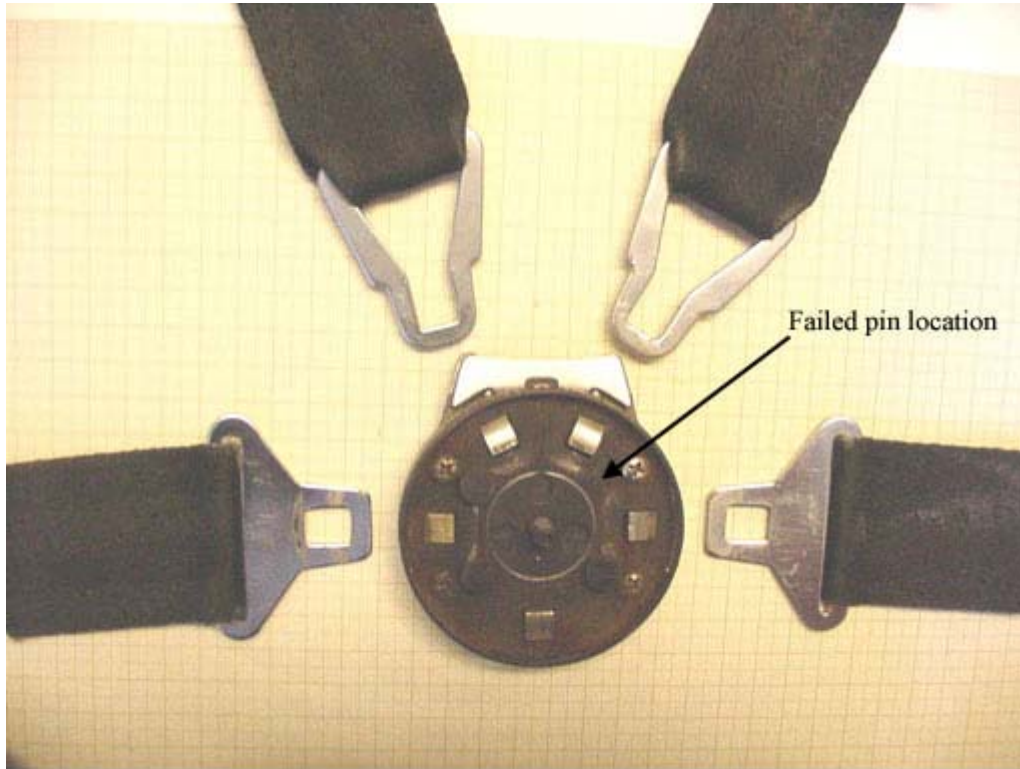
The buckle had failed (Figure 3 - failed buckle and end fittings) by the left-hand lap fitting pulling out of the buckle, which created witness marks on the fitting and on the remaining mushroom pin with which it was in contact (Figure 4).

Figure 3 - Failed buckle with harness fittings

Although the lap fitting from the failed buckle had a different pattern to the example fitting, it could not be determined whether this induced the pin failure. The metallurgist considered that of greater significance was the way in which the mushroom pins had been riveted in the failed buckle, when compared with example buckle (Figure 2) from the same manufacturer. On the example buckle the stems of the mushrooms were drilled before riveting and exhibited a greater spreading and hence a greater resistance to pull-out.

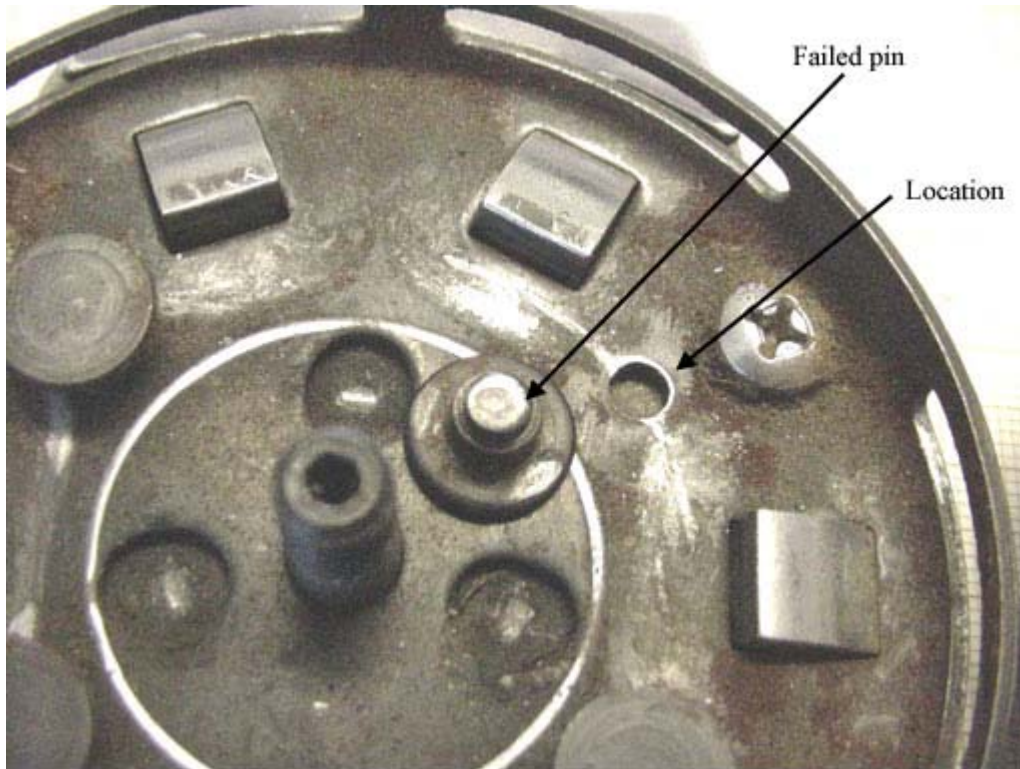
Figure 4 - Failed mushroom pin

In order for this to occur, the detached mushroom pin could not have been in place at the time of failure and the physical evidence indicated that it had been loose for some time. The arcs of scoring (Figure 4) show the rotational movement of the pin when the buckle was operated.
