INCIDENT

| Aircraft Type and Registration: | Boeing 757-28A, G-TCBA | |

Synopsis

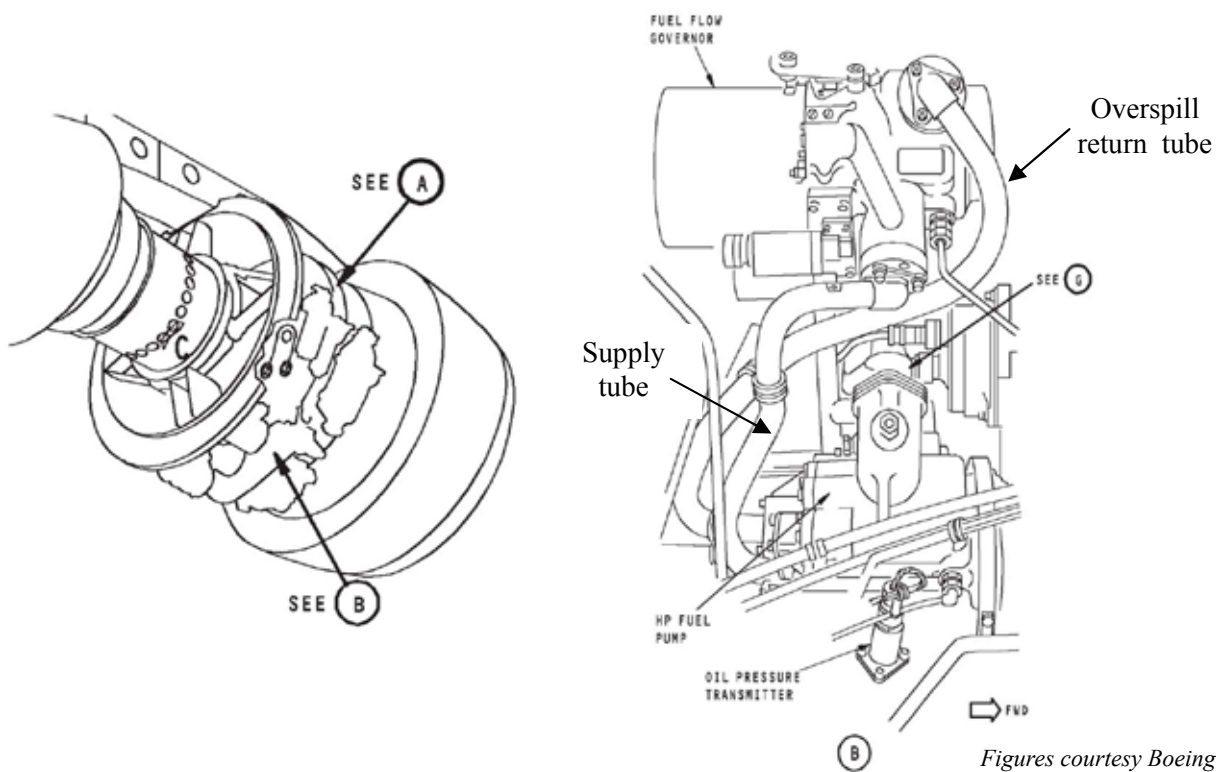
Figure 1

The operator's maintenance engineer traced the fuel leak to the seal ring between the HP fuel pump and the fuel flow governor (FFG) to HP fuel pump overspill return tube on the left-hand engine (shown in Figures 1 and 2). He therefore replaced this seal ring on both engines in accordance with the aircraft maintenance manual and a second maintenance engineer conducted a duplicate inspection, following which both engines were ground run at maximum static EPR to check for leaks. No fuel leaks were observed during this test and the aircraft was released to service.

Location of the HP fuel pump and FFG on the RB211-535E4 engine

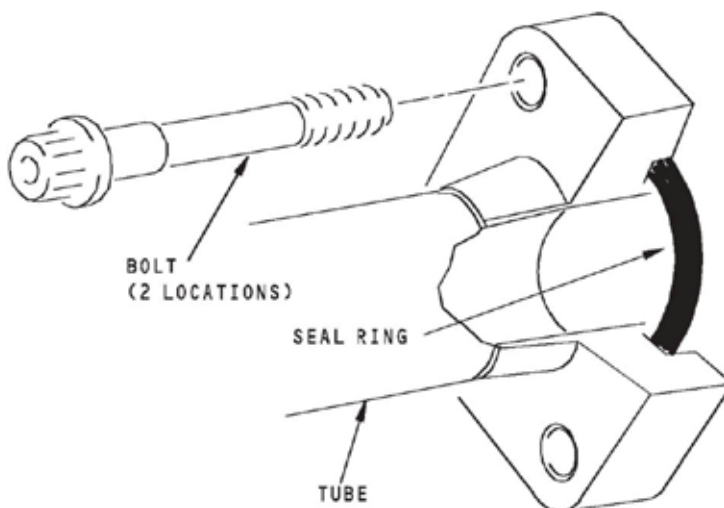
Figure 2

FFG fuel overspill return tube coupling at the HP fuel pump (post SB RB.211-73-B047)

Investigation undertaken by the engine manufacturer determined that the width of the seal ring groove in the fuel tube end adapter was insufficient to allow the seal ring to seat properly in the groove when the joint was compressed during torque tightening of the assembly. If the seal ring did not seat correctly, it was possible for it to become pinched at the corners of the groove. The action of vibration and fuel pressure fluctuations caused portions of the pinched seal ring to erode, resulting in a loss of sealing capability.

As the seal ring removed from the aircraft was discarded following the incident, contrary to the operator's maintenance organisation's procedures, it has not been possible to identify positively the cause of the fuel leak. However, given the recorded history of fuel leaks due to trapping and subsequent erosion of the seal ring on engines without SB RB.211-73-G230 embodied, it is considered that this is the most likely mechanism that caused the fuel leak in this incident.

In response, the engine manufacturer introduced a further SB, RB.211-73-G230, in November 2009 that increased the width of the seal ring groove from 2.60 mm to 4.15 mm. No engines incorporating this SB have subsequently experienced fuel leaks at the HP fuel pump fuel tube couplings. The engine manufacturer comments that compliance guidance contained in this SB currently recommends embodiment of this modification when the engine is disassembled for refurbishment or overhaul. The modification is currently optional on-wing, when the parts require renewal or when the fuel tube connections are disturbed during maintenance.

Recent human factors analysis by the engine manufacturer indicates acceptable reliability when tubes are replaced during planned on-wing maintenance. Hence a revision to the Service Bulletin is planned, to recommend on-wing replacement during planned maintenance and during unplanned overhaul shop visits. Hence, it is expected that this modification will be fully implemented into the fleet by the end of 2013 and progress against this target will be monitored.
